2011 -2012 Annual Environmental Management Report

National Ceramic Industries Australia

AECOM Australia Pty Ltd

25 September 2012

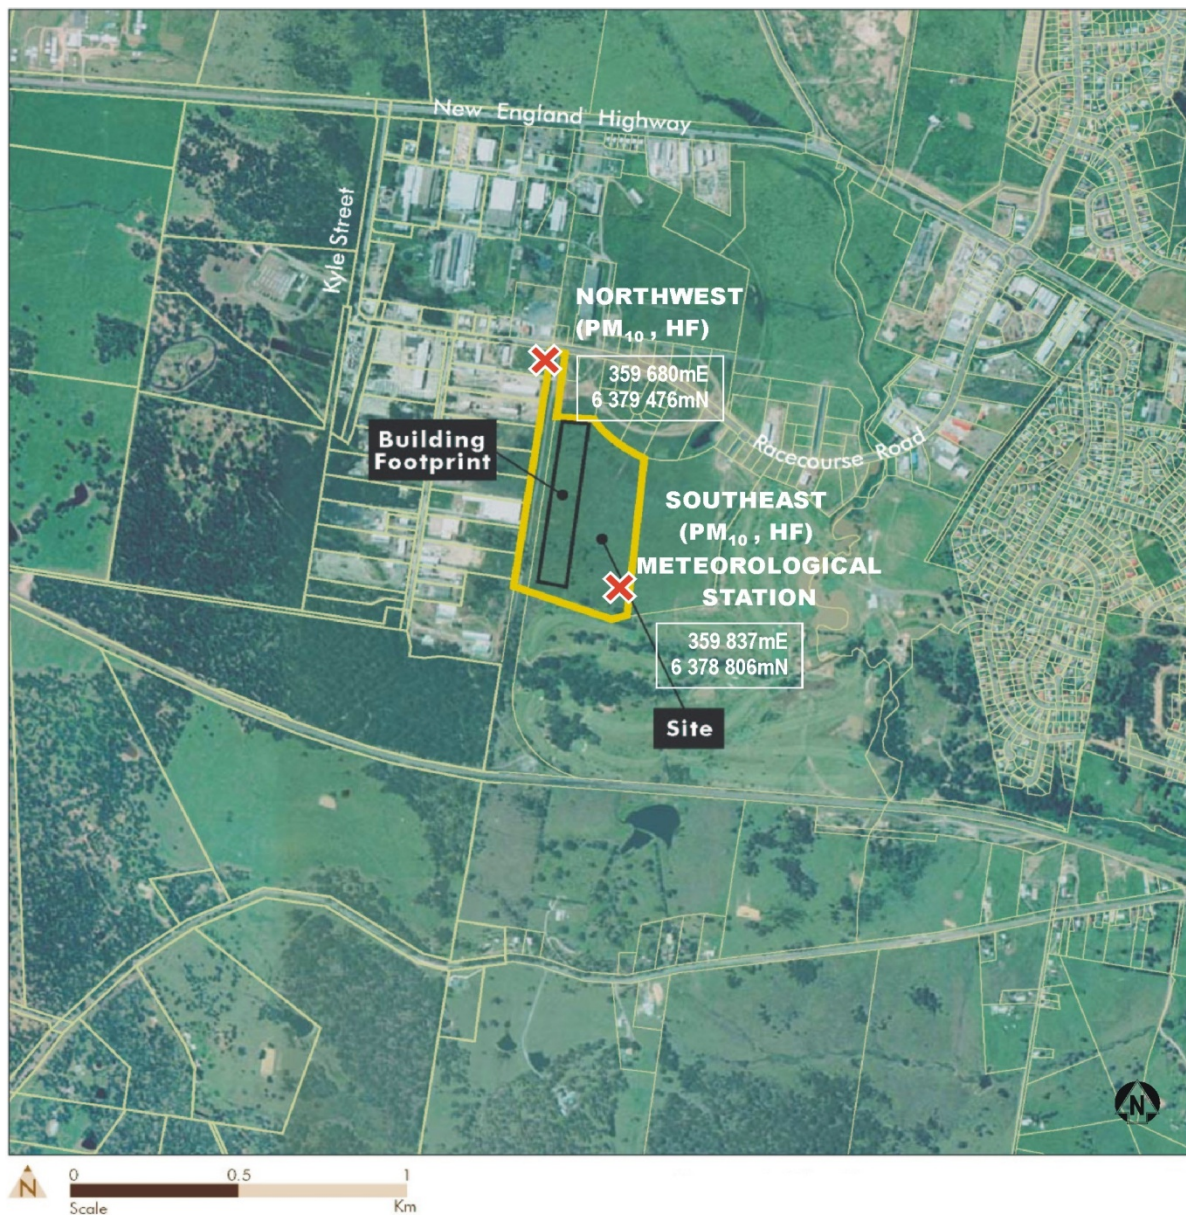
Figure 1 Ambient Air Monitoring Site Locations

Under Condition 5.2 of the Development Consent, ambient monitoring is required to “be conducted for the nearest sensitive receptors or specialised land use”. **Figure 1** identifies ambient air monitoring site locations.

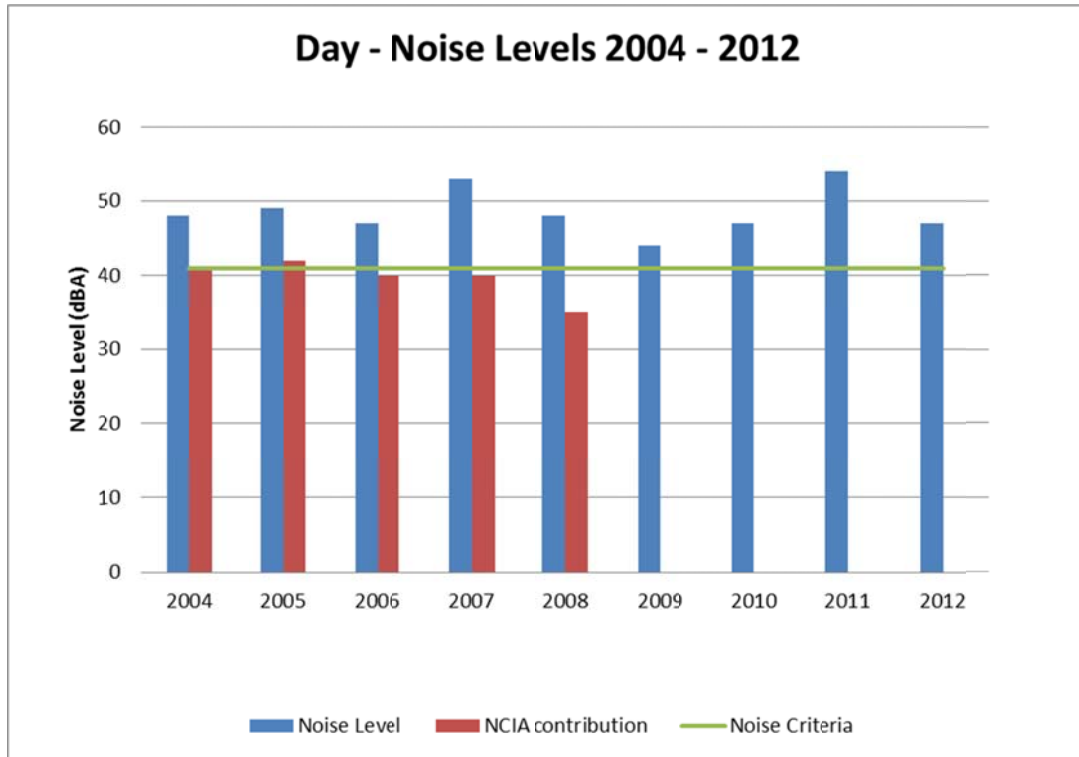
Figure 34 Day Noise Levels 2004 - 2012

Note: 2009, 2010, 2011 and 2012 – NCIA audible not measurable.

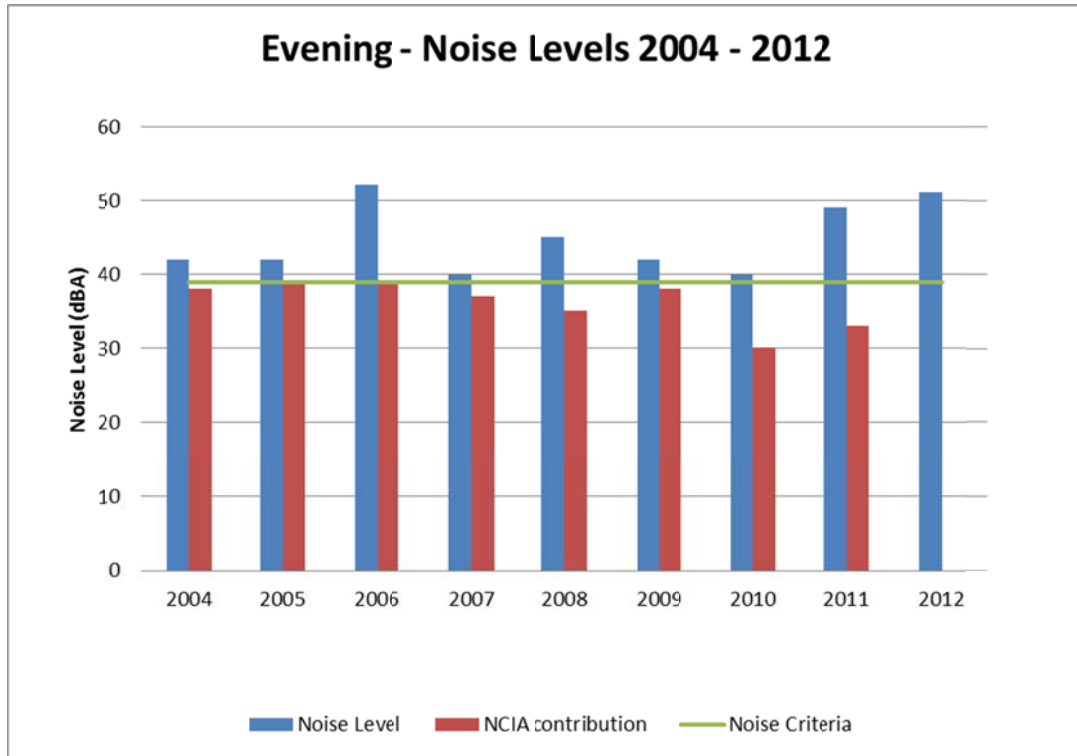
Figure 35 Evening Noise Levels 2004 – 2012

Note: 2012 – NCIA audible not measurable.

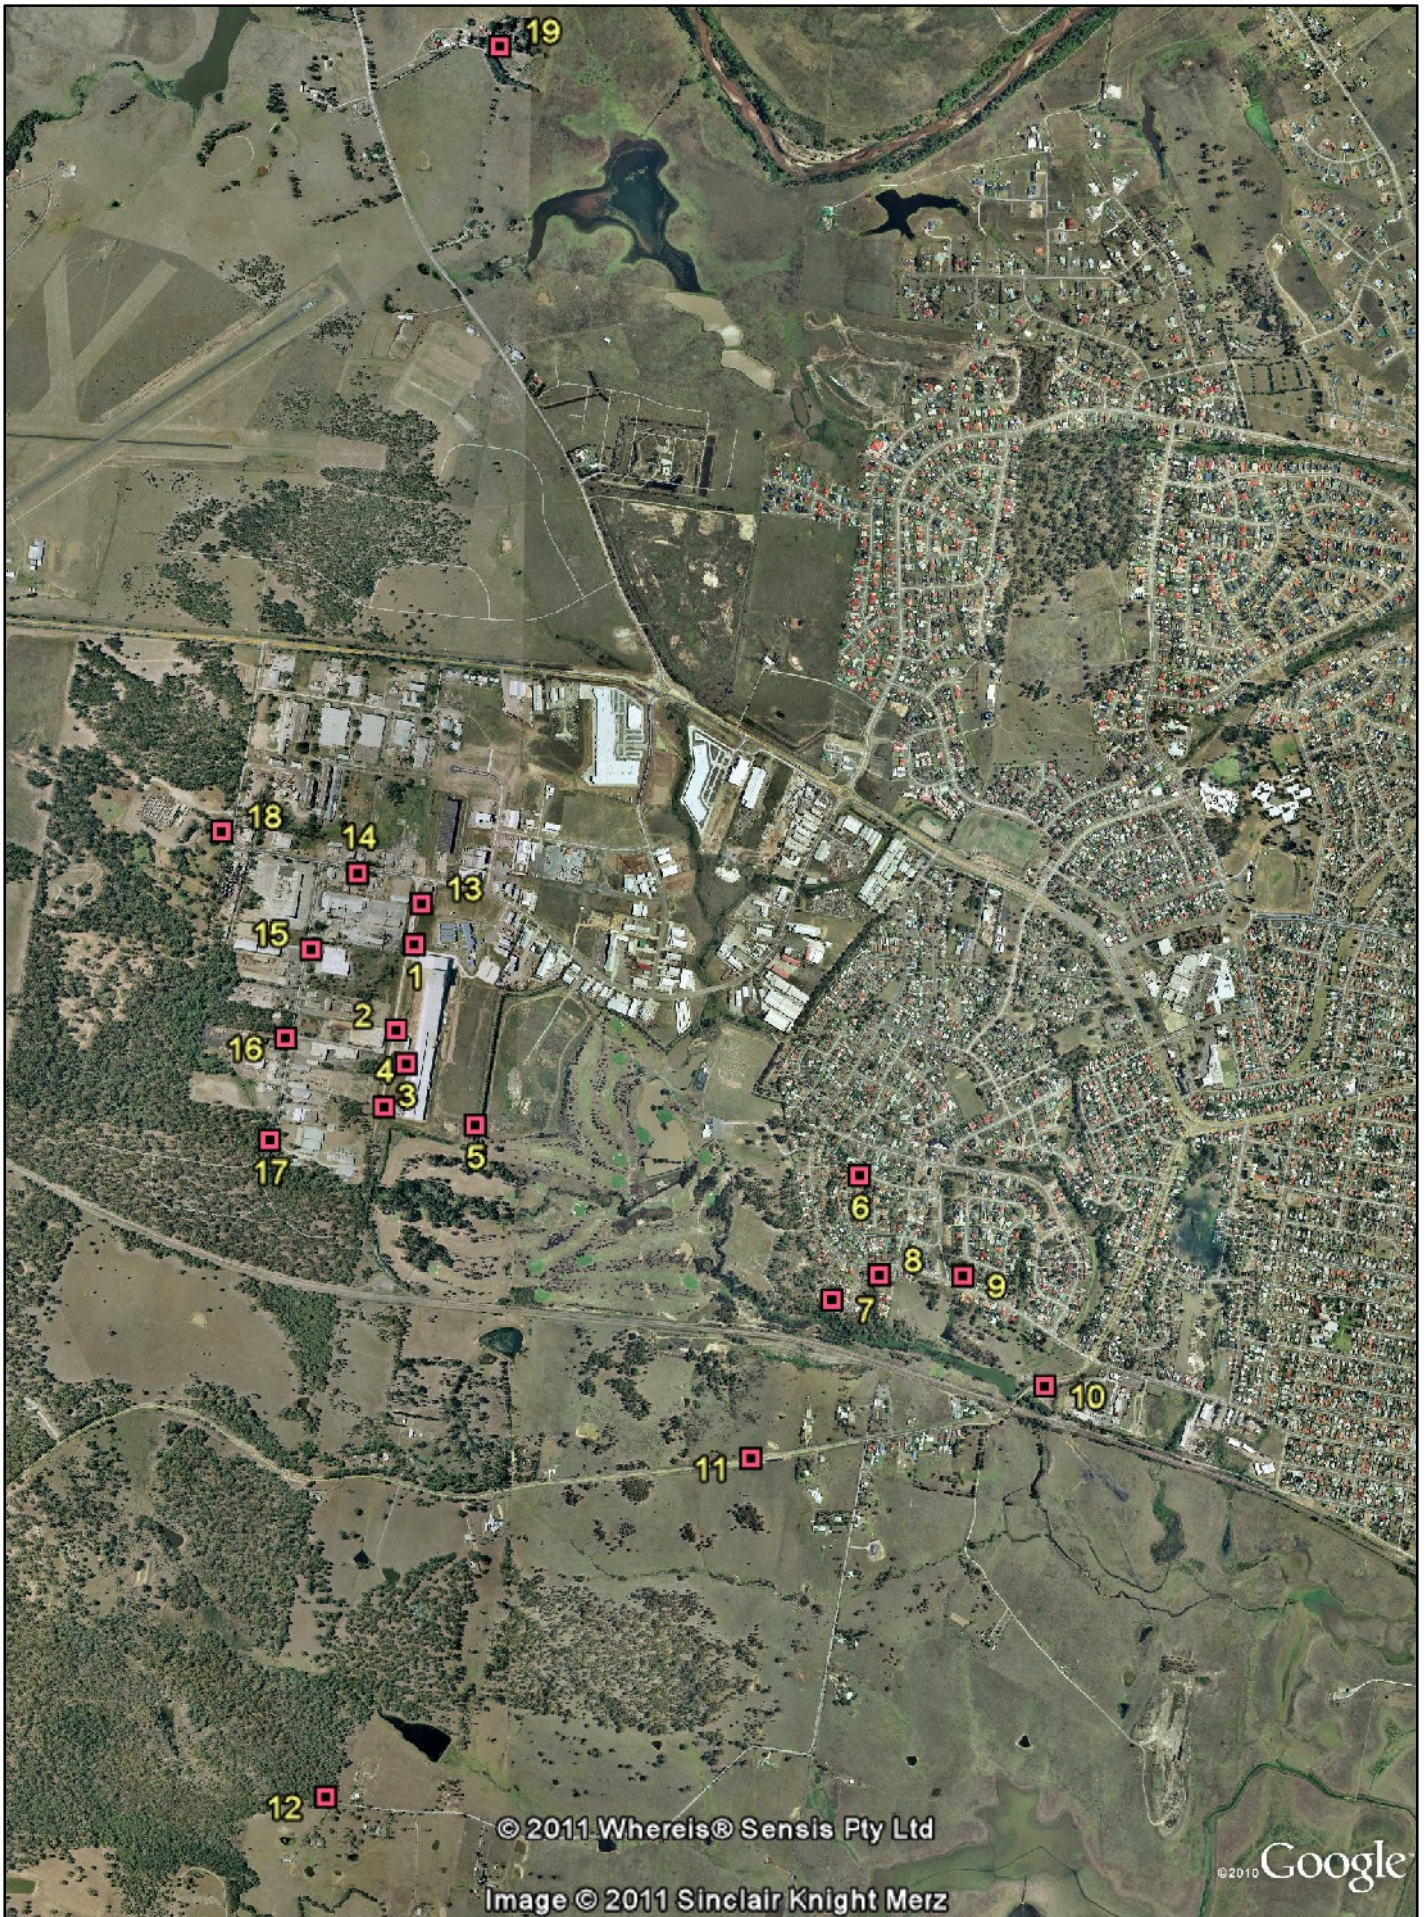
National Ceramics Industry Australia
Vegetation Monitoring Locations

Location	Site #	Location from kiln stack	Description
NCIA premises	1	280m NW	Access road north of office
	2	120m W	Office car park
	3	160m W	Access road south of office
	4	220m SW	South-west corner of site
	5	300m SE	South-east corner of site
Rutherford residential area and Farley	6	1.4km E	3 Palisade Street
	7	1.4km SE	Gillette Close
	8	1.5km SE	Regiment Road east of Dumont Court
	9	1.8kmSE	Regiment Road south-east of Squadron Crescent
	10	2km SE	Wollombi Road between sewage works and creek
	11	1.5km SE	Hill top on Wollombi Road west of Owl Pen Lane, Farley
	12	2.2km S	Western end of Quarry Road, Farley
Rutherford industrial estate	13	480m N	NCIA entrance, Racecourse Road
	14	570m NW	100-104 Kyle Street
	15	500m NW	11 Gardiner Road
	16	450m W	56 Gardiner Road
	17	550 SW	Gardiner Road, southern end

Location	Site #	Location from kiln stack	Description
	18	920m NW	Maitland Saleyards, Kyle Street
Anambah homestead	19	3km N	200 Anambah Road – Reference site

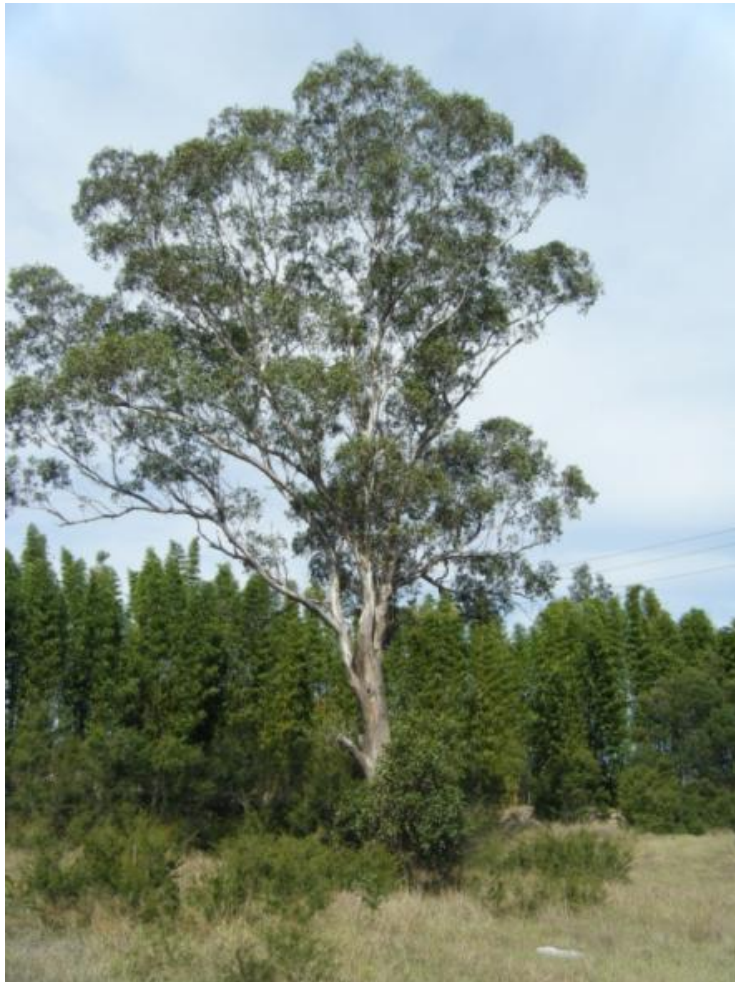
The *Bursaria spinosa* shrubs only showed very slight chlorosis symptoms and very slight branch dieback.

Plate 1 View of Site 5, with mature *Eucalyptus amplifolia* and *Bursaria spinosa* shrubs (in the foreground)

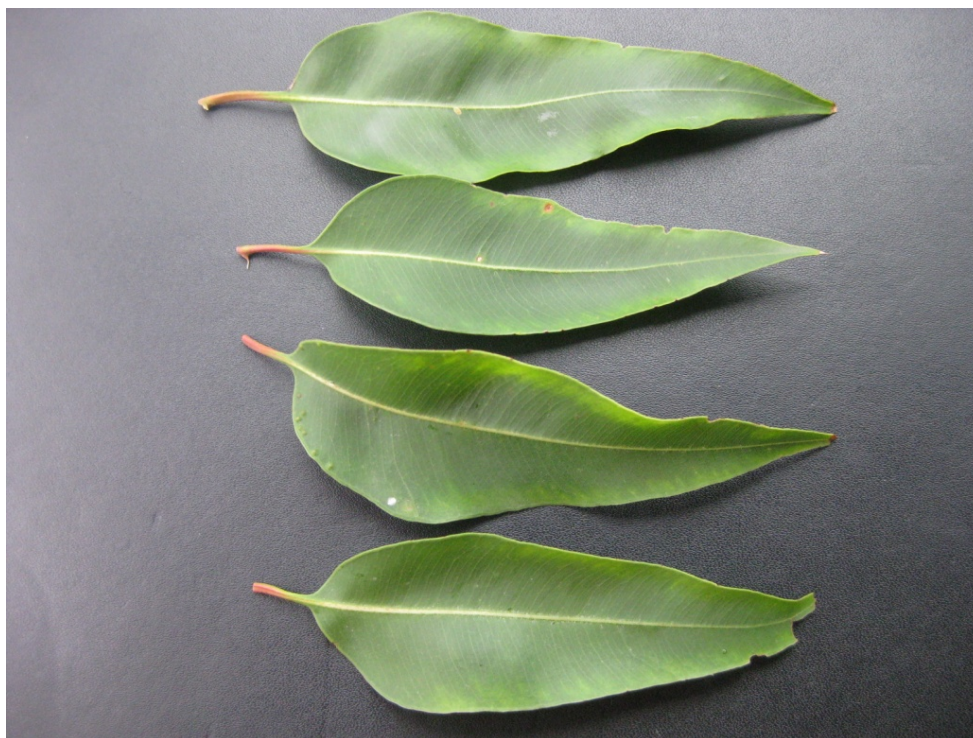
Overall, the Spotted Gums at this site were in a healthier state than during last year's survey where marked emission related injuries were noted.

Plate 2 Site 6 – *Corymbia maculata* (back of block) leaves showing slight chlorosis and cupping and very slight tip necrosis

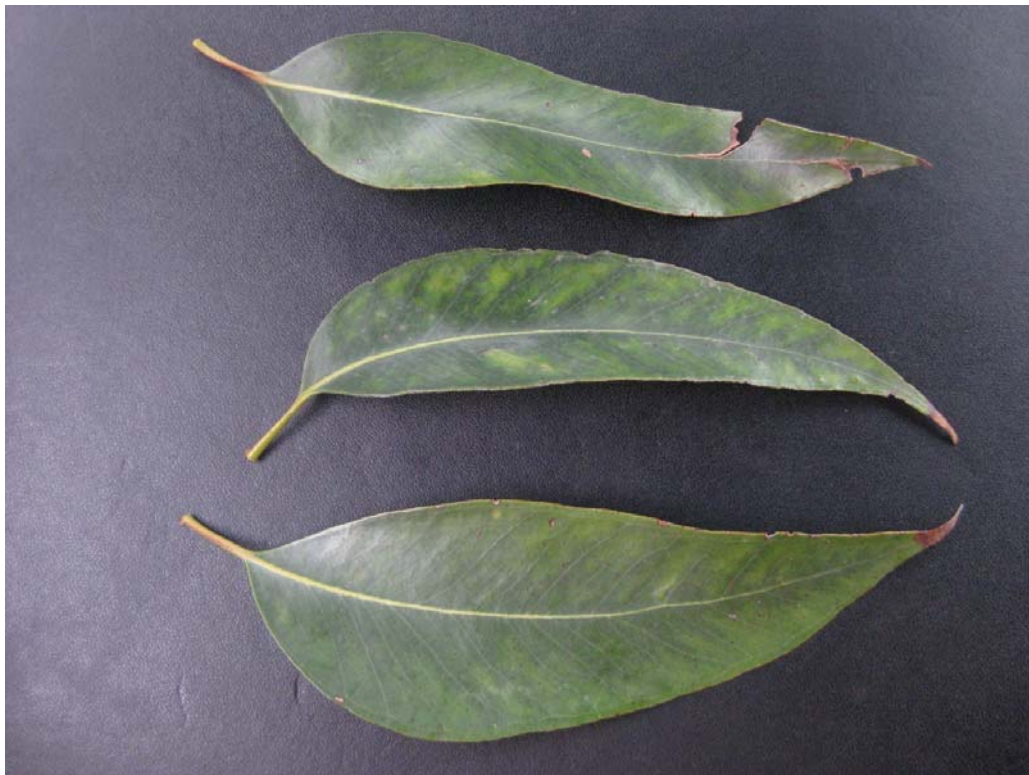
Plate 3 Site 7 – *Eucalyptus acmenoides* leaves with very slight tip necrosis and cupping, and slight chlorosis

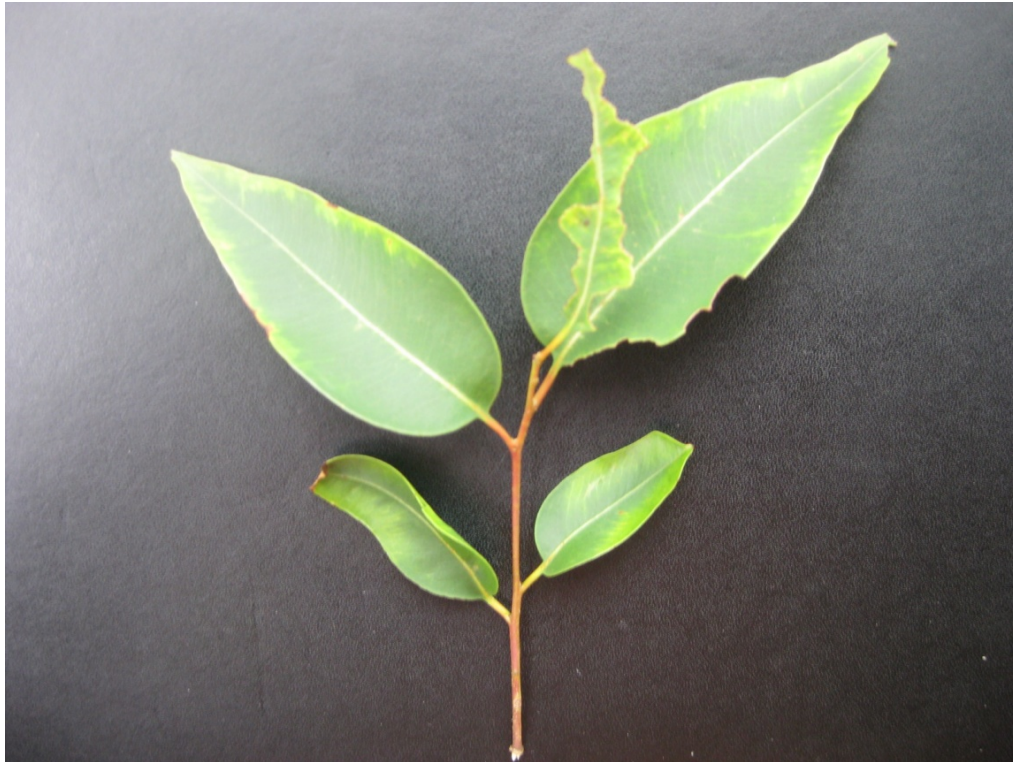
Plate 4 Site 7 – *Corymbia maculata* leaves showing very slight cupping, slight chlorosis and distinct leaf chewing

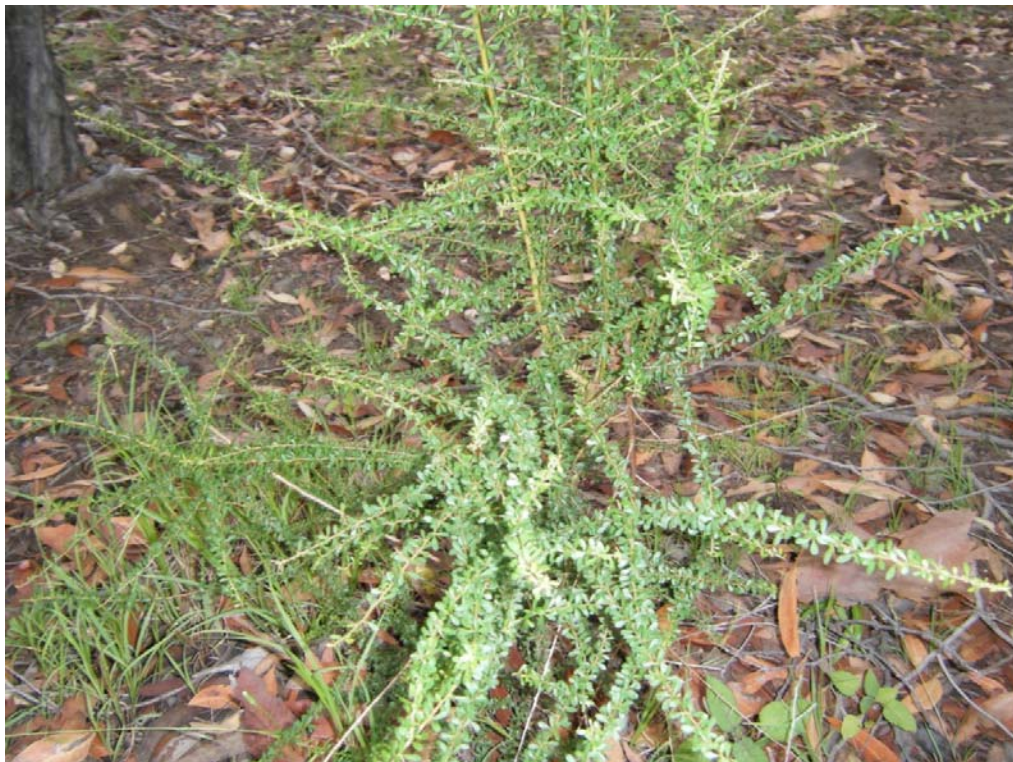
Lantana camara and *Bursaria spinosa* (Plate 5) were healthy with no fluoride or insect injury.

Plate 5 Site 7 – *Bursaria spinosa*

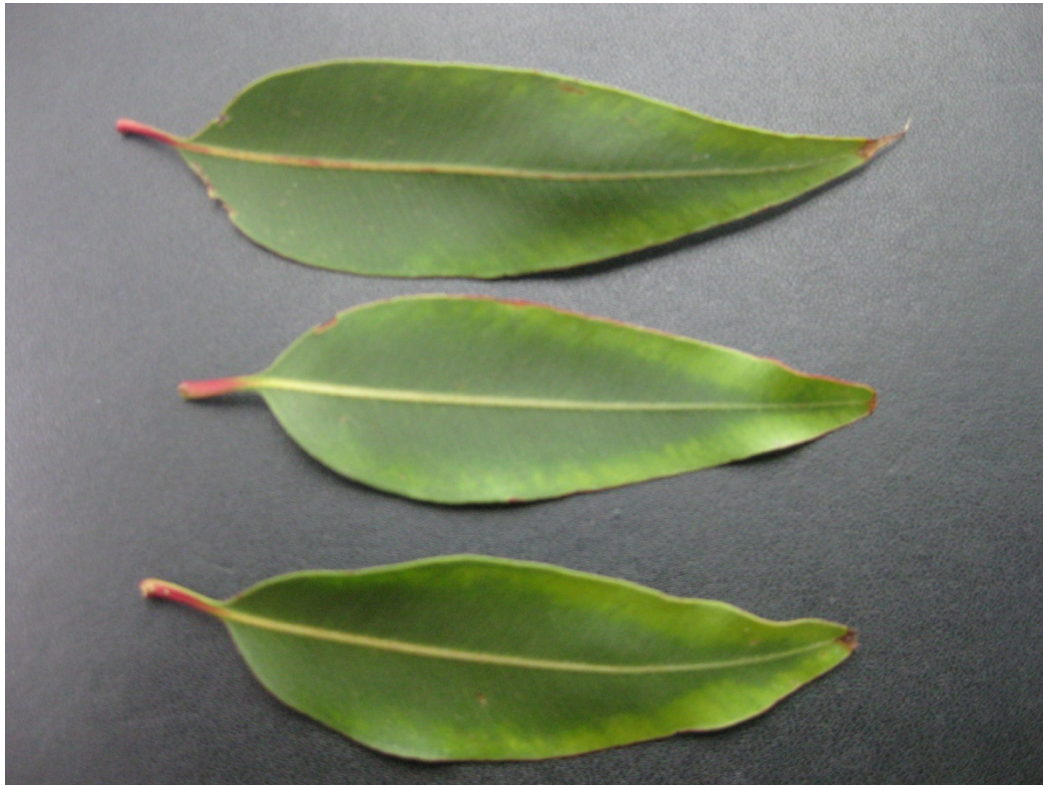
The overall condition of trees at Site 8 was comparable with that of the previous year.

Plate 6 Site 8 – *Corymbia maculata* leaves showing very slight cupping and tip necrosis, and distinct chlorosis

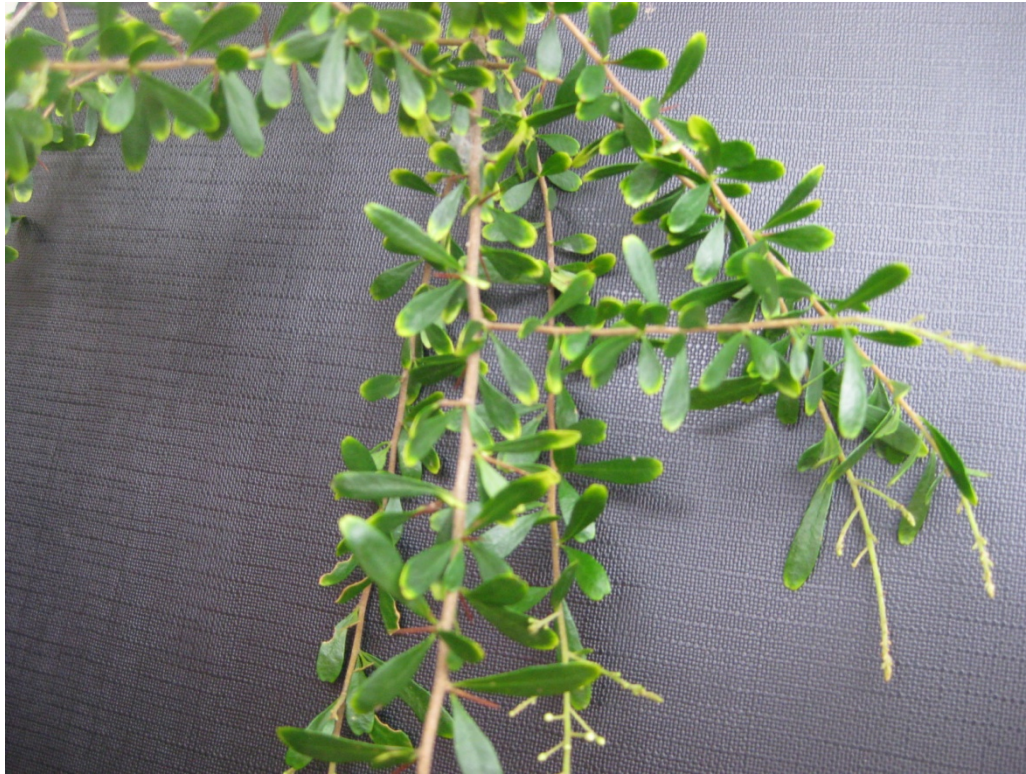
Plate 7 Site 9 – *Bursaria spinosa* leaves displaying slight chlorosis symptoms

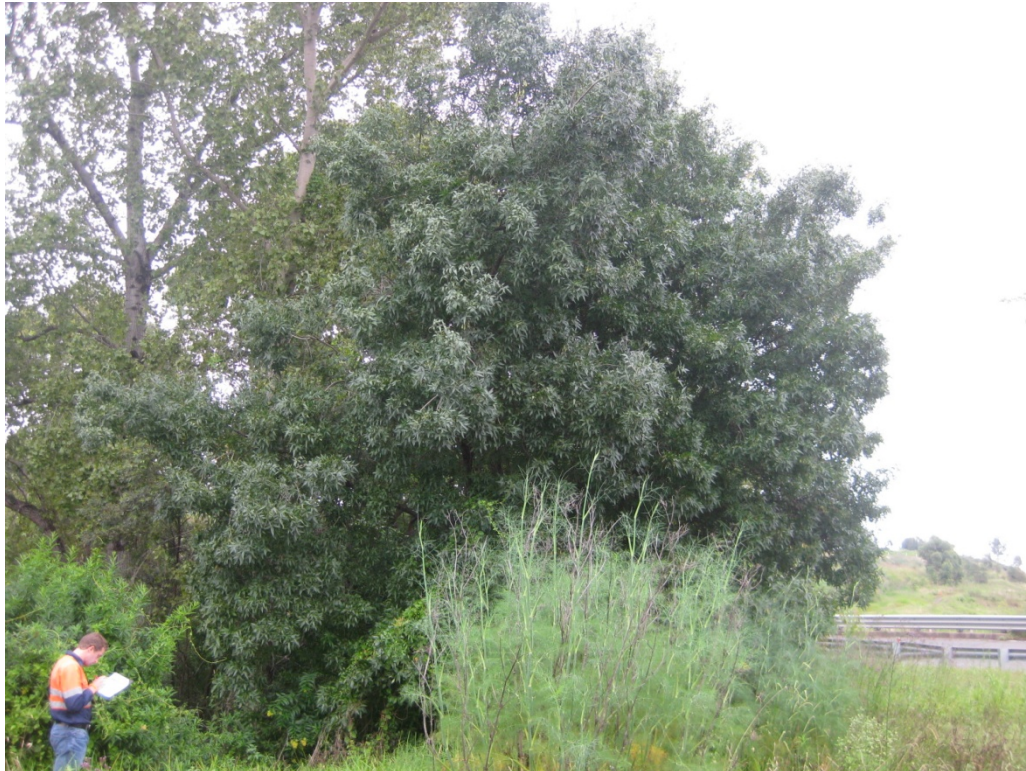
Plate 8 Site 10 – *Fraxinus excelsior*

Despite being sensitive species, *Fraxinus excelsior* (Plate 8) and *Populus nigra* var. *Italica* (Plate 9) displayed no symptoms of emission related injury and were generally in a healthy condition, with no or only very slight insect damage in the case of the Poplar tree.

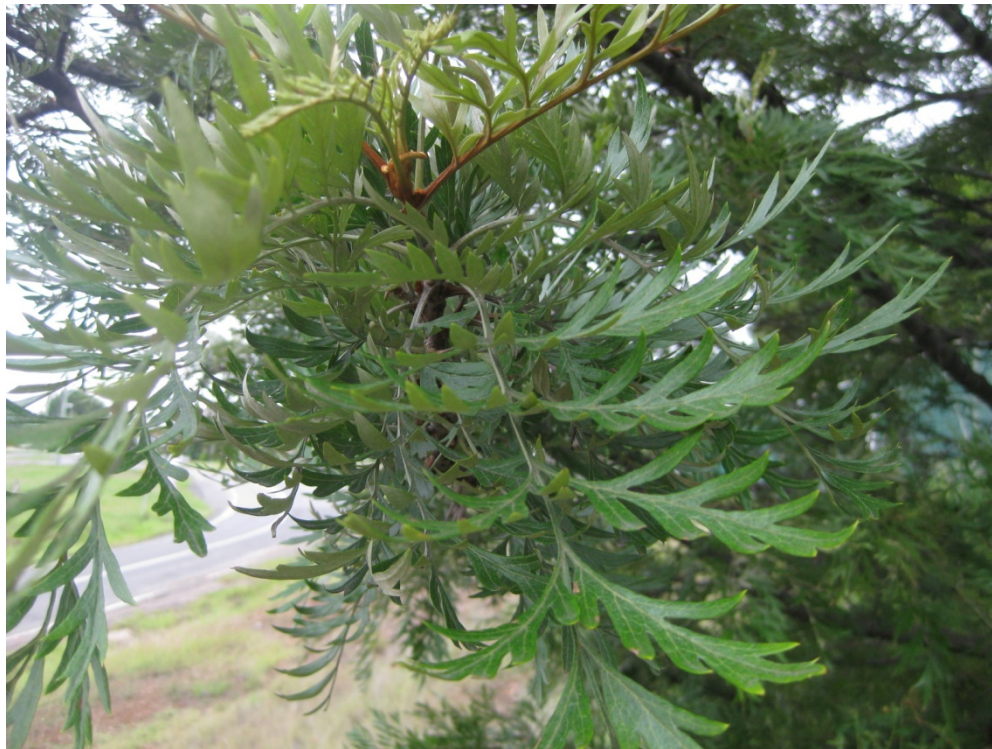
Similarly, *Grevillea robusta* (Plate 10) and *Pinus radiata* showed no injury.

Plate 10 Site 10 – *Grevillea robusta* leaves

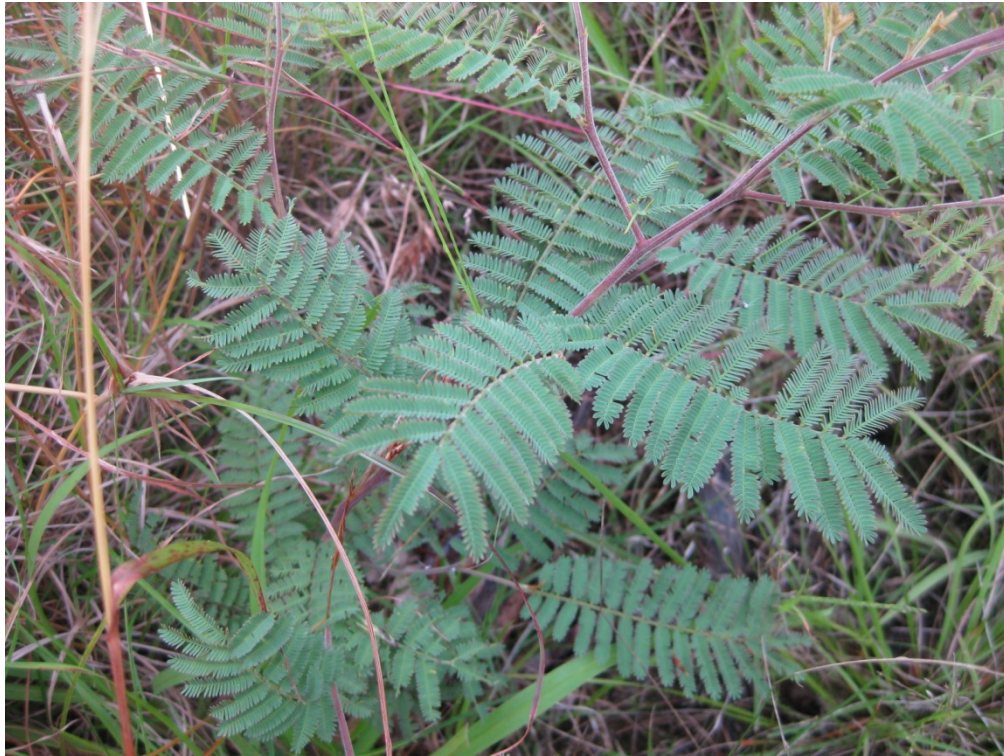
Plate 11 Site 11 – *Acacia baileyana*

The *Acacia baileyana* was a very young sapling (Plate 11) that showed no sign of impact. Although *Bursaria spinosa* foliage displayed no fluoride or insect injury, the shrub was in poor condition with some branch dieback resulting from recent roadside maintenance activities.

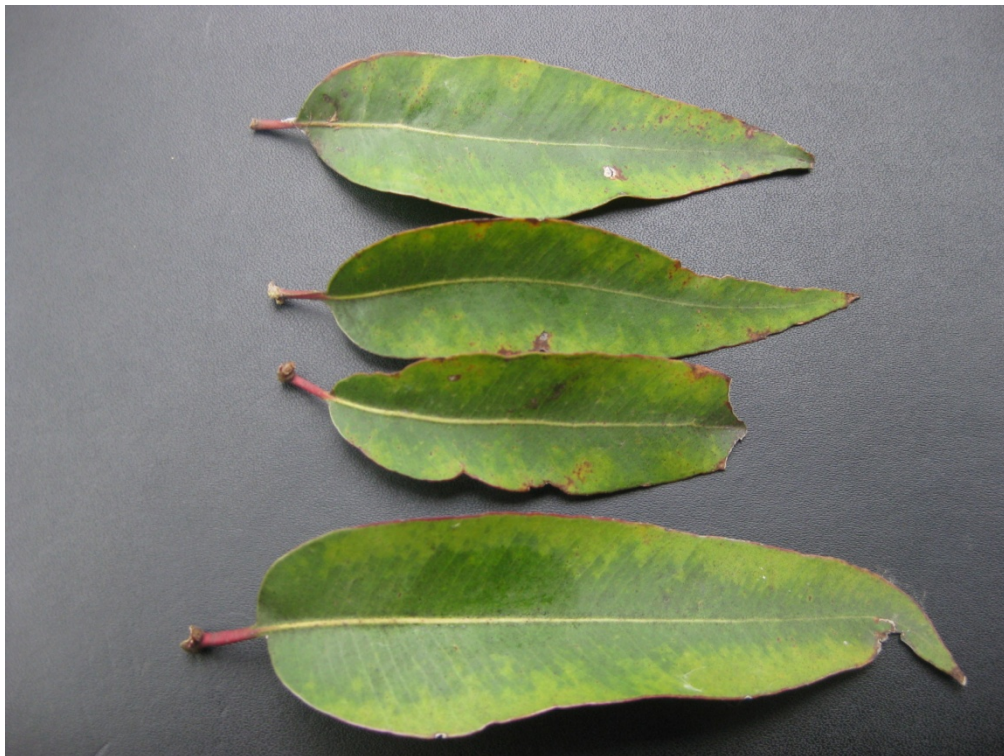
Plate 12 Site 11 – *Corymbia maculata* leaves showing chlorosis, necrosis and chewing

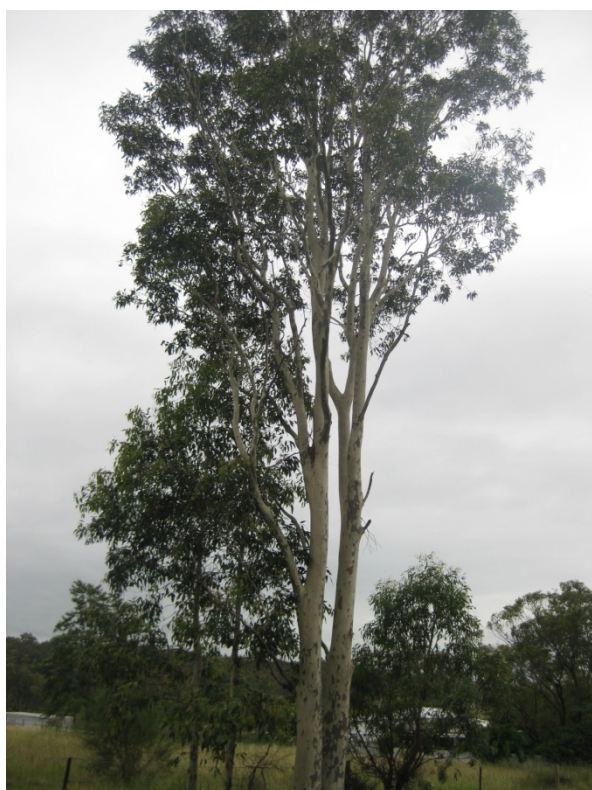
Plate 13 Site 12 – *Corymbia maculata*

Site 12 is located approximately 2.2 km south of the NCIA plant. The condition of the species *Corymbia maculata* (Plate 13), *Eucalyptus paniculata* (Plate 14) and *Pinus radiata* was visually assessed.

Neither species appeared affected by fluoride emissions at this location, reflecting the distance to the emission stacks and the location of the site outside the prevailing winds pattern. Only *Corymbia maculata* had very slight tip necrosis, which given the healthy state of all surrounding vegetation can likely not be attributed to fluoride. Emission injury was generally in accordance with previous seasons' observations at the site, apart for *Corymbia maculata* for which necrosis and anthocyanin accumulation were more evident last year.

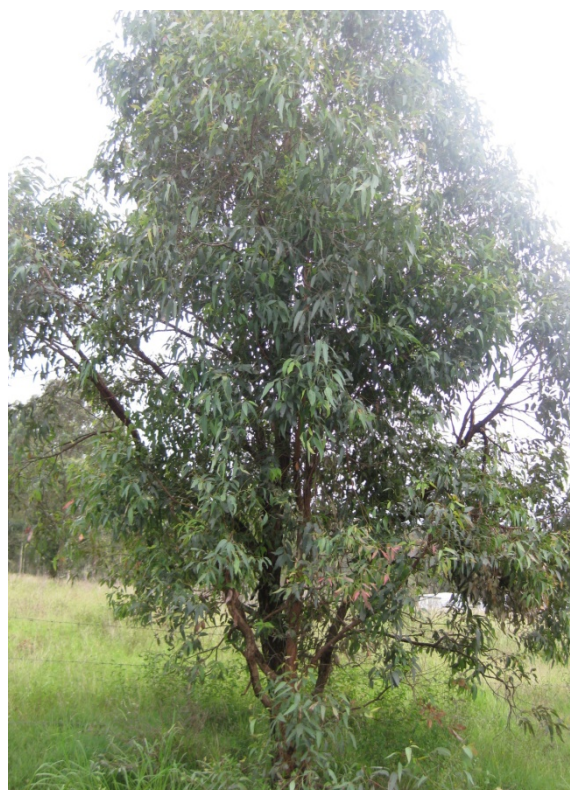
Plate 14 Site 12 – *Eucalyptus paniculata*

Insect attack was present in the Gum trees, with slight or distinct symptoms in *Corymbia maculata* (Plate 15) and very slight or slight symptoms in *Eucalyptus paniculata*. Buds were present on *Eucalyptus paniculata*.

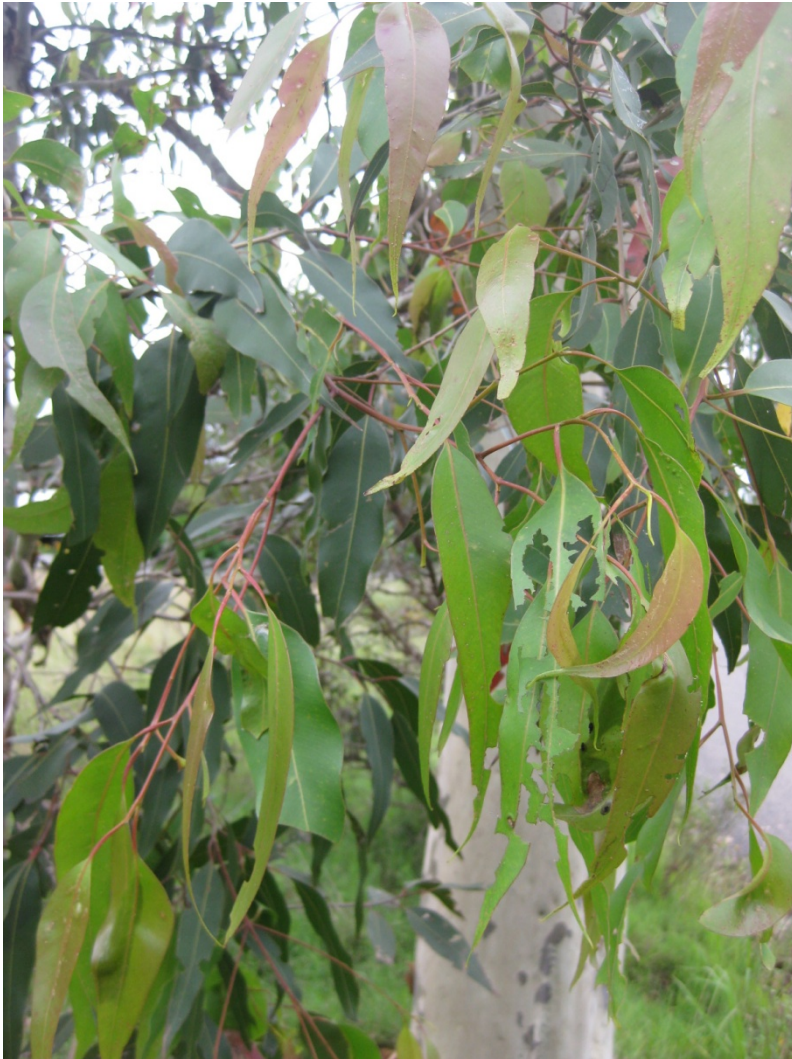
Plate 15 Site 12 – *Corymbia maculata* leaves showing chewing and sap sucking damage

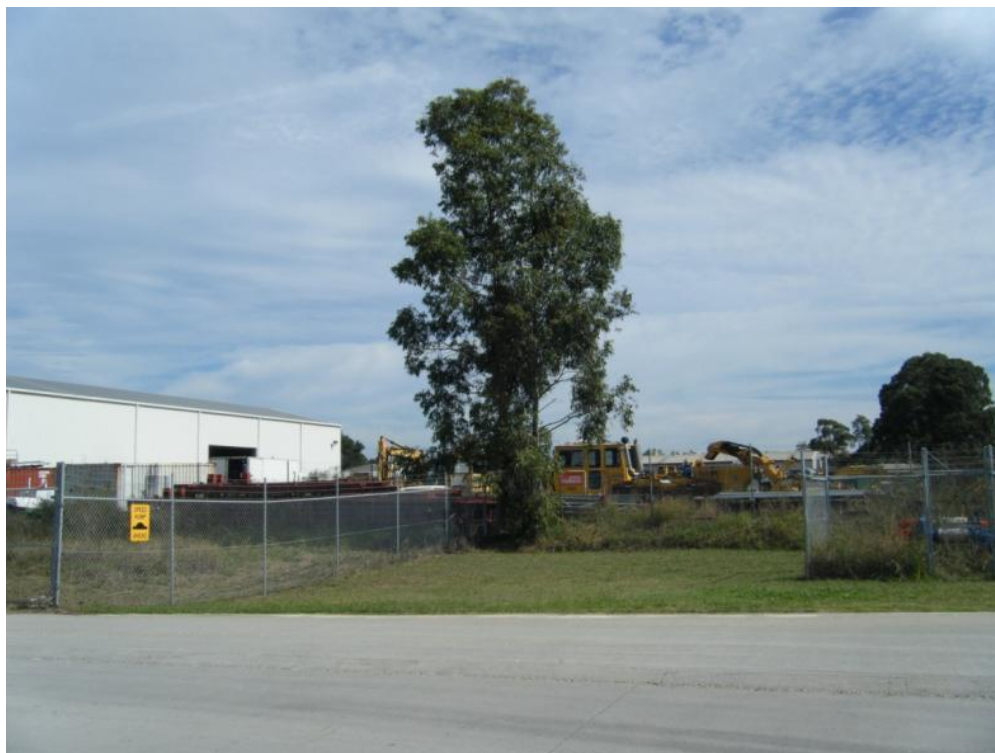
Plate 16 View of Site 13, showing *Corymbia maculata* and *Eucalyptus amplifolia*

Corymbia maculata and *Eucalyptus amplifolia* were selected for both visual and foliar fluoride sampling (Plate 16).

Eucalyptus amplifolia proved less sensitive with current season leaves showing no emission impact, and current season leaves only having very slight tip necrosis. All leaves were very slightly chewed by insects and sap sucking was slight. Reproductive buds were present.

The condition of trees at this site was comparable to last year's.

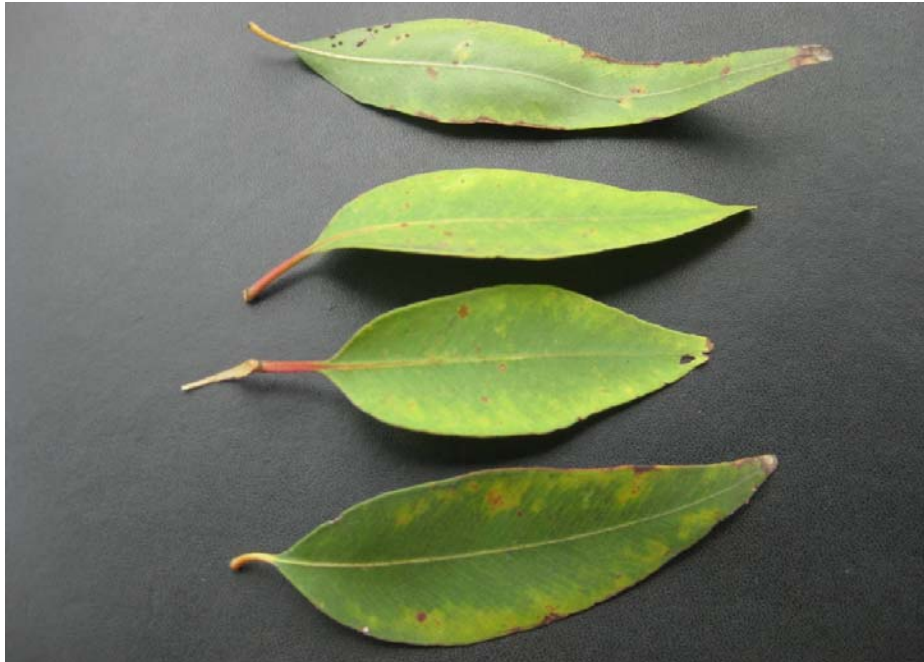
Plate 17 Site 13 – *Corymbia maculata* leaves with distinct chlorosis and slight cupping

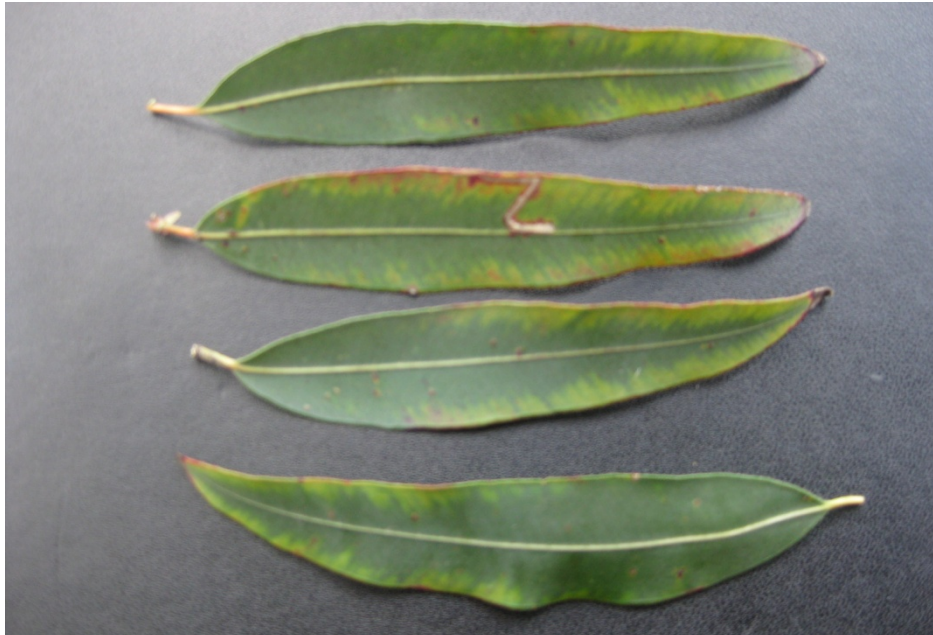
Plate 18 Site 14 – *Angophora floribunda* leaves showing very slight cupping, tip necrosis and anthocyanin, and slight chlorosis

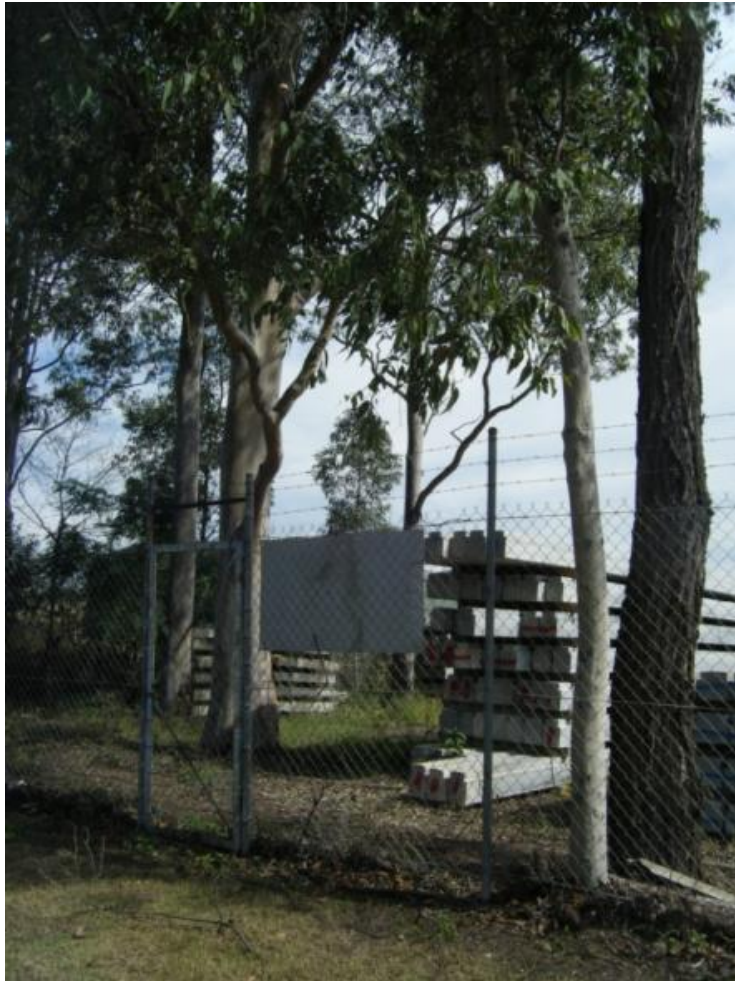
Plate 19 View of Site 15, with *Corymbia maculata* (left) and *Eucalyptus fibrosa* (right)

Corymbia maculata and *Eucalyptus fibrosa* were visually assessed for fluoride impacts (Plate 19). Leaves of *Corymbia maculata* were collected for foliar fluoride sampling.

Corymbia maculata was observed to have a similar moderate health as noted in the previous survey. New season leaves showed distinct chlorosis and tip necrosis, slight cupping and were very slightly impacted by sap sucking insects. The leaves from the previous season had very slight signs of chlorosis, cupping, tip and marginal necrosis, leaf chewing and sap sucking.

Eucalyptus fibrosa appeared in a similar good health as observed in the previous survey. Insect damage on all leaves was very slight (chewing) to slight (sap sucking). Fluoride did not affect young leaves and only slight tip necrosis was observed in older leaves. Reproductive buds were present.

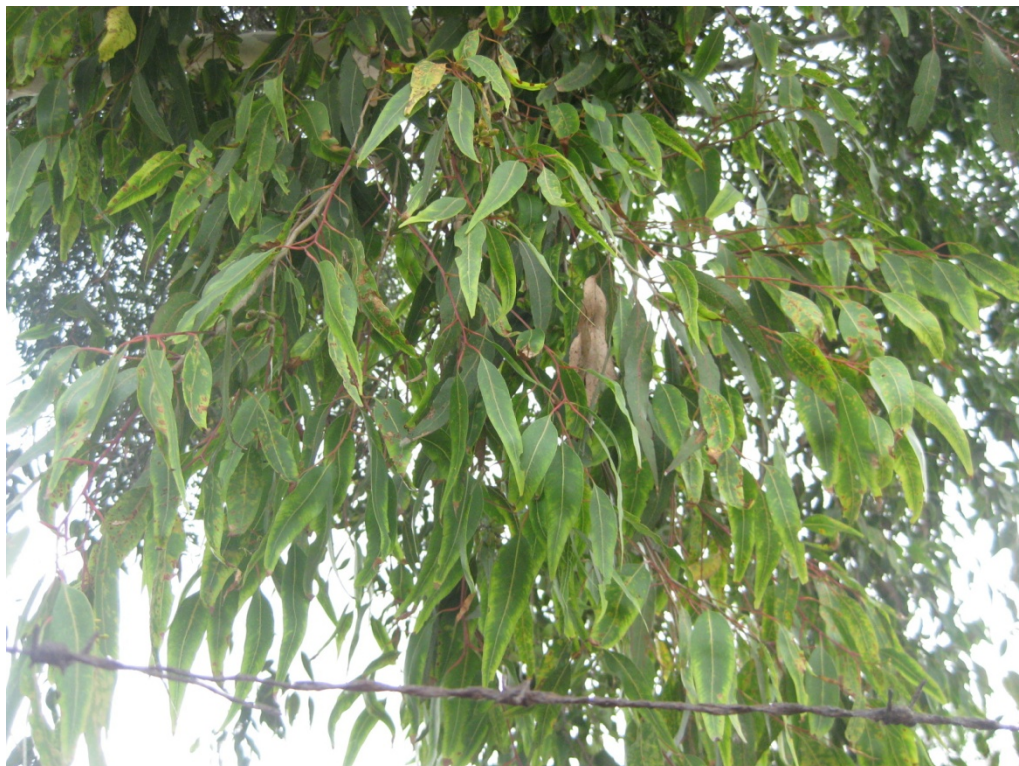
A *Corymbia maculata* supporting a mistletoe infestation was assessed at Site 16. No new season growth was present on this specimen and only previous season leaves were assessed. Overall, the scale of injury was similar to that of the previous survey. Previous season leaves were distinctly chlorotic with very slight cupping and tip necrosis (Plate 20). Insect damage was observed to be very slight for leaf chewing and slight for sap sucking.

Plate 20 Site 16 – *Corymbia maculata* foliage showing distinct chlorosis and very slight cupping and tip necrosis

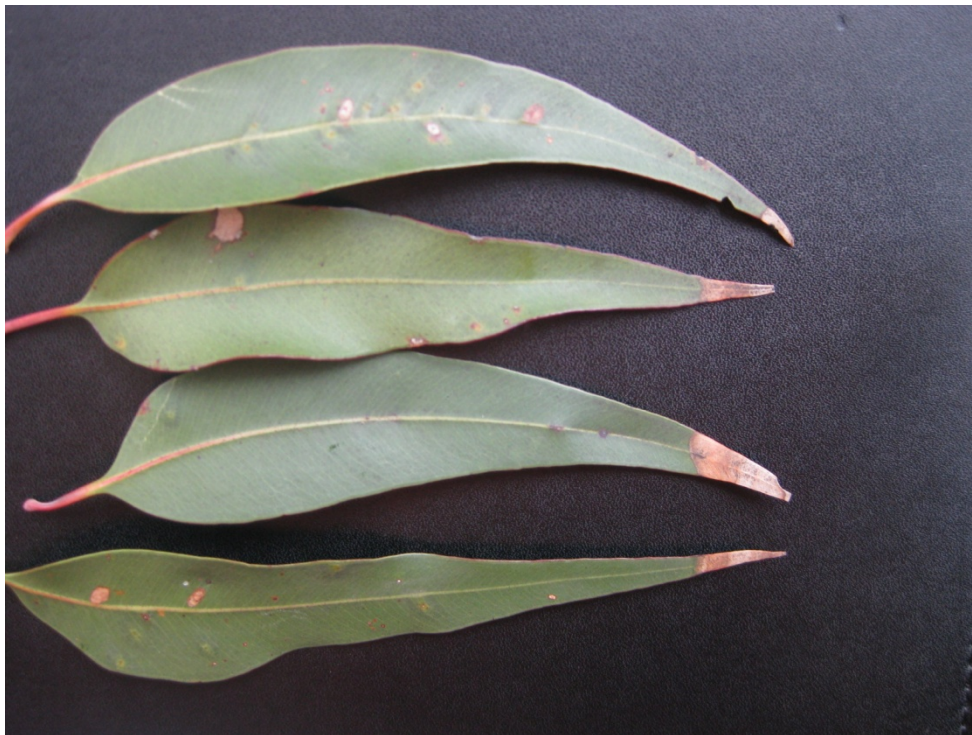
Plate 21 Site 18 – *Corymbia maculata* leaves showing slight tip necrosis, very slight cupping and very slight insect damage

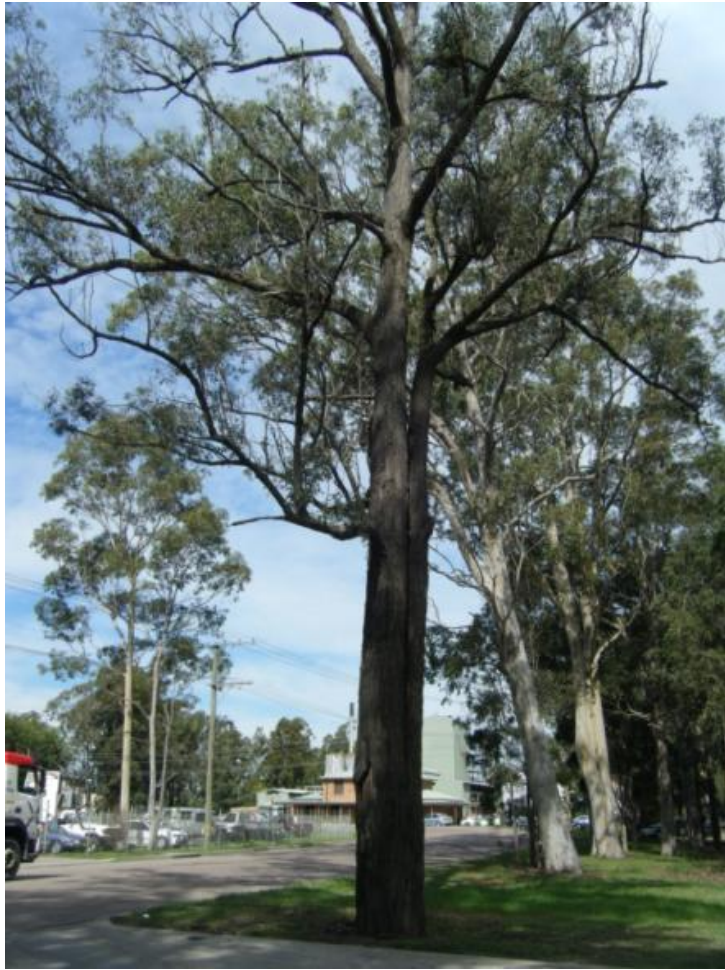
The *Eucalyptus paniculata* at the site is a large individual in very poor condition with severe dieback and severely damaged canopy (Plate 22). All previous season leaves were in the canopy and too elevated to be surveyed; therefore only current season leaves from a sprout at the base of the tree were able to be assessed. Young leaves observed only showed very slight anthocyanin accumulation but no other fluoride impact. Leaves also distinctively suffered from insect chewing and sap sucking. The condition of this tree has been consistently poor over the last quarterly and annual surveys.

Plate 22 Site 18 – *Eucalyptus paniculata*
