2011 -2012 Annual Environmental Management Report

National Ceramic Industries Australia

AECOM Australia Pty Ltd

25 September 2012

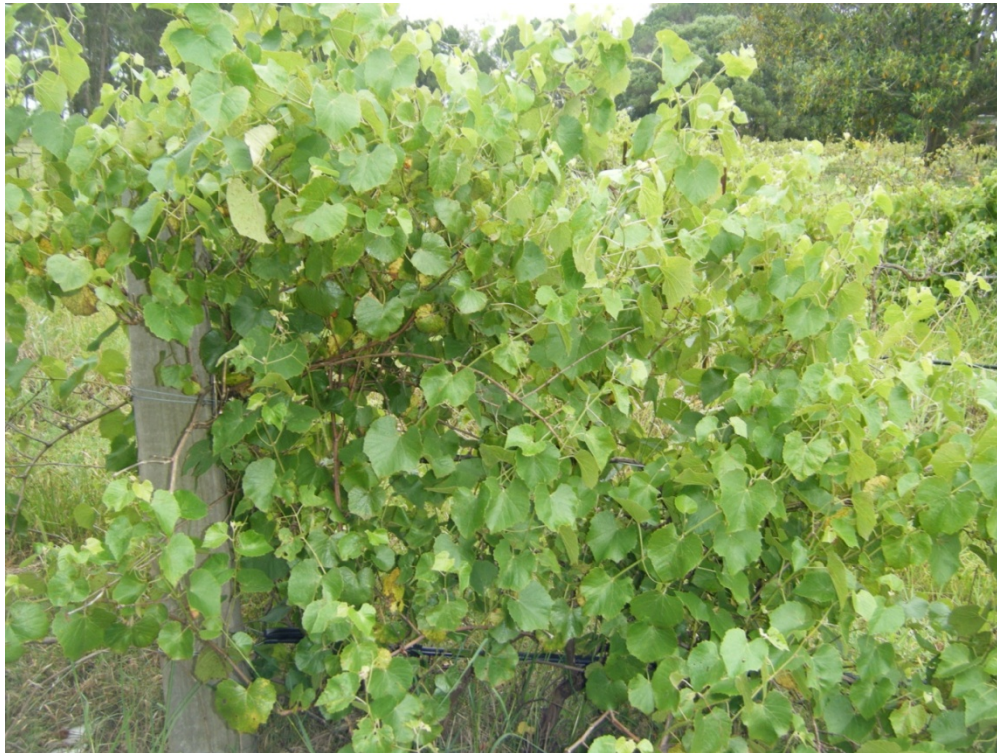
Plate 23 Site 19 – *Vitis vinifera*

Vine leaves (Plate 23) in the upper block showed slight signs of anthocyanin accumulation. Leaves in the lower block displayed very slight necrosis of the tips and margins. All other species showed no sign of emission related injury. Insect damage was present in most specimens but only to a very slight or slight degree.

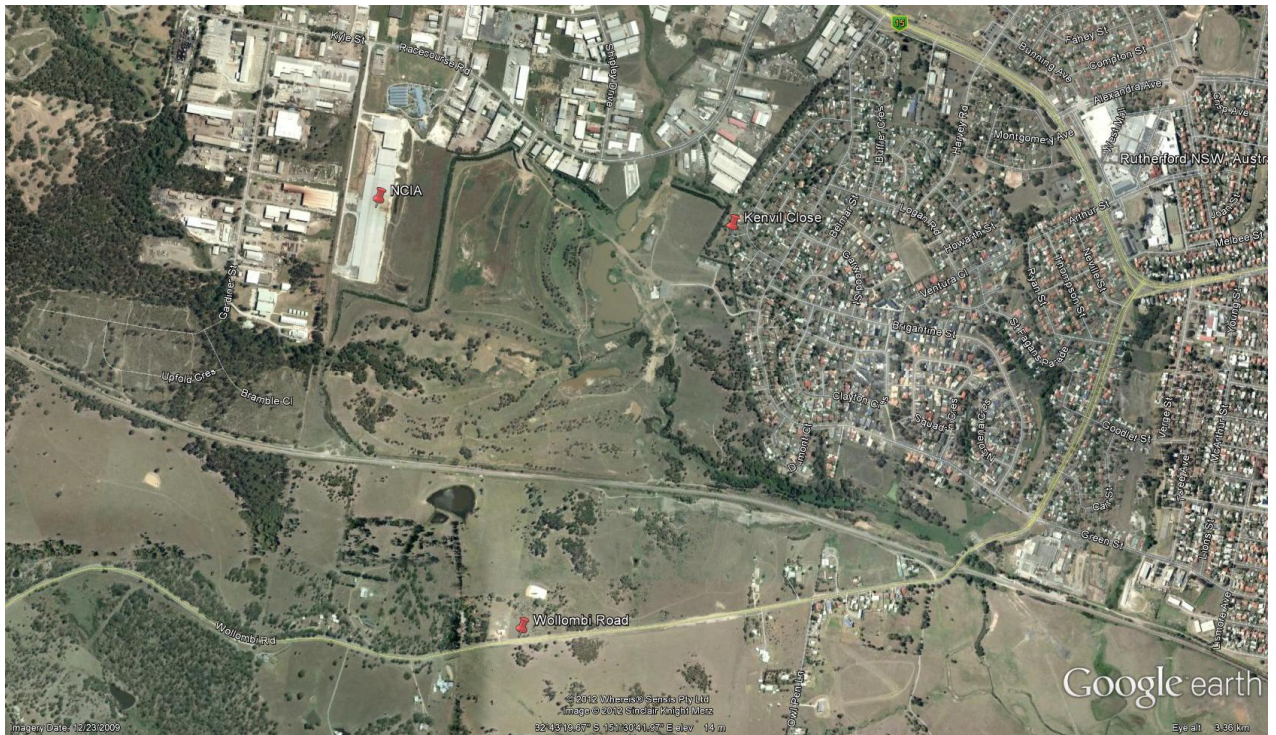
SITE PLAN AND MONITORING LOCATIONS

The measurements were inconclusive as the acoustic environment of both sites was dominated by emissions from other industries not related to NCIA.

Theoretical calculations were carried out to predict received noise levels under neutral atmospheric conditions. The predicted noise levels were in compliance with the noise criteria for all time periods.
