# 2014 Annual Environmental Management Report

**National Ceramic Industries Australia**

17-Apr-2015

Job No.: 60329408

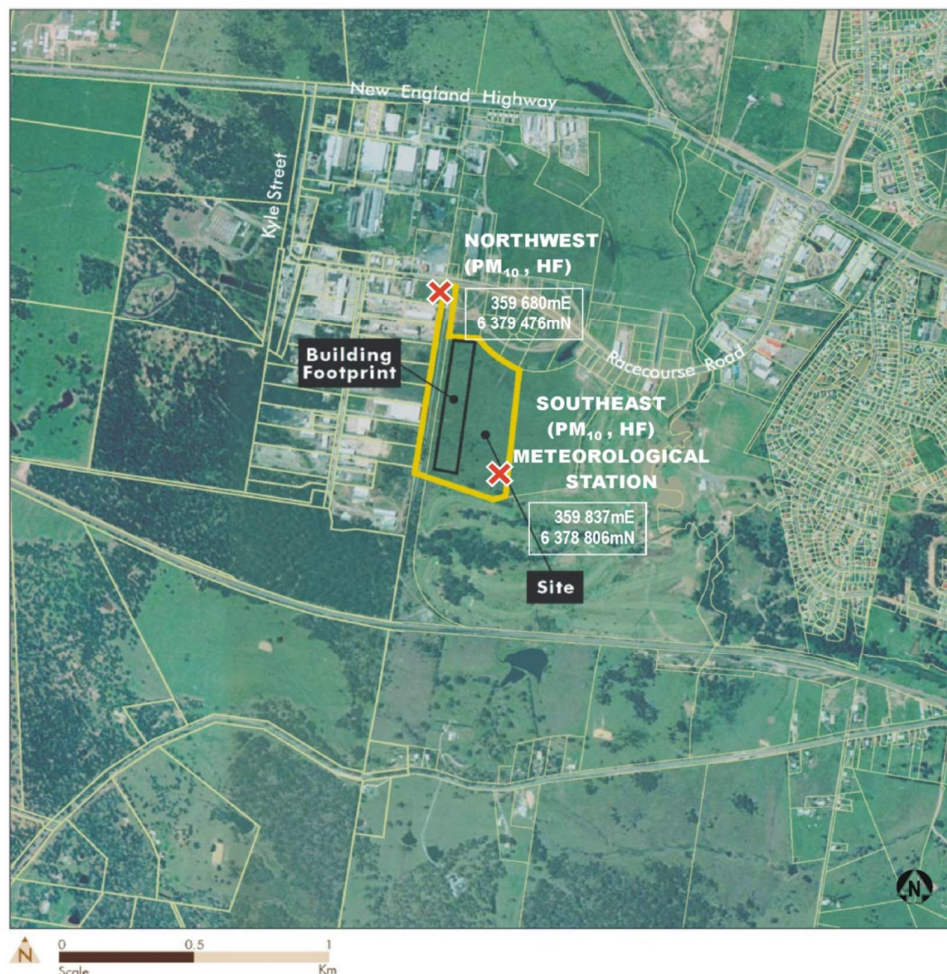
Figure 1 Ambient Air Monitoring Site Locations

In accordance with EPL condition M2.1, PM<sub>10</sub> (24-hour) and Fluoride (24-hour and weekly) are monitored at two locations: northwest and southeast of the facility (refer Figure 1).

For PM<sub>10</sub> monitoring, two sampling locations have been established to determine concentrations at the NCIA property boundary, along the dominant southeast-northwest wind axis. The monitors are sited in accordance with *AS/NZS 3580.1.1:2007 Guide to siting air monitoring equipment*. Sampling and analyses of PM<sub>10</sub> are undertaken as per *AS/NZS 3580.9.6:2003 Determination of suspended particulate matter*. Discrete 24-hour samples are collected every 6 days according to the NSW EPA schedule.

Two fluoride monitoring units (manual, double filter paper samplers) have been sited at each of the two locations identified for monitoring of PM<sub>10</sub>, and are operated in accordance with *AS3580.13.2:2013 Determination of gaseous and acid-soluble particulate fluorides*. At each location, one monitor operates continuously over a 7-day period to provide weekly fluoride concentration averages. These units are designated 'Northwest HF7' and 'Southeast HF7'. The remaining unit at each site operates continuously for discrete 24-hour periods according to the NSW EPA 6-day cycle to provide 24-hour averages for sampler operation days. Units are designated 'Northwest HF' and 'Southeast HF'.

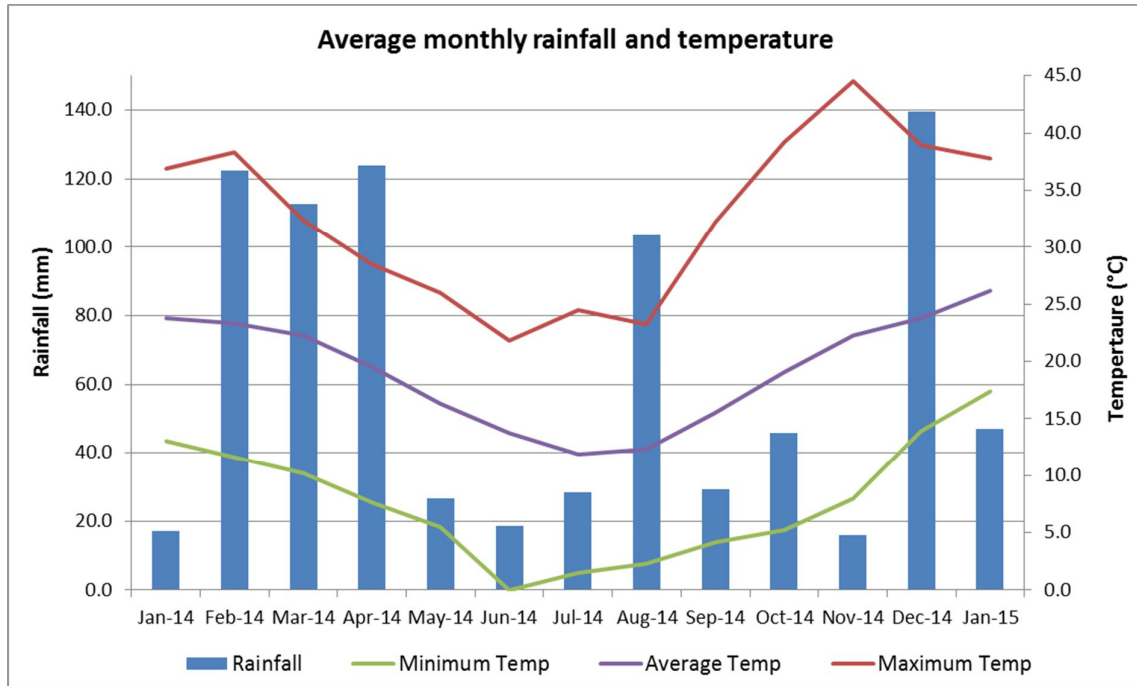
Figure 8 Average Monthly Rainfall and Temperature Range (19 January 2014 – 18 January 2015)

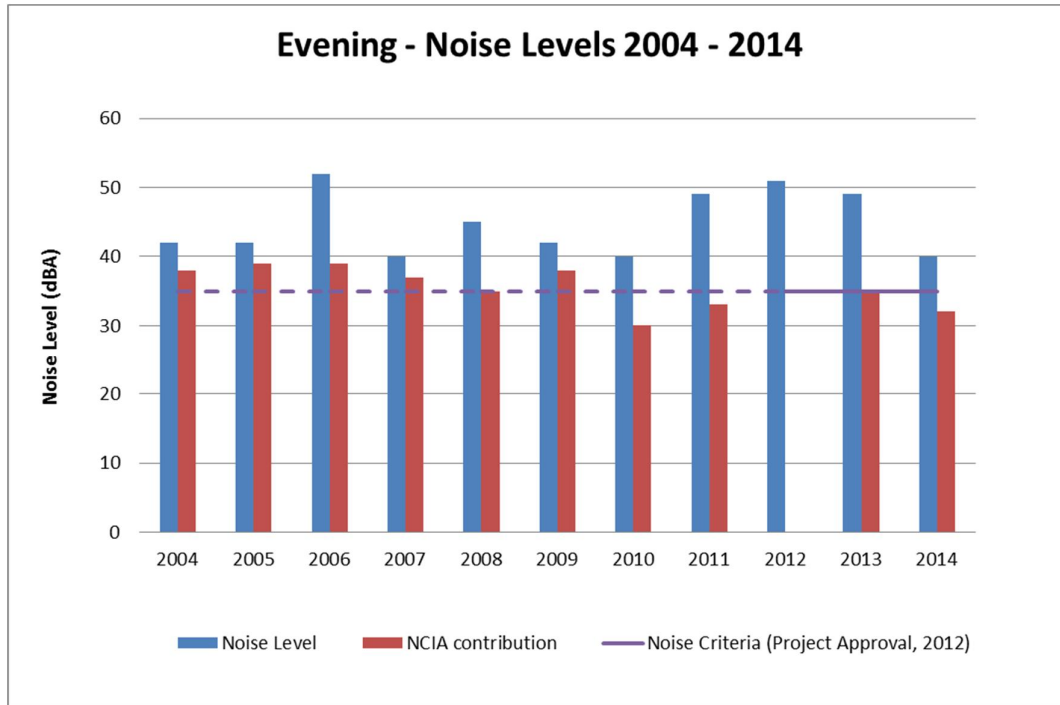
Figure 25 Evening Noise Levels 2004 - 2013

Note: 2012 – NCIA contribution audible but not measurable.

Historical noise monitoring results at the closest sensitive residential receiver (Kenvil Close) are provided in Figure 24 – Figure 26. Noise levels from the facility for the day, evening and night periods were estimated based on operator notes taken during the noise survey and free field calculations. On many occasions the NCIA facility was not clearly audible over other dominant industrial and traffic noise sources nearby.

No trends in the noise monitoring are clearly discernible, with historical noise emissions generally complying with noise limits. During the daytime for the past six years, the NCIA noise contribution was audible but not measurable. The current noise monitoring report noted that the acoustic environment at the Kenvil Close monitoring locations was significantly impacted by noise from the construction of the subdivision on the old golf course site. Traffic noise on the New England Highway also contributes to the background noise levels. The 2010 EA indicated that the increase in background levels in the Rutherford region was likely to be due to the development of new industrial facilities in the Rutherford Industrial Estate.
