2015 Annual Environmental Management Report

National Ceramic Industries Australia
19 January 2015 to 31 July 2015

Client: National Ceramic Industries Australia

AECOM Australia Pty Ltd

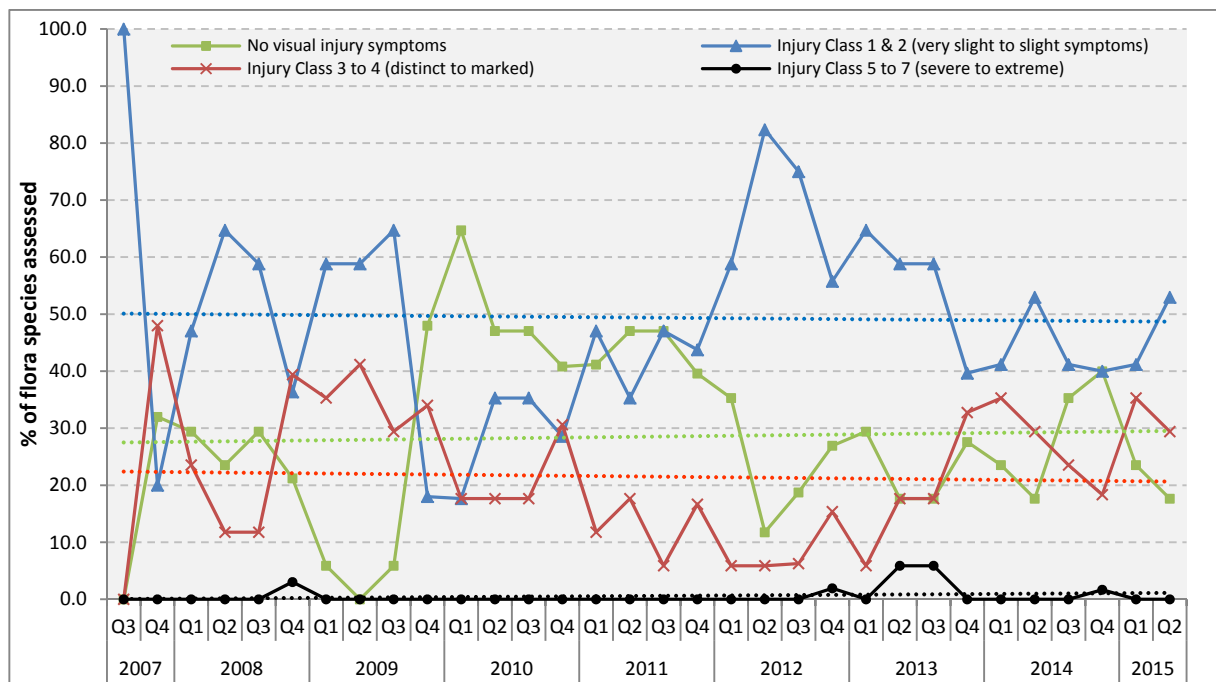
Figure 24 Proportion of Flora Species Affected by Emission Related Visual Injury Symptoms (2007-2015)

- Species showing no visible fluoride injury symptoms;
- Species displaying at worst Class 1 (very slight) or Class 2 (slight) injury symptoms;
- Species displaying at worst Class 3 (distinct) or Class 4 (marked) injury symptoms; and
- Species displaying Class 5 injury symptoms and above (severe to extreme).

Historical data show that there are no clear trends (improving nor worsening) in the health condition of the vegetation surrounding the NCIA factory (as depicted by the corresponding trend lines in Figure 24). Although the severity of visual fluoride injury symptoms in the foliage of the species assessed generally varies on a quarterly basis, variations tend to oscillate around a relatively consistent average over the long term. The following observations generally apply to the long term data:
