2017 Annual Environmental Management Report

1 August 2016 - 31 July 2017

Client: National Ceramic Industries Australia

AECOM Australia Pty Ltd

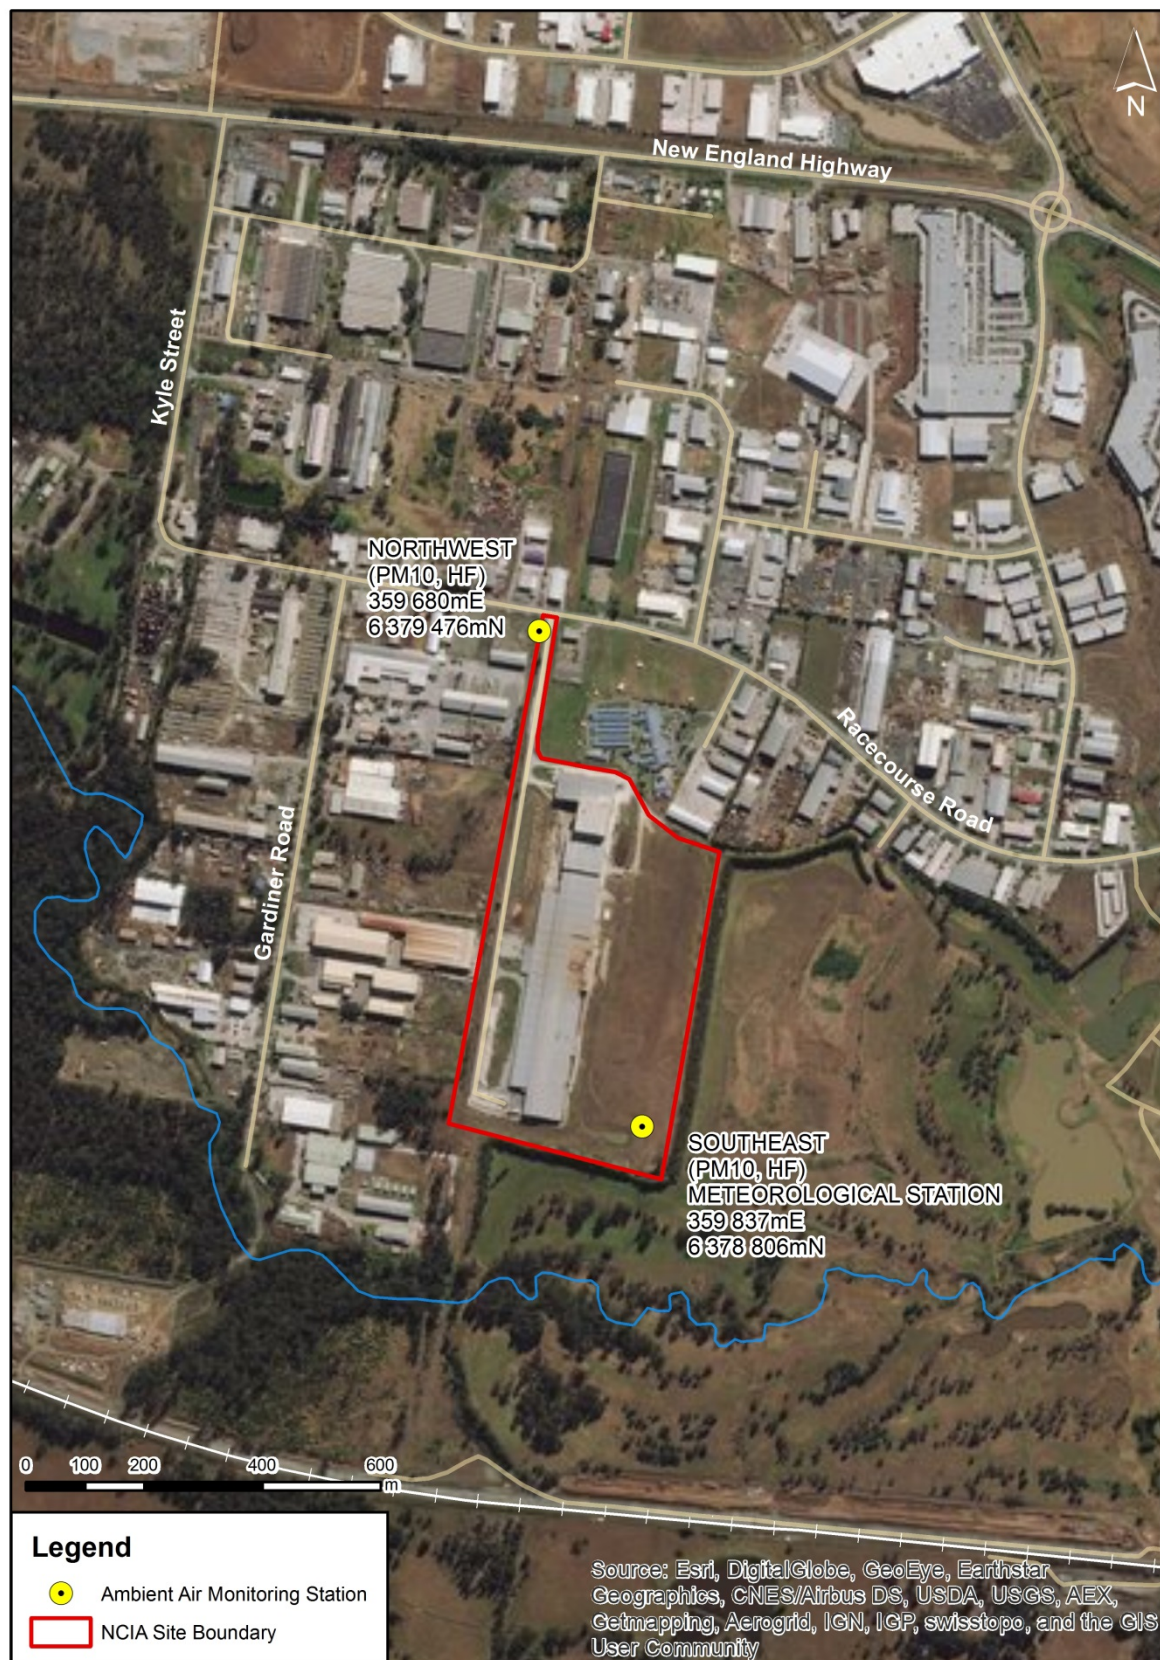
Figure 2 Ambient air monitoring locations

In accordance with EPL condition M2.1, PM₁₀ (24-hour) and Fluoride (24-hour and weekly) are monitored at two locations: northwest and southeast of the facility (refer Figure 2).

For PM₁₀ monitoring, two sampling locations have been established to determine concentrations at the NCIA property boundary, along the dominant southeast-northwest wind axis. The monitors are sited in accordance with *AS/NZS 3580.1.1:2007 Guide to siting air monitoring equipment*. Sampling and analyses of PM₁₀ are undertaken as per *AS/NZS 3580.9.6:2015 Determination of suspended particulate matter*. Discrete 24-hour samples are collected every 6 days according to the NSW EPA schedule.

Two fluoride monitoring units (manual, double filter paper samplers) have been sited at each of the two locations identified for monitoring of PM₁₀, and are operated in accordance with *AS3580.13.2:2013 Determination of gaseous and acid-soluble particulate fluorides*. At each location, one monitor operates continuously over a 7-day period to provide weekly fluoride concentration averages. These units are designated 'Northwest HF₇' and 'Southeast HF₇'. The remaining unit at each site operates continuously for discrete 24-hour periods according to the NSW EPA 6-day cycle to provide 24-hour averages for sampler operation days. Units are designated 'Northwest HF' and 'Southeast HF'.
