2018 Annual Environmental Management Report

1 August 2017 - 31 July 2018

Client: National Ceramic Industries Australia

AECOM Australia Pty Ltd

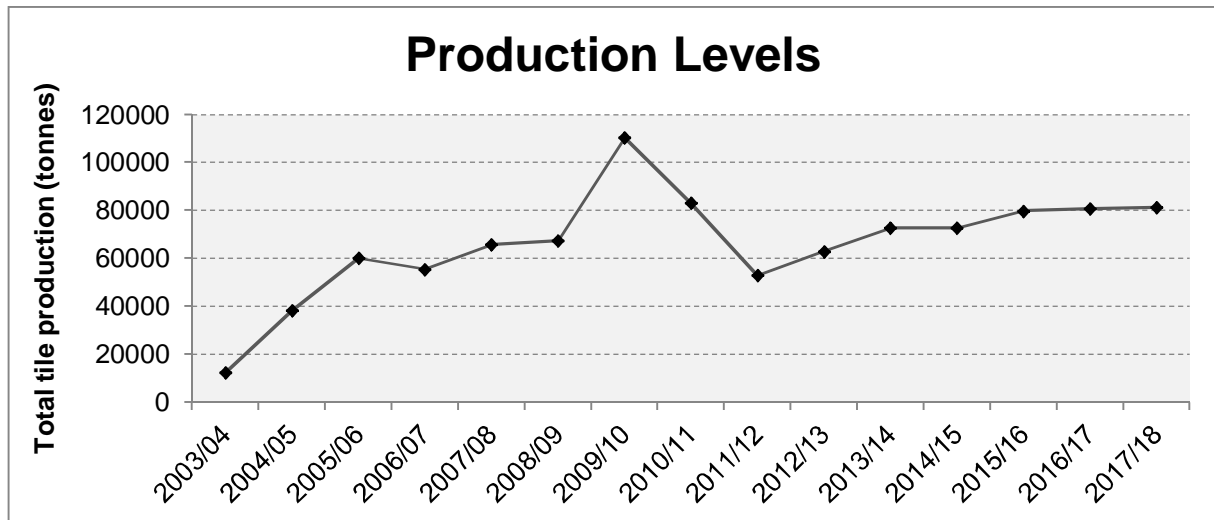
Figure 1 Production volume since 2004

Between 1 August 2017 and 31 July 2018 the facility operated 330 days, for a total output of 81,161 tonnes of ceramic tiles (or approximately 5.41 million m²). These production levels are below the maximum production authorised under NCIA's current approvals (refer to Section 1.2) and are commensurate to the current stage of development of the facility (i.e. Stage Two).

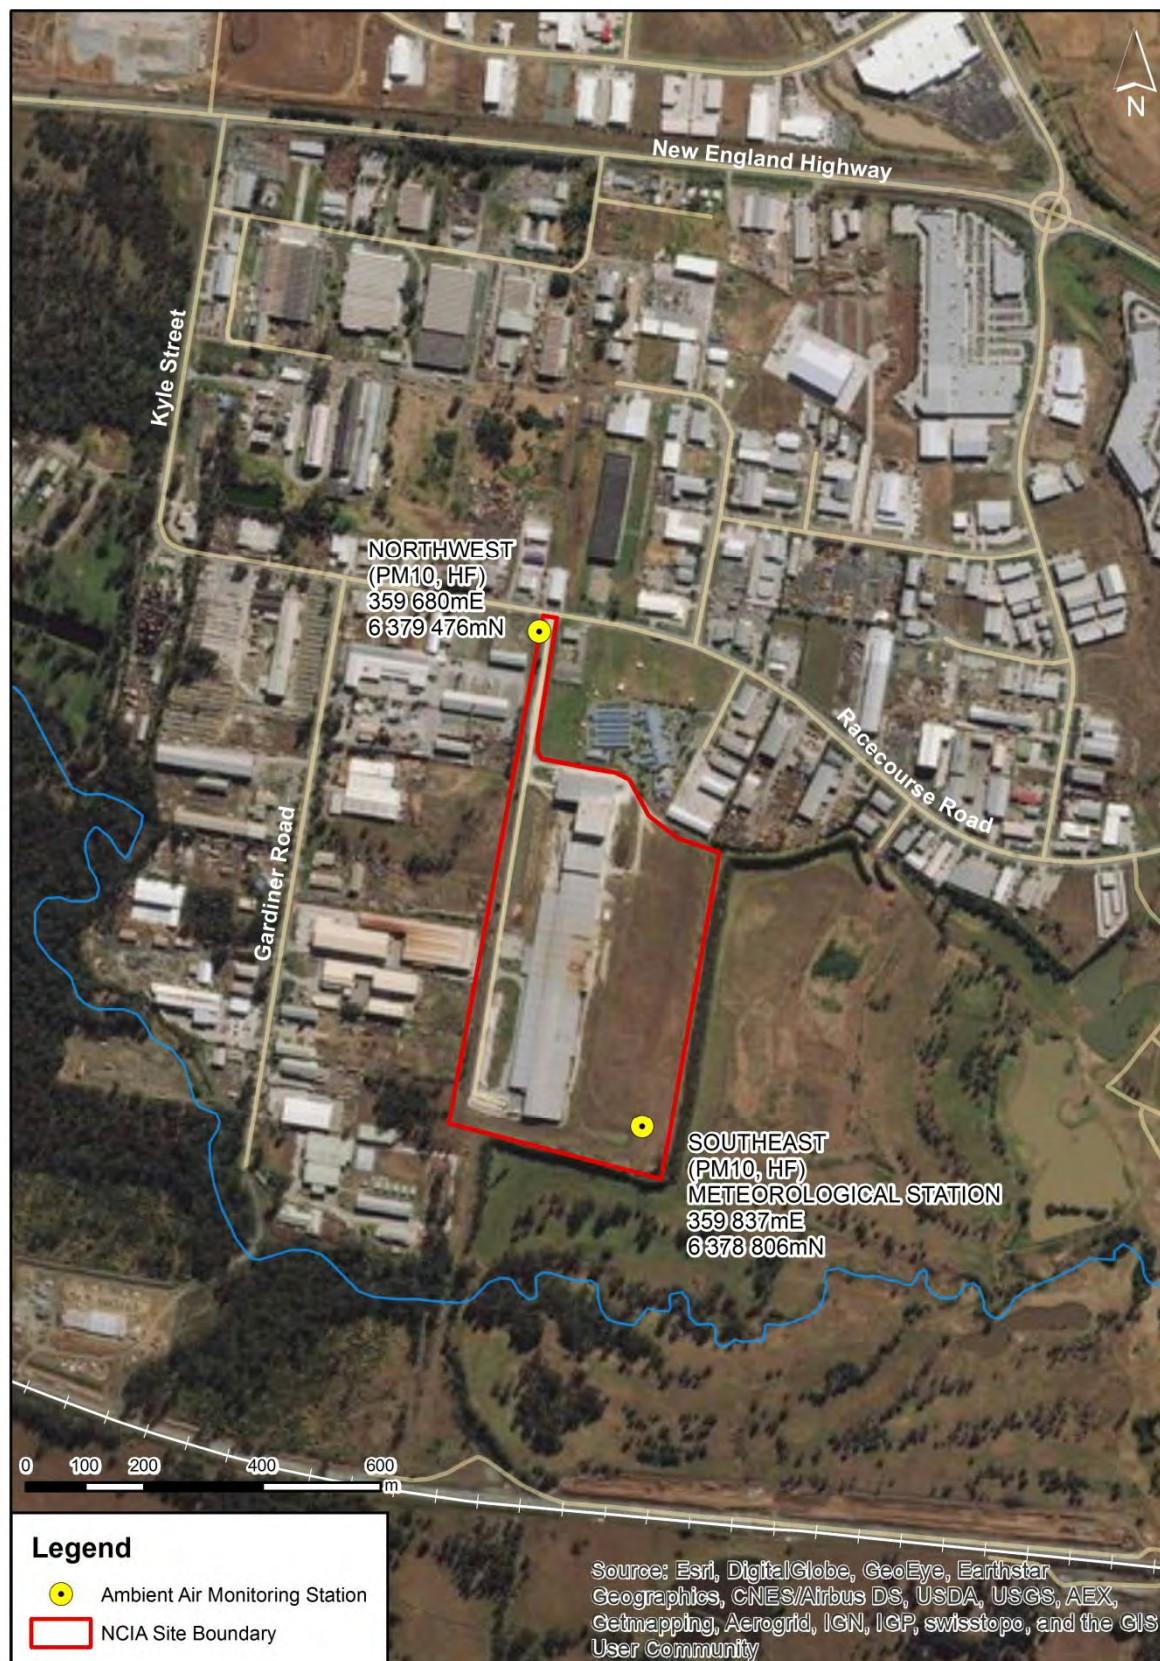
Figure 2 Ambient air monitoring locations

In accordance with EPL condition M2.1, PM₁₀ (24-hour) and Fluoride (24-hour and weekly) are monitored at two locations: northwest and southeast of the facility (refer Figure 2).

Two fluoride monitoring units (manual, double filter paper samplers) have been sited at each of the two locations identified for monitoring of PM₁₀, and are operated in accordance with *AS3580.13.2:2013 Determination of gaseous and acid-soluble particulate fluorides*. At each location, one monitor operates continuously over a 7-day period to provide weekly fluoride concentration averages. These units are designated 'Northwest HF7' and 'Southeast HF7'. The remaining unit at each site operates continuously for discrete 24-hour periods according to the NSW EPA 6-day cycle to provide 24-hour averages for sampler operation days. Units are designated 'Northwest HF' and 'Southeast HF'.

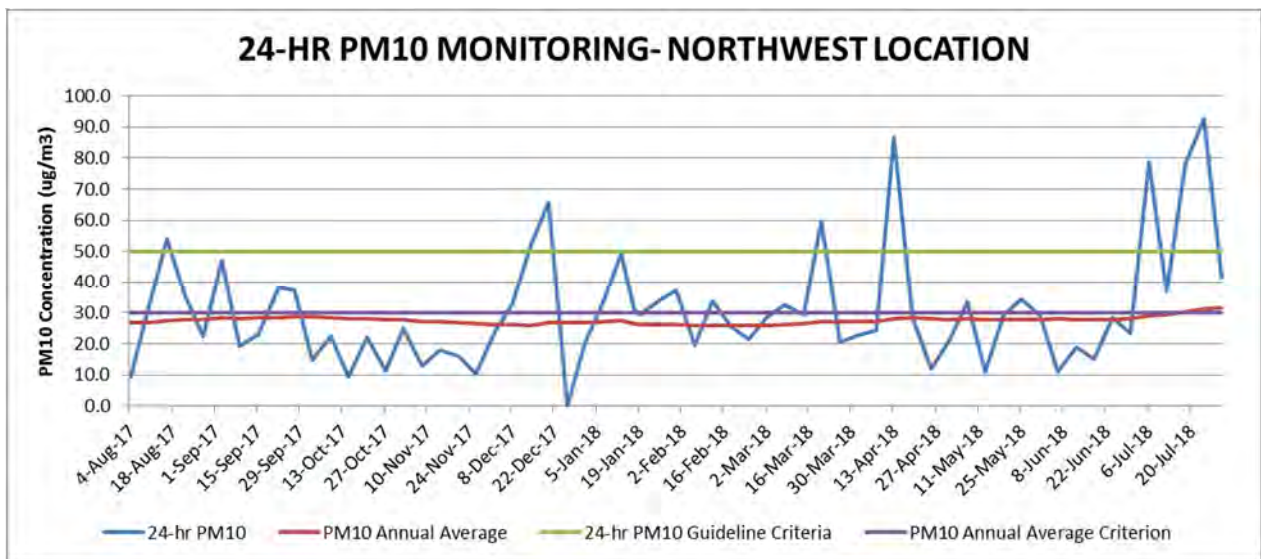
Figure 3 PM₁₀ monitoring – northwest location

At the completion of this 12 month period the North West location returned an annual average of 31.4 µg/m³ which is above the criteria. It should be noted that this annual average remained below the criteria until 18 July where three elevated results caused the annual average to move above the criteria.

Meteorological data on the 16th August indicates strong north westerly winds gusting above 60 km/h. As the NCIA site is downwind of the North West sampling location, it is unlikely to be the dust source. Regional PM₁₀ data along with meteorology conditions, suggest that increased regional background PM₁₀ levels contributed significantly to the measured values on the 16th August at NCIA.

The NCIA facility was not operational on 20 December as it was shut down for the Christmas period on 19 December. Meteorological data for both 14 and 20 December show temperatures in excess of 40 degrees with winds from the North West. The NCIA facility is downwind of the North West monitoring location under these wind conditions, so NCIA is unlikely to be the cause of the exceedances at the North West monitoring site.

In summary, the PM₁₀ result recorded at the North West monitoring location on 20 March is likely to be significantly influenced by high regional PM₁₀ concentrations as a result of warm, dry and windy conditions.

In summary, the PM₁₀ result recorded at the North West monitoring location on 13 April is likely to be significantly influenced by high regional PM₁₀ concentrations as a result of warm, dry and windy north westerly conditions. The North West sampler was upwind of the NCIA facility on this day meaning the facility was not the source of the exceedance.

The NCIA facility was predominantly downwind of the North West monitoring station on 6 July with strong north westerly winds recorded at the onsite meteorology station. Elevated PM₁₀ readings upwind of the facility and a significantly lower reading at the South East site (downwind of the facility) indicate that the NCIA facility was unlikely to be the primary source of the PM₁₀ emissions on this day with a localised upwind offsite source the likely cause of exceedances.

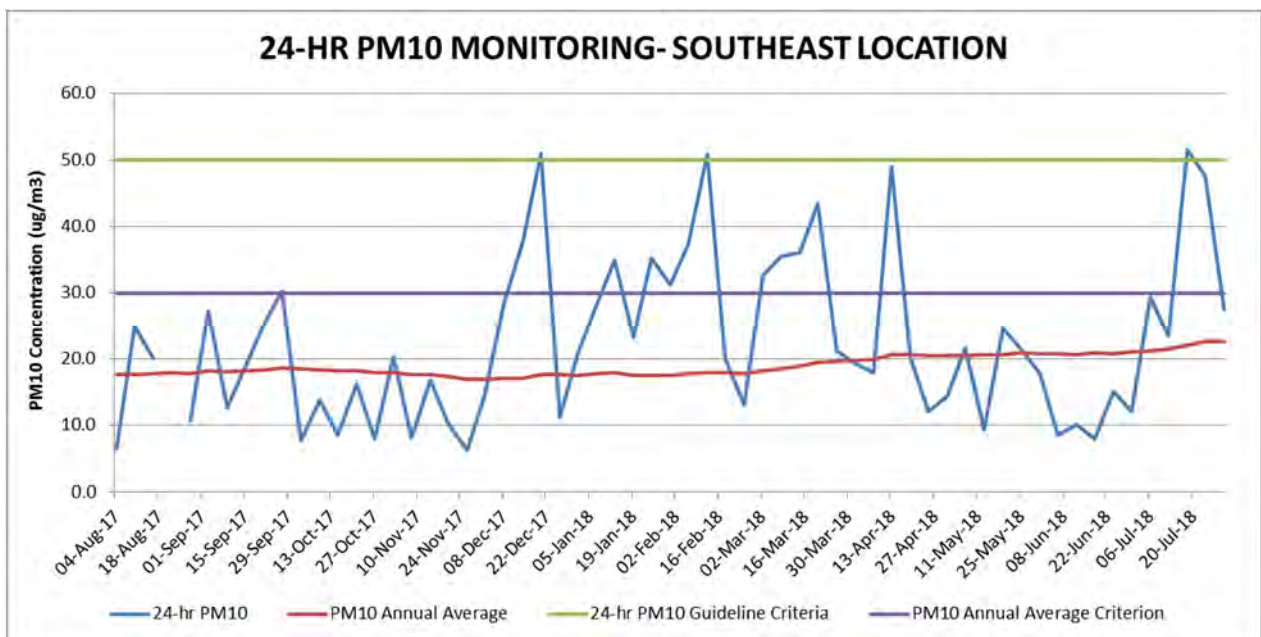
Figure 4 PM₁₀ monitoring – southeast location

It had been observed that off-site earthworks are occurring to the South East of the facility with front end loaders observed filling tipper trucks with other heavy vehicles operating on unsealed roads. Given the wind conditions on 12 February it is probable that these off-site earthworks have resulted in the elevated PM₁₀ concentrations recorded at the South East sampler on 12 February.

In addition, although the South East monitoring location on 18 July recorded a reading above the criteria, the South East result was significantly lower than the North West result (upwind of the facility) and as such it is likely that elevated regional conditions was the probable cause of exceedance.

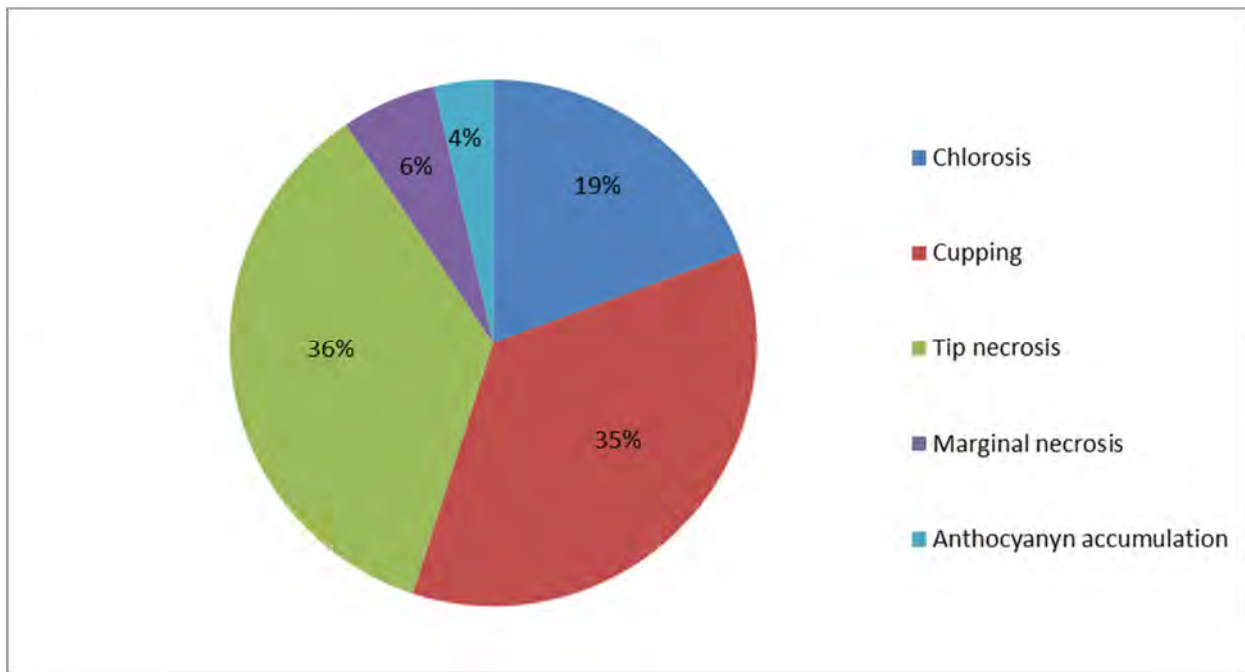
Figure 10 Relative prevalence of fluoride related symptoms

Figure 10 shows the prevalence of each visual foliage injury symptom observed in all species during the surveys. It indicates that tip necrosis, leaf undulation / cupping, and chlorosis were the most commonly occurring symptoms (with 19 - 36% of all observations), followed by marginal necrosis (6%), whilst symptoms of anthocyanin accumulation were generally uncommon (4% of all observations).

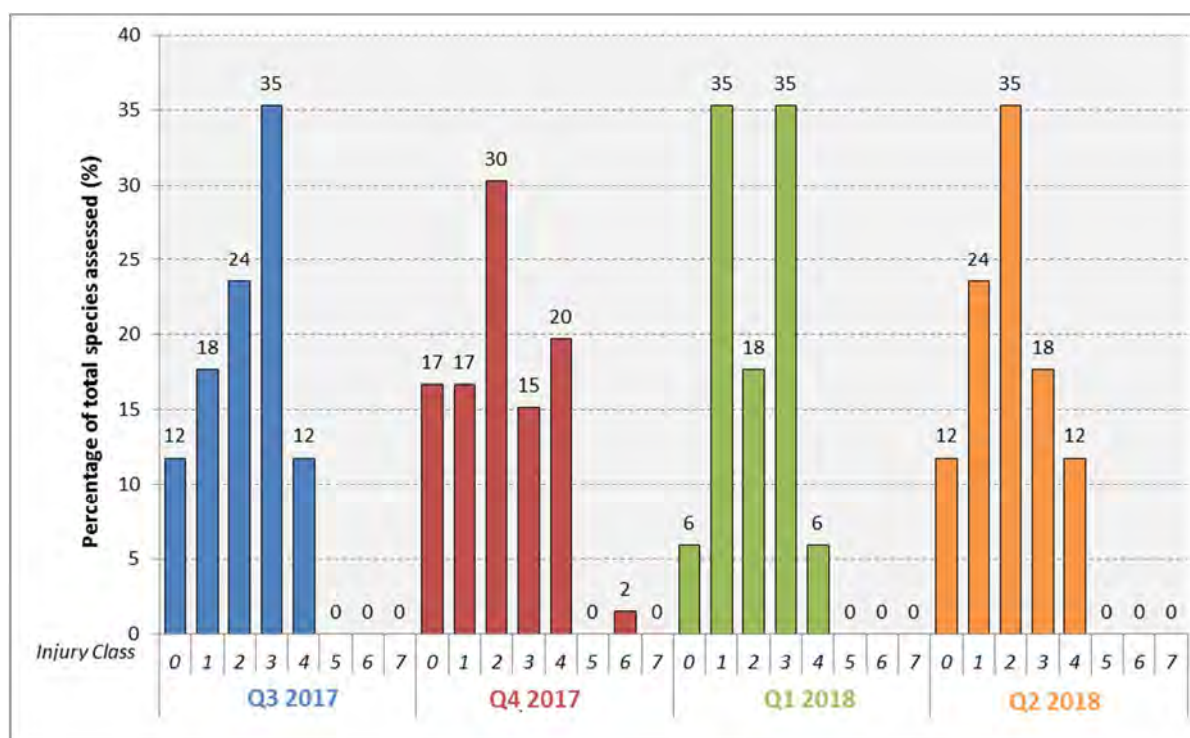
Figure 11 Proportion of flora species affected by emissions related visual injury symptoms during the surveys

- For each survey between 54% and 64% of plants surveyed were affected at worst by slight injury symptoms (i.e. injury class 2 and less, maximum of 5% leaf area impacted);
- For each survey between 30% and 47% of plants surveyed were affected by distinct or marked injury symptoms (i.e. injury class 3 or 4, 10-25% of leaf area impacted);
- During the annual Q4 2017 survey only, 2% of plants surveyed displayed severe to very severe visual injury symptoms (i.e. injury class 5 or 6, 50-75% of leaf area impacted); and
- No species displayed extreme injury symptoms (i.e. injury class 7, >75% of leaf area impacted) during any of the four surveys.

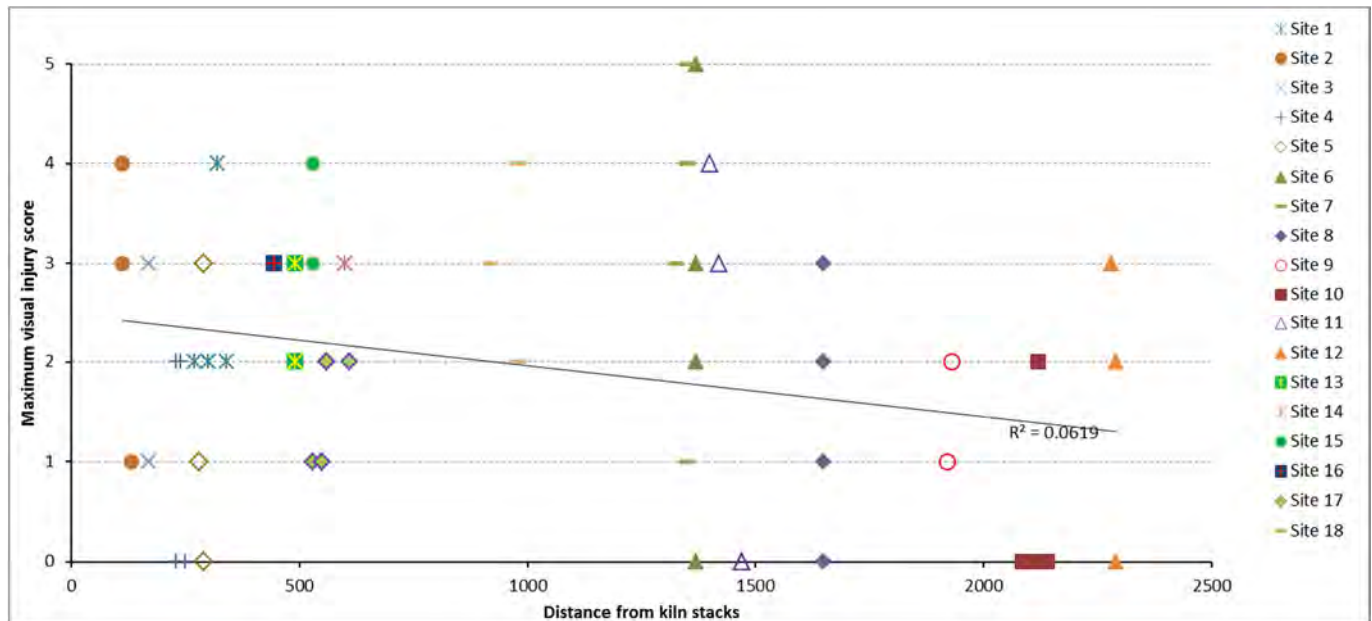
Figure 12 Relationship between distance from kiln stacks and maximum visual injury score in foliage of species assessed

Figure 12 depicts the relationship between the maximum emission related visual injury score recorded for each species (inclusive of all surveys) and their distance from the kiln stacks at NCIA. The results showed little correlation between foliage injury and the distance to the emission source ($r^2 = 0.06$), indicating that emission impacts to foliage may spread further from the NCIA site than the furthest monitoring site. For instance, category 5 injury symptoms were observed up to ~1,400m away from the NCIA facility at Site 6 and Site 7, while category 3 symptoms occurred as far as Site 12 (~2,300m from the NCIA facility). This also suggests that within the current suite of monitoring sites, variables such as flora species type or the sensitivity of specific individuals are more relevant than the distance from emission source in determining atmospheric fluoride impacts on local vegetation. However and importantly, there are several other air pollution sources in the region which may impact vegetation and foliage condition. Therefore the geographical extent of fluoride impacts to foliage attributable to NCIA activities alone cannot be confidently determined.

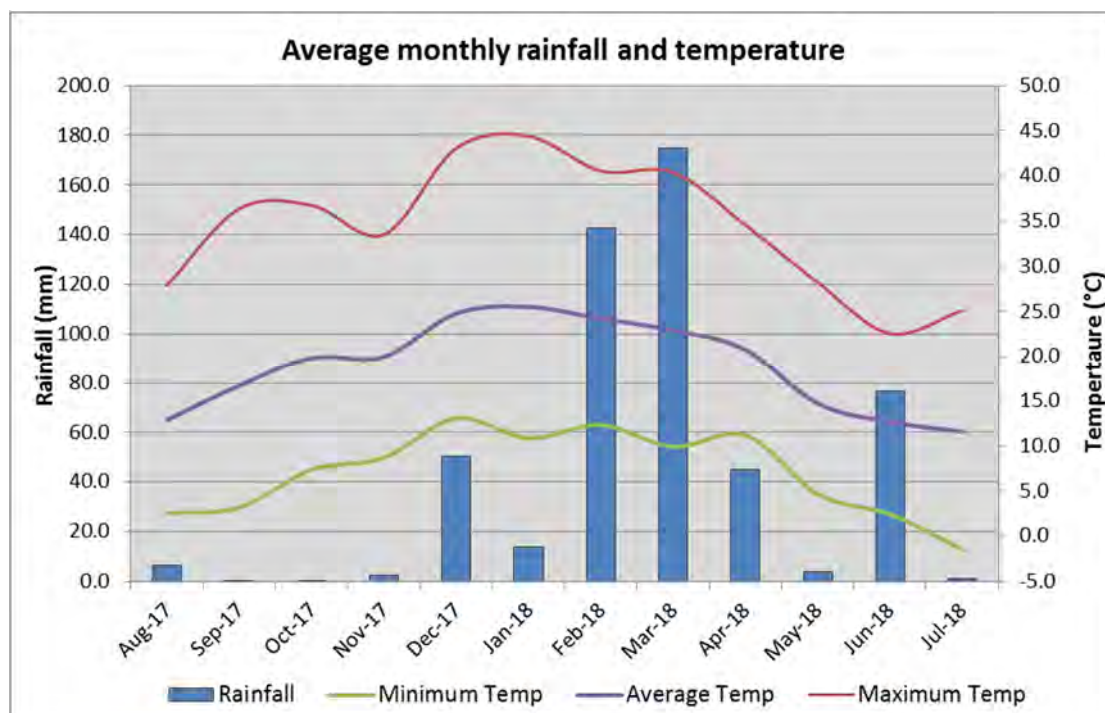
Figure 13 Average monthly rainfall and temperature range (1 August 2017 – 31 July 2018)

Wind speeds recorded over the year were generally low to medium with an average wind speed of 2.0 m/s during the reporting period. The maximum hourly average wind gust during the reporting period was recorded at 10.4 m/s on 15 April 2018.

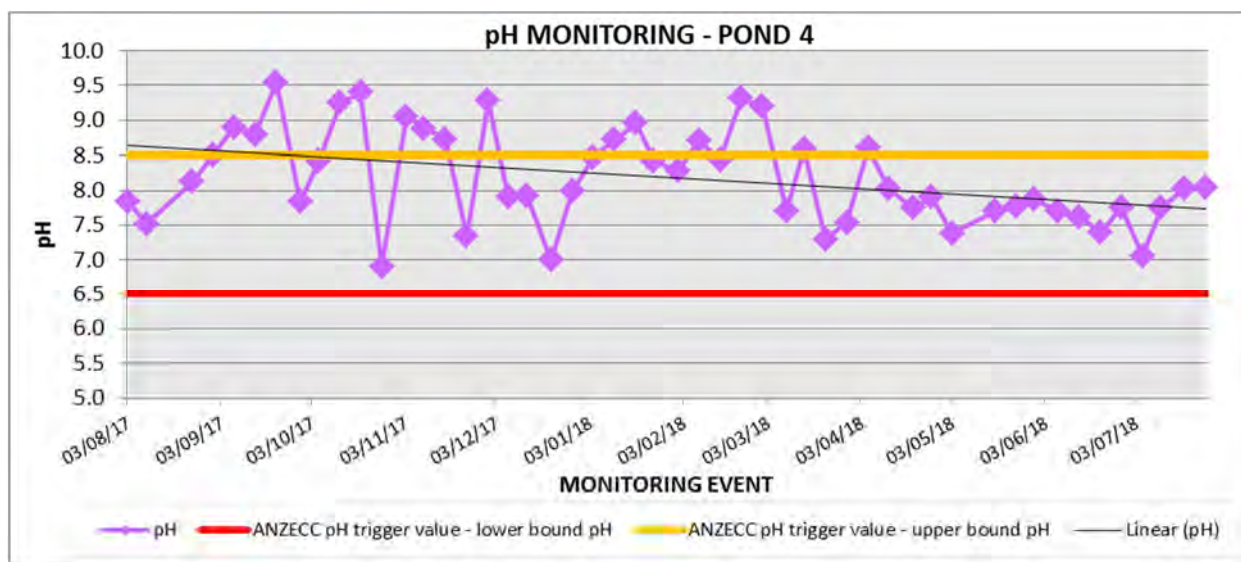
Figure 14 Stormwater quality monitoring – pH

Pond 4 was noted to be discharging on one occasion throughout the reporting period, 21 June 2018. Pond 4 water parameters were all within relevant criteria on this date.

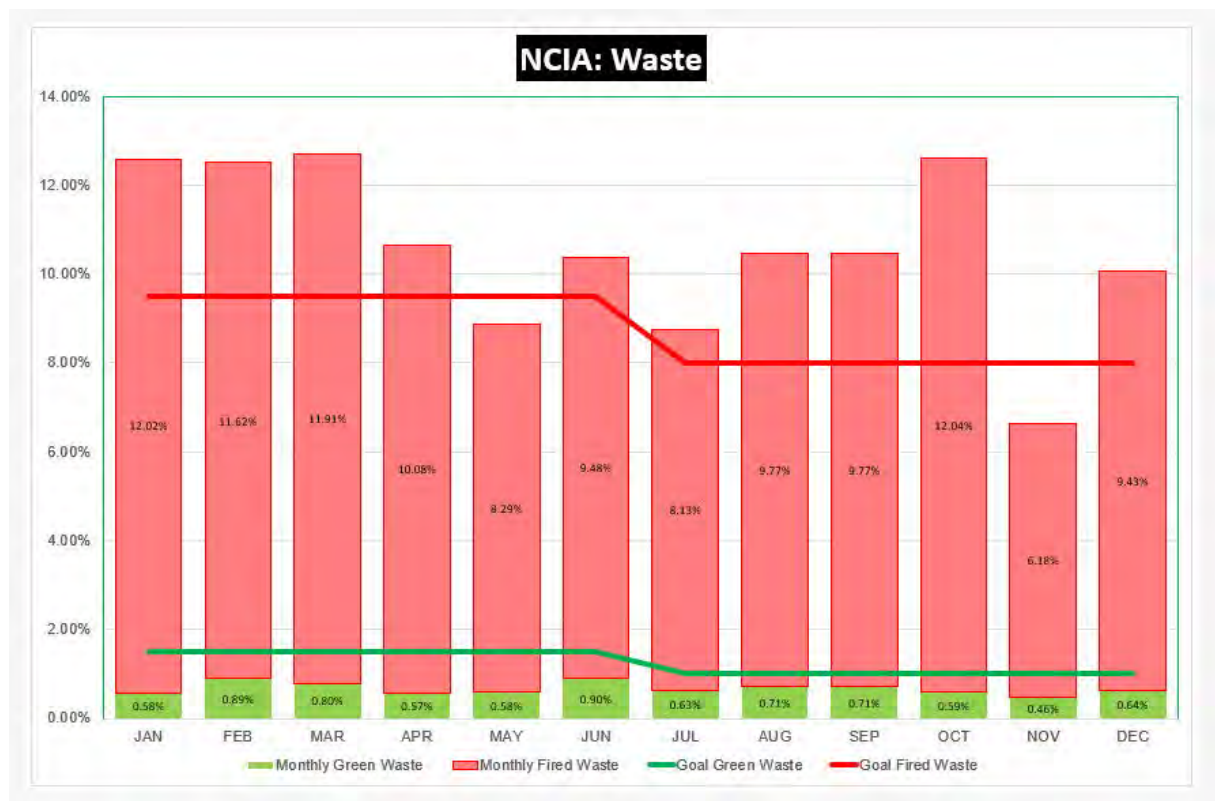
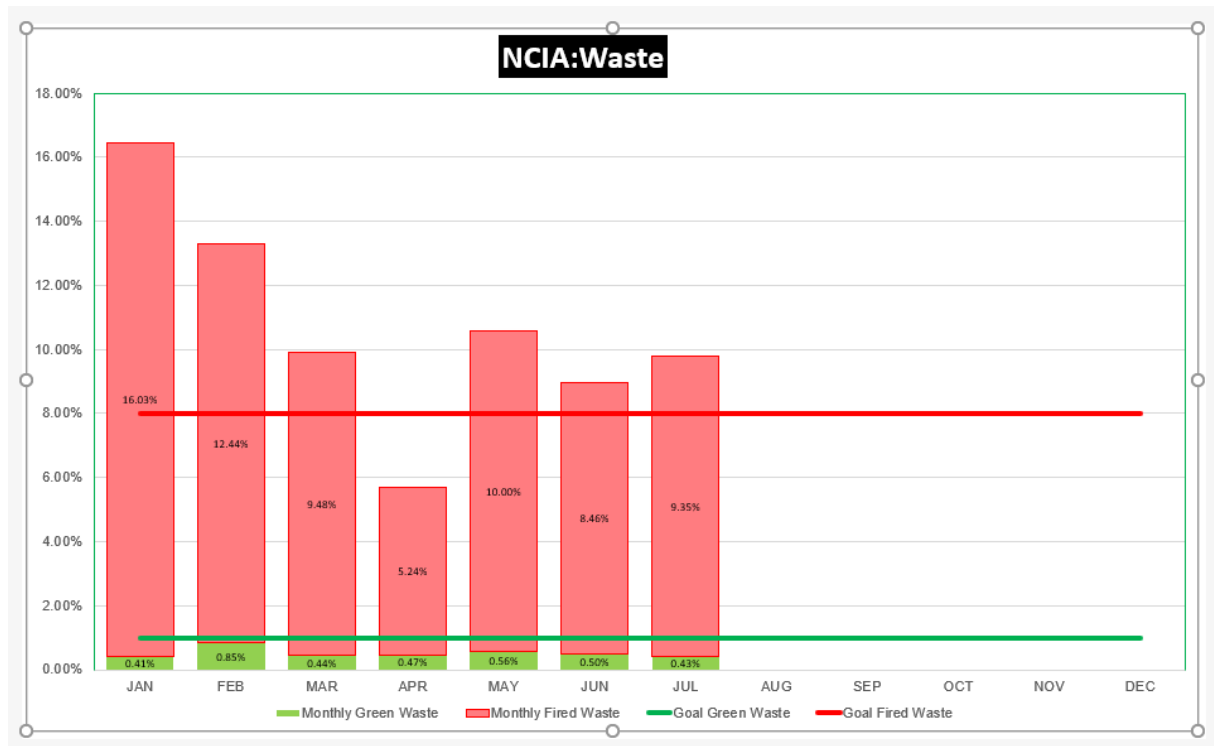
Figure 16 Tile waste (green and fired) generation during 2017-2018

NCIA's targets for tile wastes were lowered in July 2017 to not exceed 1% (for green tile waste) and 8% (for fired tile waste) of the total tile production, respectively. The green tile waste target was achieved every month throughout the reporting period. The amount of fired tile waste exceeded the target for ten months of the reporting period, with a monthly average of 9.85%. Management have programs in place to reduce fired waste to 5% by June 2018. Management are exploring potential on site processing options to turn this waste into reusable saleable product.

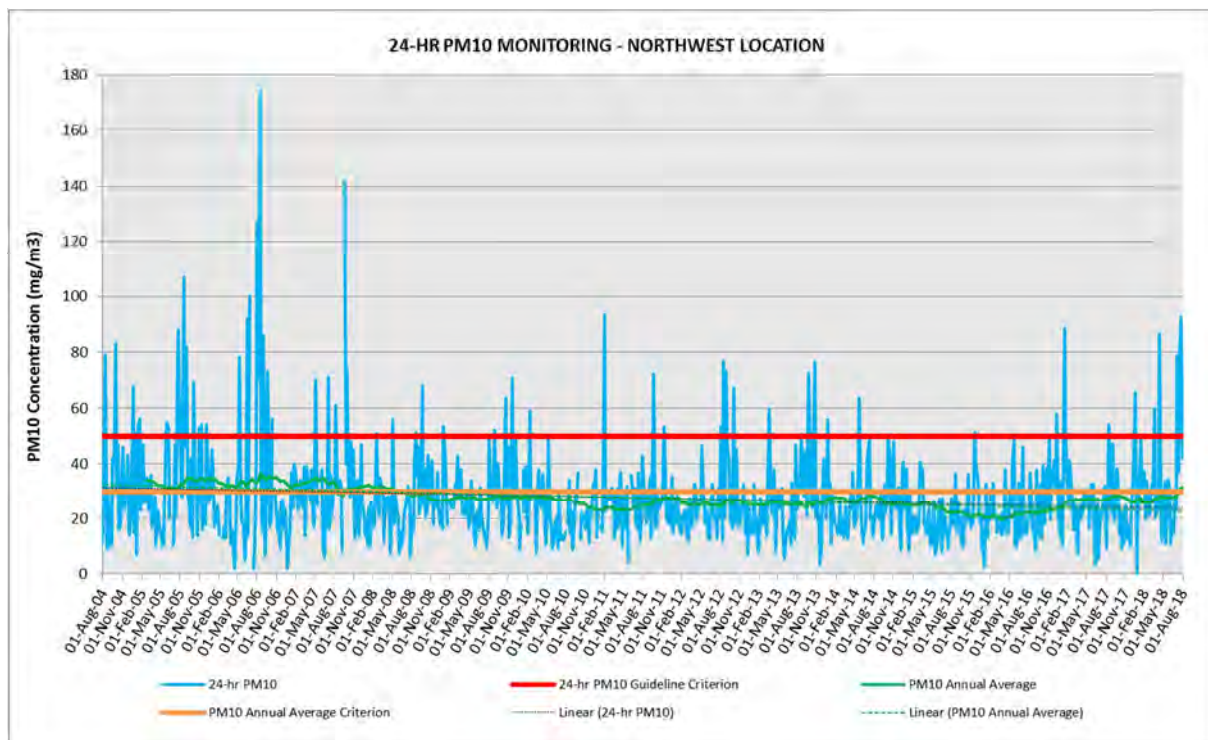
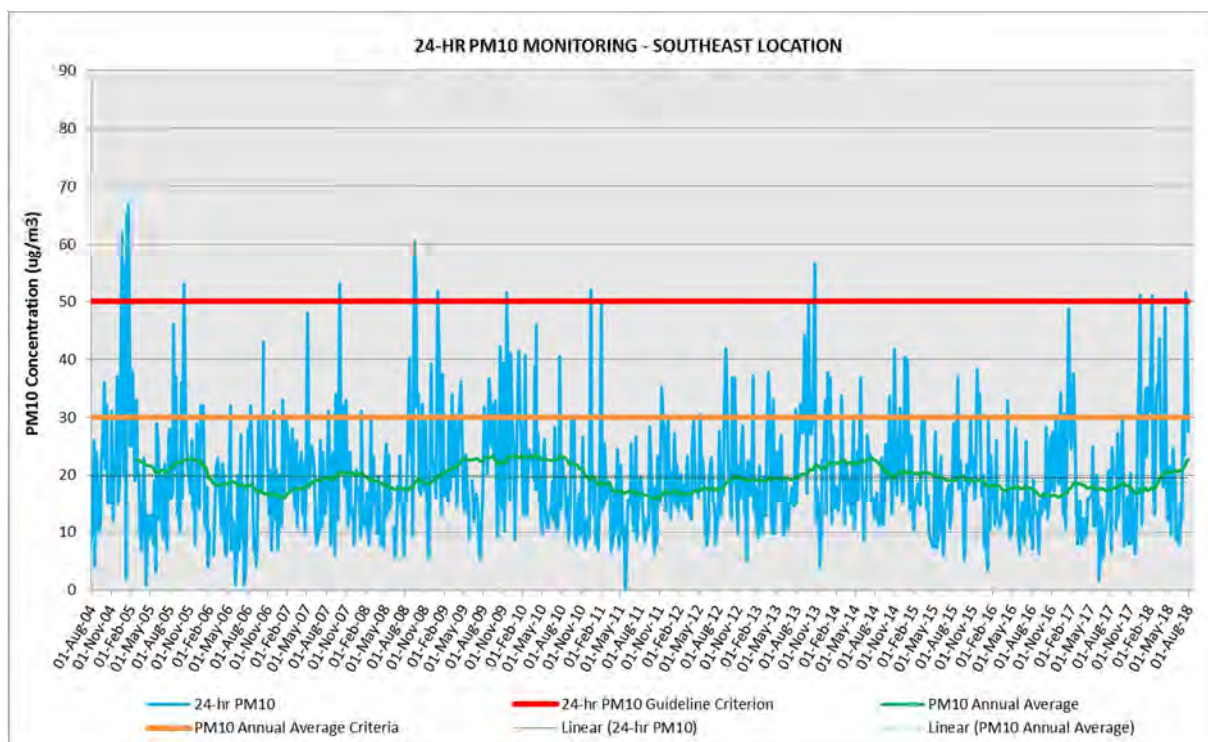
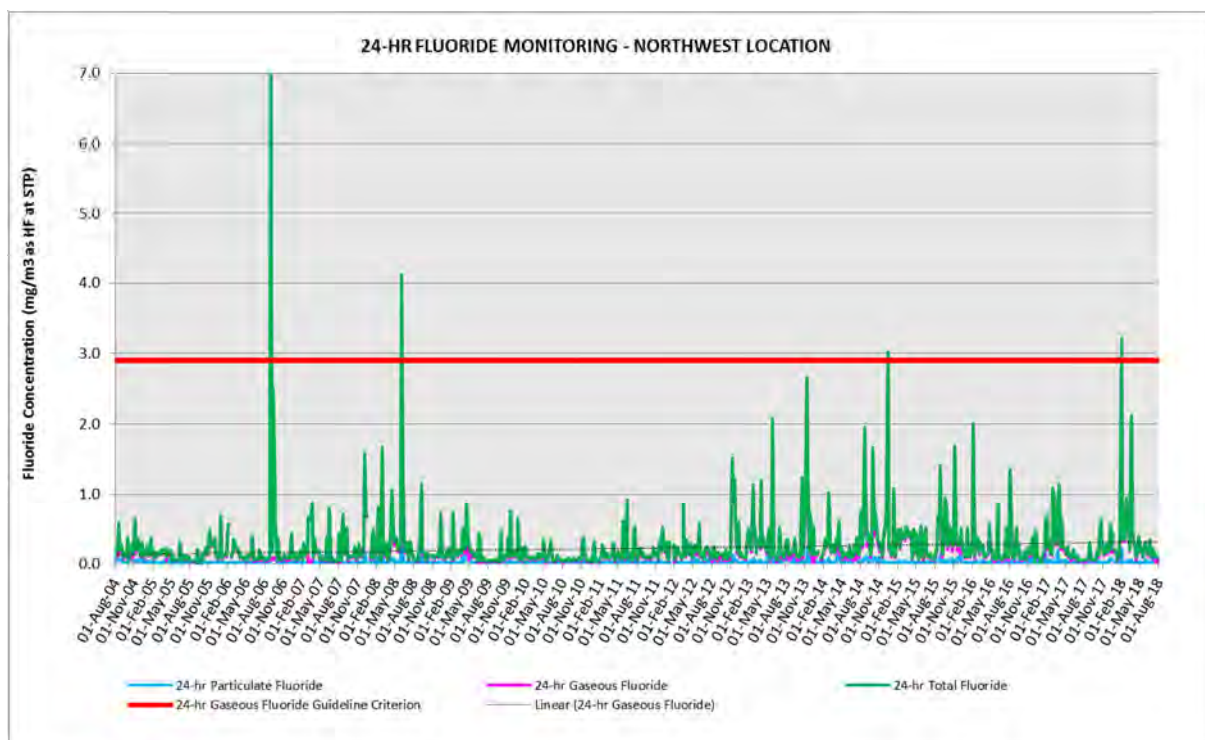
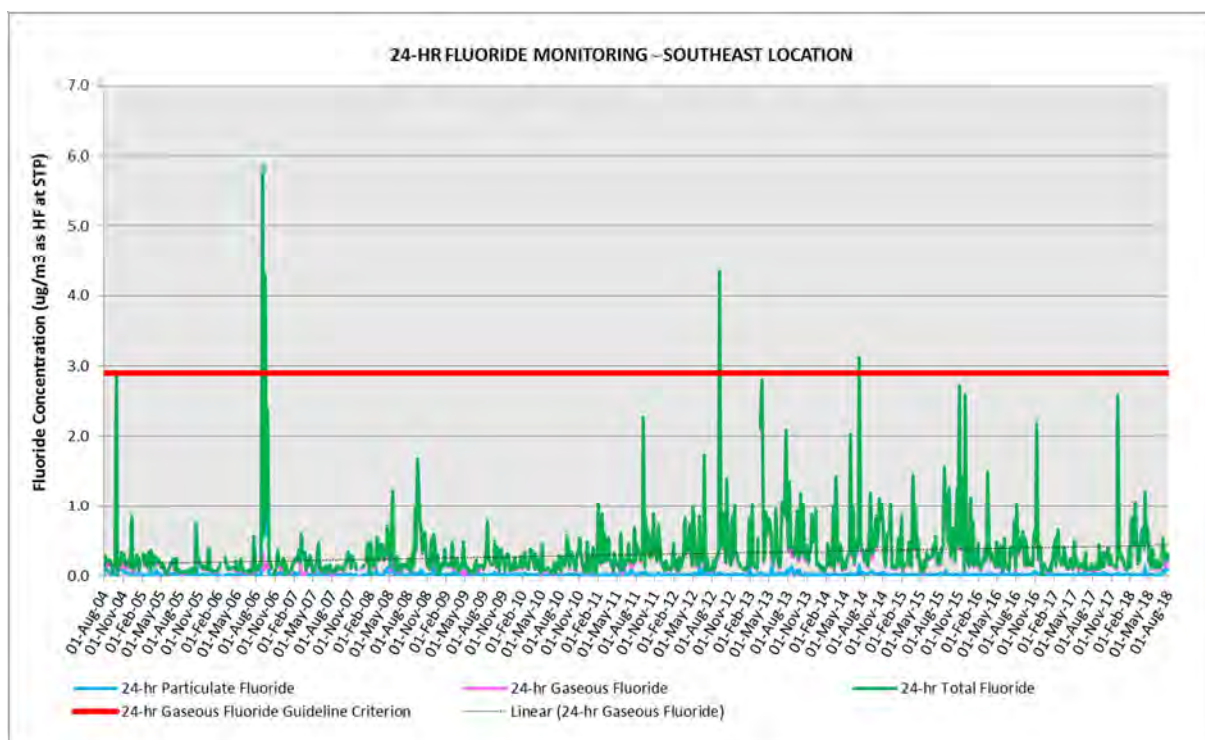
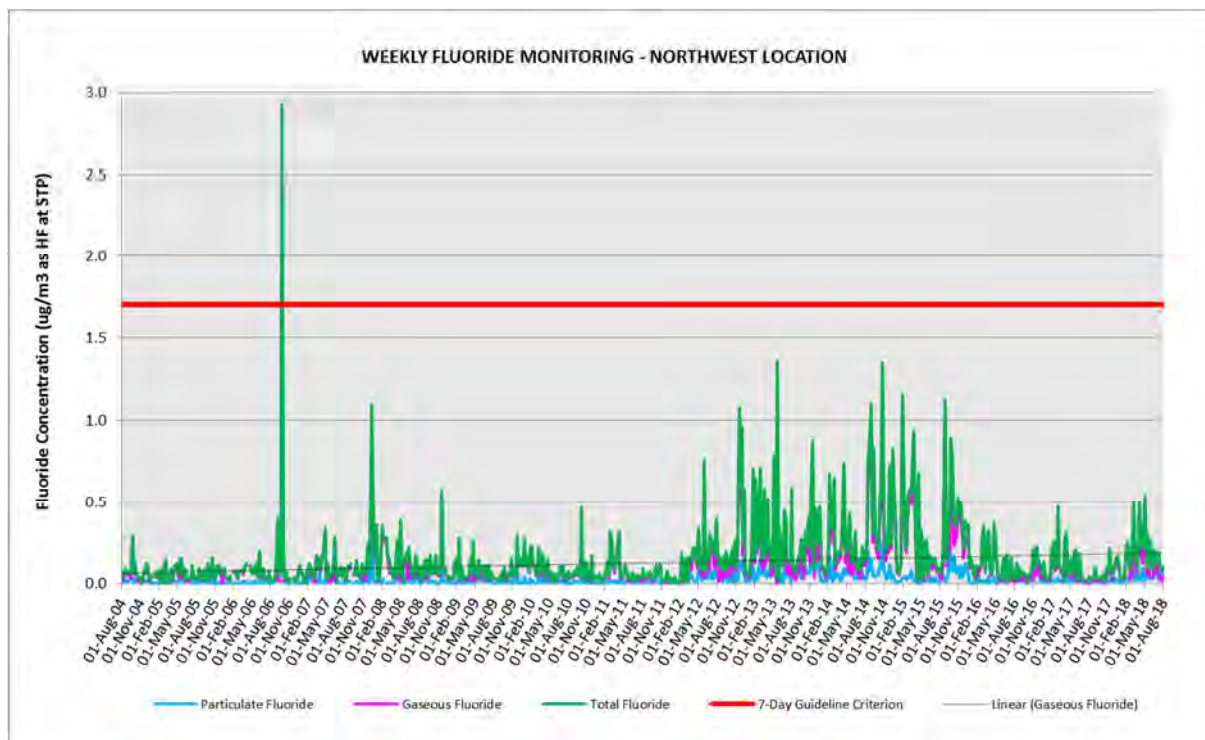
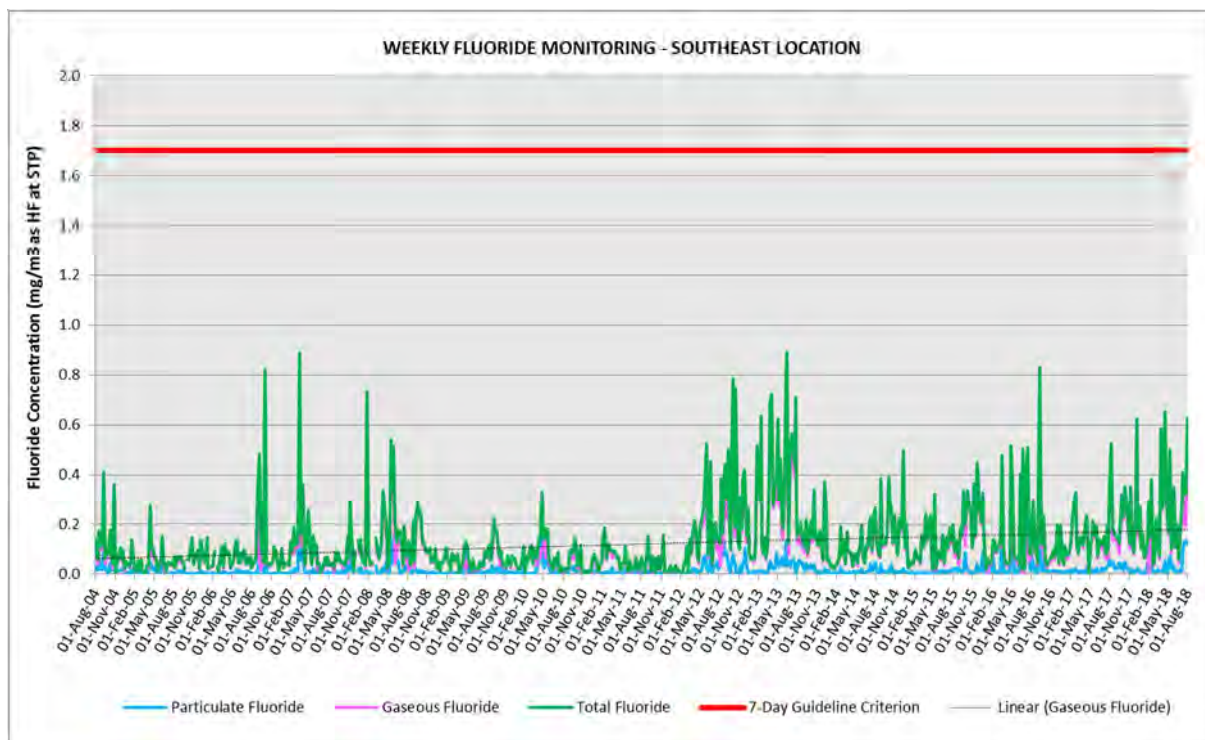
- Following seven years of relatively low and steady levels of fluoride emissions between 2004 and 2011 (despite isolated and episodic increases), gaseous fluoride levels have slightly increased since 2012 in both the 24-hour and weekly fluoride levels. Fluoride emissions during the 2018 reporting period were similar to the previous four years. Nonetheless, there is an overall increasing linear trend in 24 hour and weekly fluoride levels at both monitoring locations.

Figure 17 24-hour PM₁₀ monitoring – northwest location (2004 – 2018)

Figure 18 24-hour PM₁₀ monitoring – southeast location (2004 – 2018)

Figure 19 24-hour fluoride monitoring – northwest location (2004 – 2018)

Figure 20 24-hour fluoride monitoring – southeast location (2004 – 2018)

Figure 21 Weekly fluoride monitoring – northwest location (2004 – 2018)

Figure 22 Weekly fluoride monitoring – southeast location (2004 – 2018)

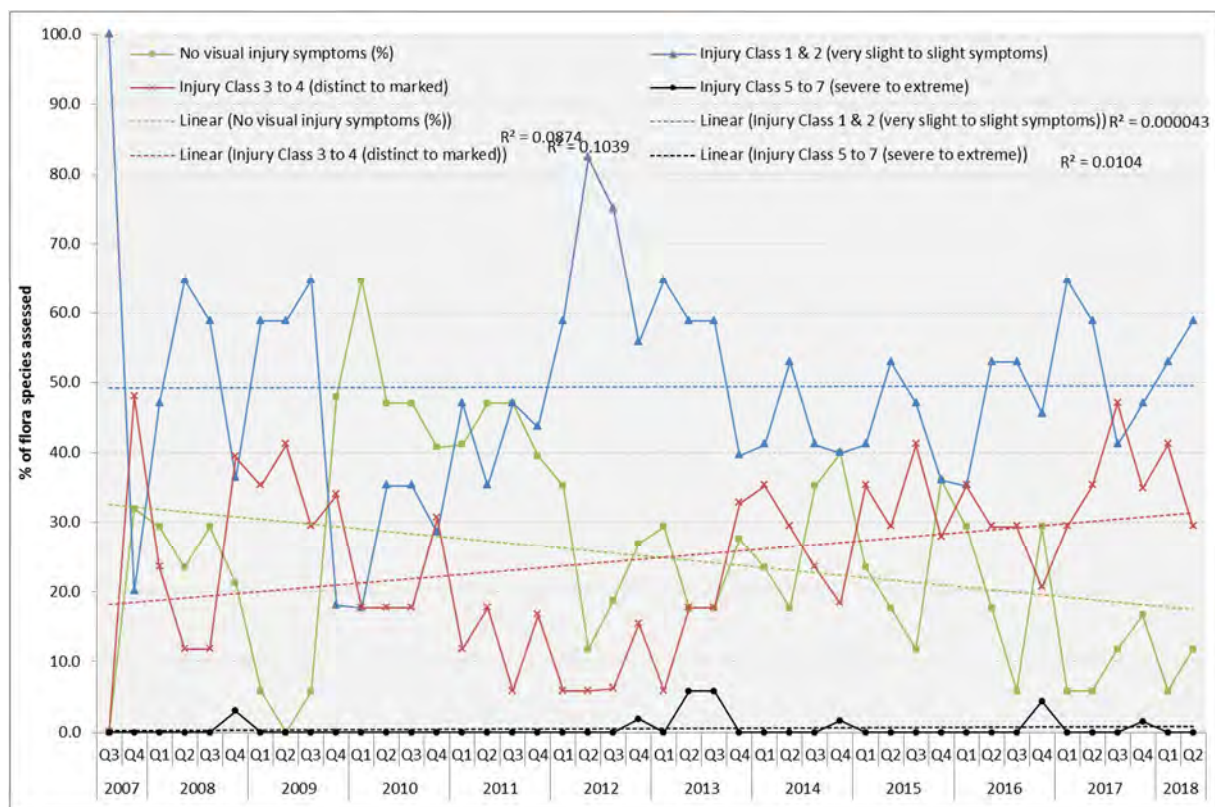
Figure 23 Proportion of flora species affected by emission related visual injury symptoms (2007-2017)

- Species showing no visible fluoride injury symptoms;
- Species displaying at worst class 1 (very slight) or class 2 (slight) injury symptoms;
- Species displaying at worst class 3 (distinct) or class 4 (marked) injury symptoms; and
- Species displaying class 5 injury symptoms and above (severe to extreme).

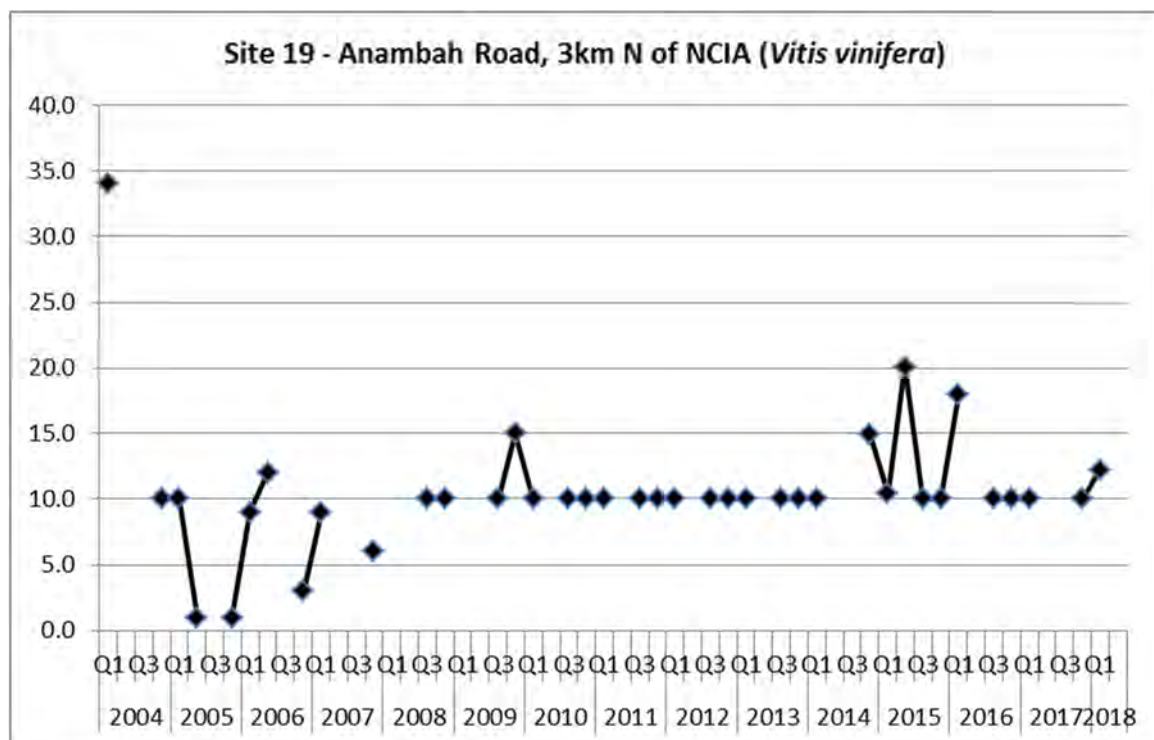
Figure 28 Fluoride content in *Vitis vinifera* foliage at Site 19 (Q1 2004 – Q2 2018)²

Given the social and economic importance of the viticultural industry in the Hunter Valley the potential impact of atmospheric pollutant emissions from industrial sources on the health of the grape vine *Vitis vinifera* (a known sensitive species) has traditionally been a concern for the industry. Consequently, foliar sampling and analysis of *Vitis vinifera* foliage from the reference site has historically been included as part of this vegetation monitoring program. Historical concentrations since the commencement of the monitoring programme are presented in Figure 28.

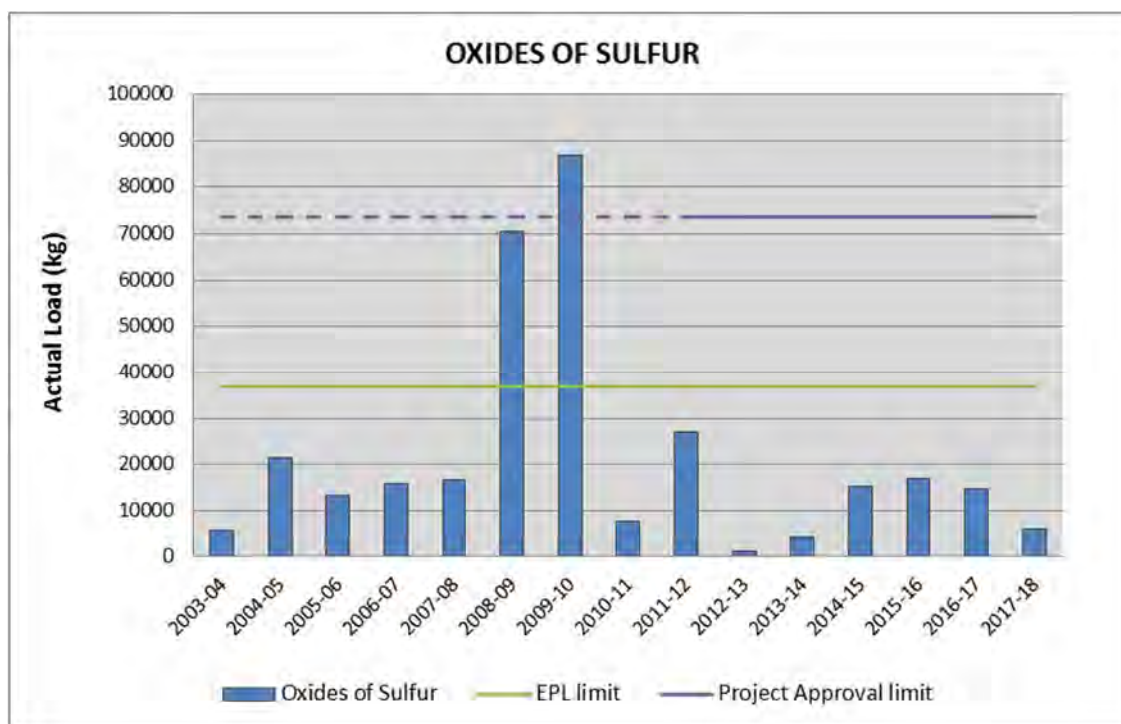
Figure 32 Sulfur oxides (as sulphuric acid mist and sulfur trioxide (as SO₃)) annual load (2004 – 2018)

Note: Sulfur oxide loads for the 2012-13 and 2013-14 reporting years have been corrected to only include sulfuric acid mist and sulfur trioxide, as agreed with regulatory authorities in 2012, and not sulfur dioxide as previously calculated.

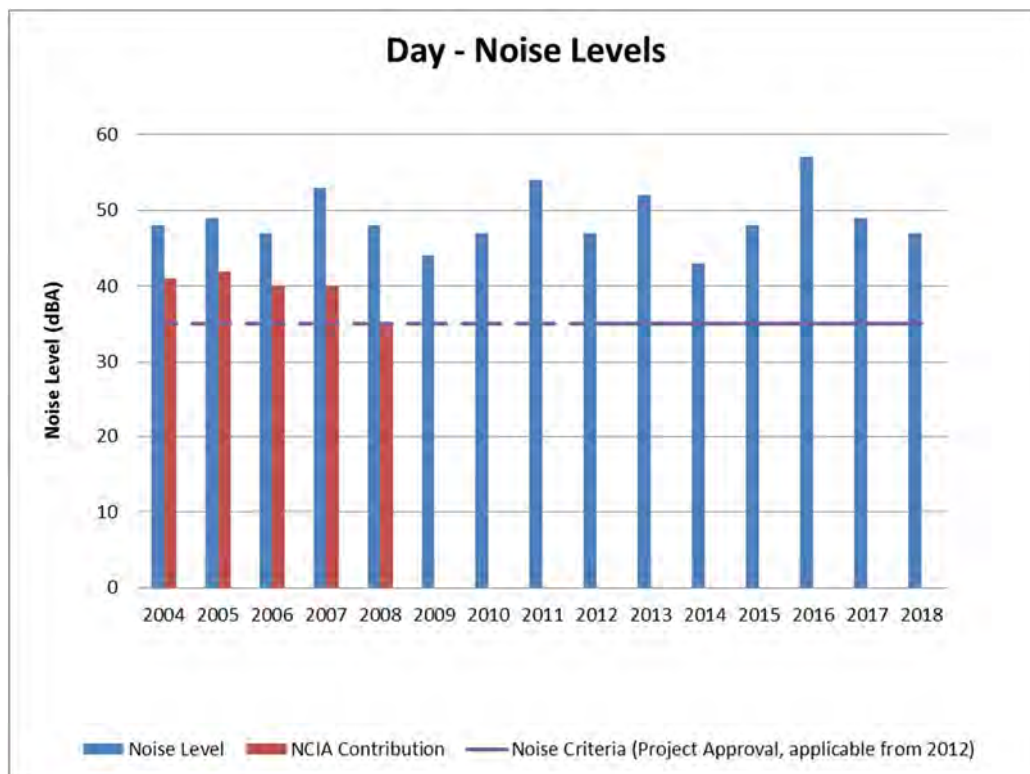
Figure 34 Day noise levels 2004 – 2018

During the daytime for the past ten years the NCIA noise contribution was either inaudible or audible but not measurable. The current noise monitoring report noted that traffic noise from the New England Highway contributed significantly to the background noise levels at Kenvil Close.

Note 1: 2009 - 2017: NCIA contribution was either inaudible or not measurable.

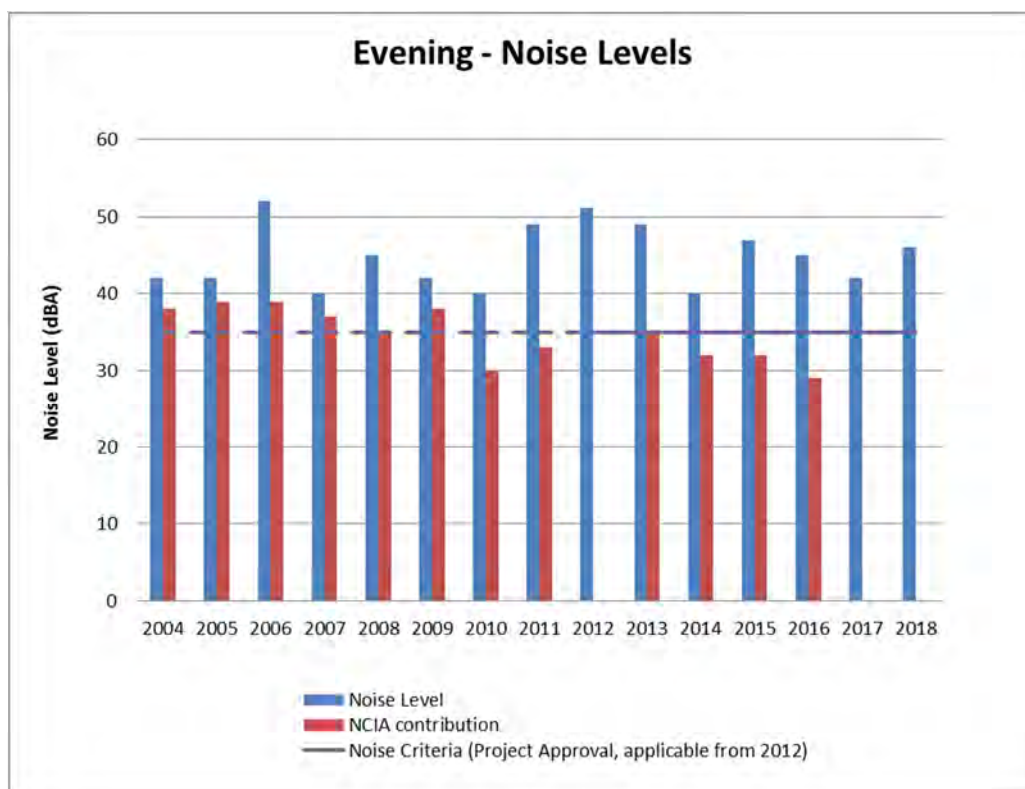
Figure 35 Evening noise levels 2004 – 2017

Note: 2012 and 2017: NCIA contribution was either inaudible or not measurable.
