2018 Annual Environmental Management Report

1 August 2017 - 31 July 2018

Client: National Ceramic Industries Australia

AECOM Australia Pty Ltd

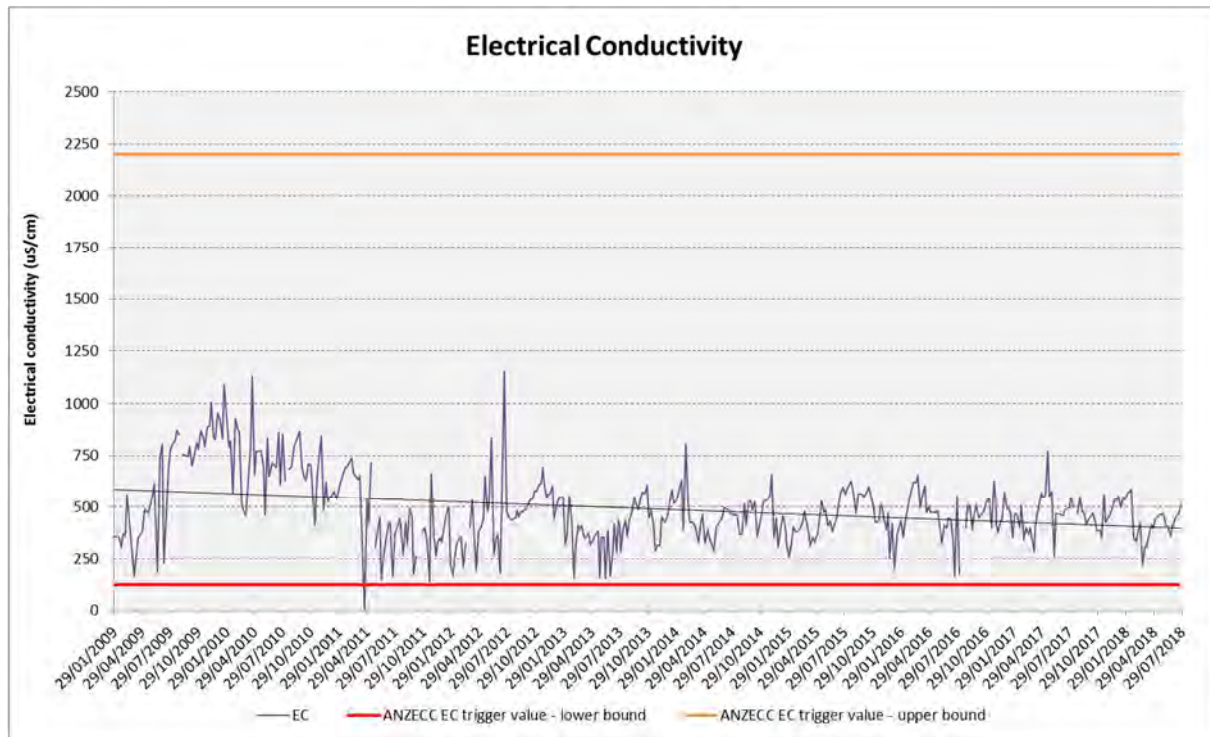
Figure 38 Stormwater quality, EC – Pond 4 (2009-2018)

EC results during 2018 are comparable to previous years with a stable average and no exceedances of the criteria (refer to Figure 38). A review of historical EC values indicates an overall decreasing trend. EC values are generally within the ANZG guidelines trigger values and indicate that the stormwater is non-saline.

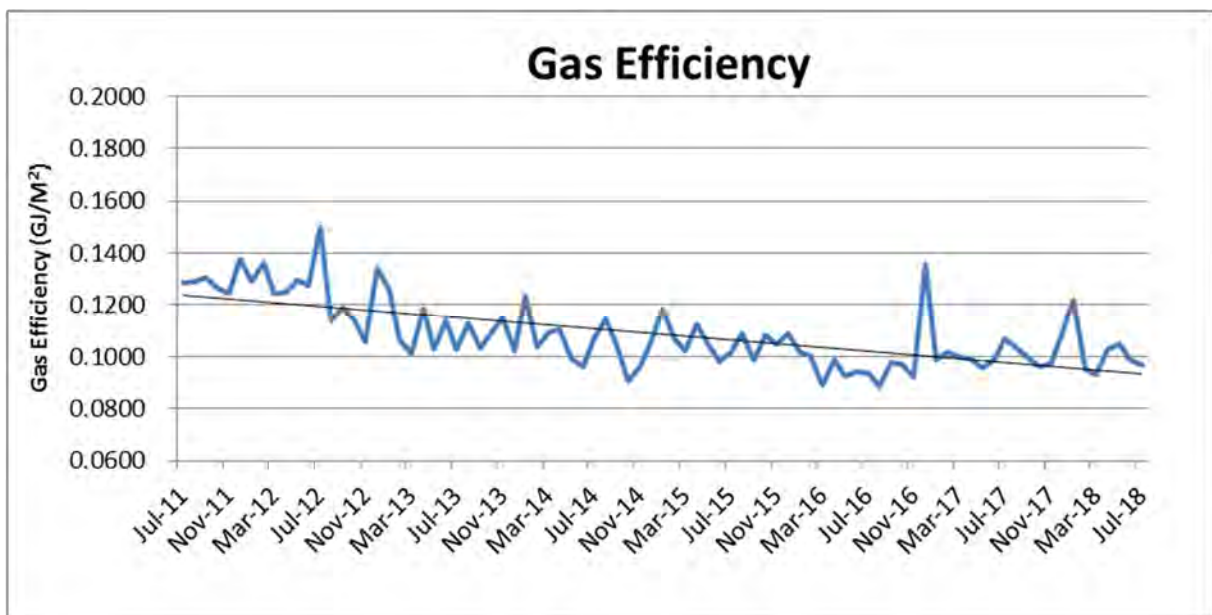
Figure 39 Gas efficiency in tile manufacturing process

NCIA has installed a Quality Assurance (QA) machine before the kiln on each of its production lines. This effectively reduces waste tiles going through the kiln and being fired, creating both a reduction in waste and a saving in energy consumption.
