2019 Annual Environmental Management Report

1 August 2018 - 31 July 2019

Client: National Ceramic Industries Australia

AECOM Australia Pty Ltd

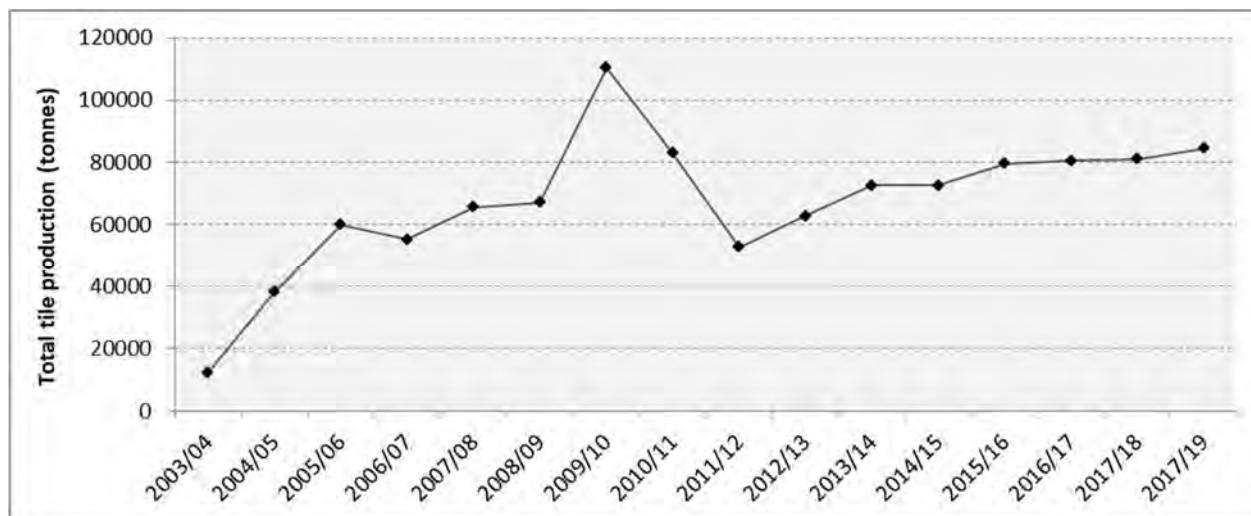
Between 1 August 2018 and 31 July 2019 the facility operated 330 days, for a total output of 84,675 tonnes of ceramic tiles (or approximately 5.64 million m²). These production levels are below the maximum production authorised under NCIA's current approvals (refer to Section 1.2) and are commensurate to the current stage of development of the facility (i.e. Stage Two).

Figure 1 Production volume since 2004

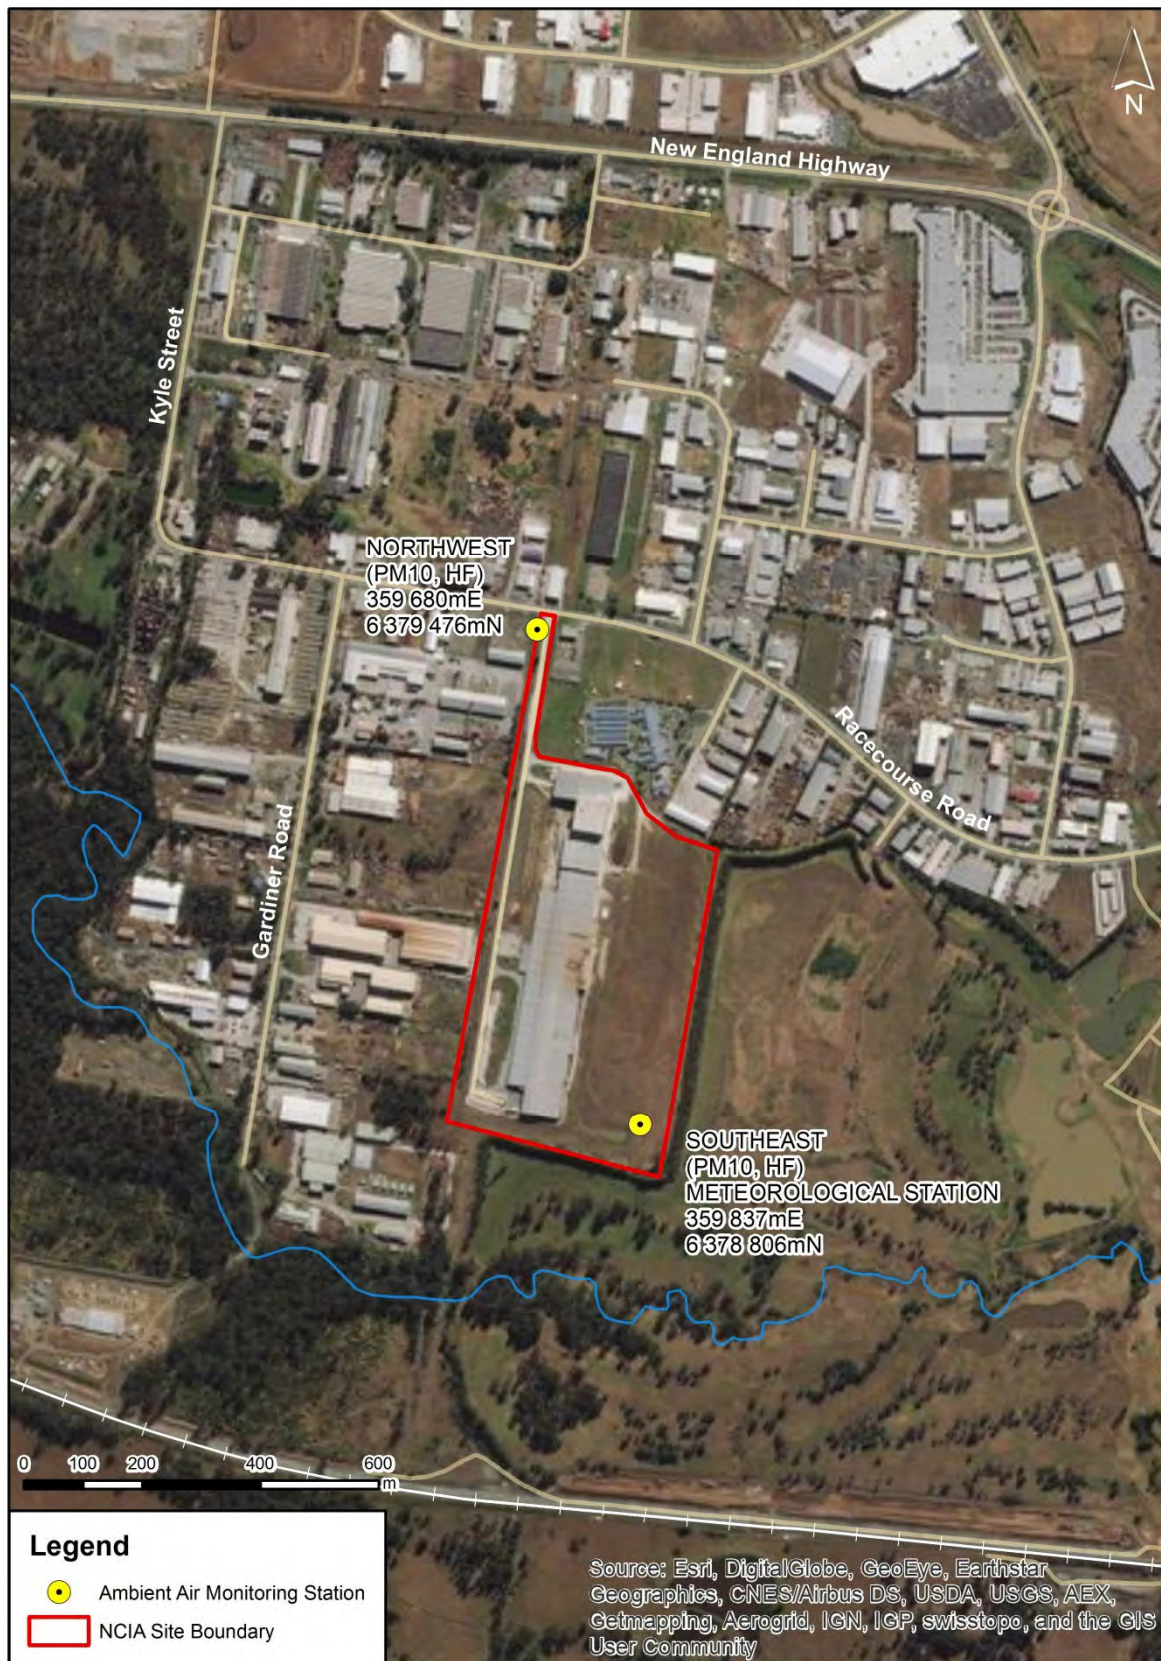
In accordance with EPL condition M2.1, PM₁₀ (24-hour) and Fluoride (24-hour and weekly) are monitored at two locations: northwest and southeast of the facility (refer Figure 2).

Two fluoride monitoring units (manual, double filter paper samplers) have been sited at each of the two locations identified for monitoring of PM₁₀ and are operated in accordance with *AS3580.13.2:2013 Determination of gaseous and acid-soluble particulate fluorides*. At each location, one monitor operates continuously over a 7-day period to provide weekly fluoride concentration averages. These units are designated 'Northwest HF₇' and 'Southeast HF₇'. The remaining unit at each site operates continuously for discrete 24-hour periods according to the NSW EPA 6-day cycle to provide 24-hour averages for sampler operation days. Units are designated 'Northwest HF' and 'Southeast HF'.

Figure 2 Ambient air monitoring locations

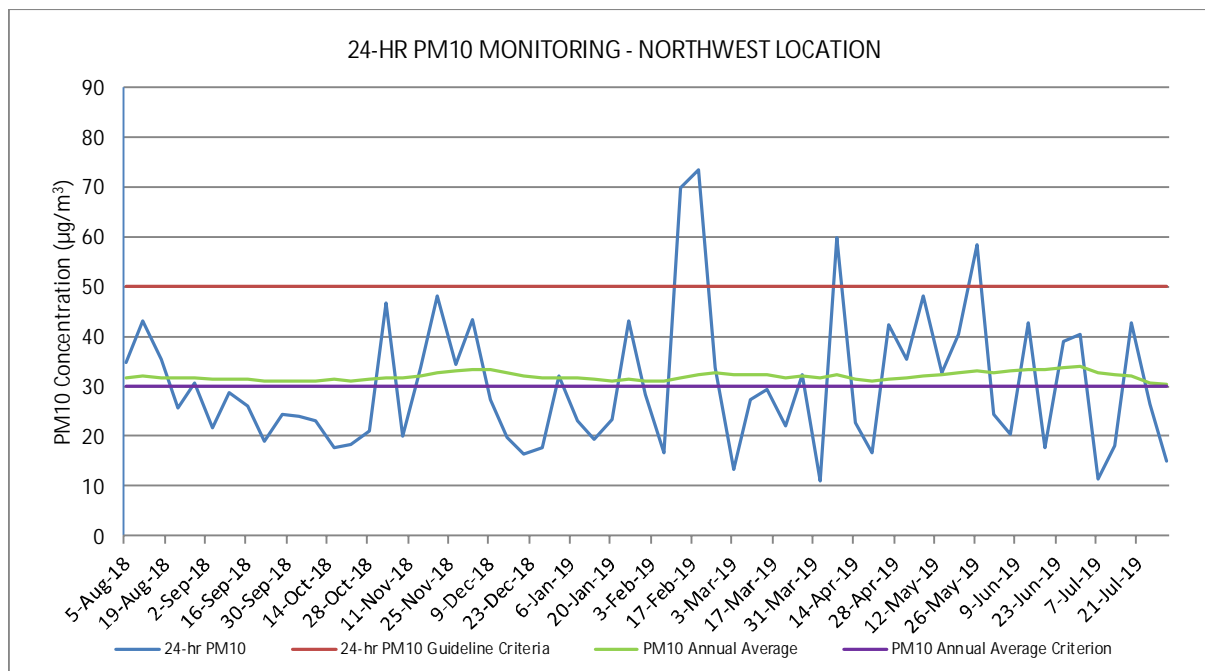
Figure 3 PM₁₀ monitoring – northwest location

Elevated PM₁₀ readings were recorded at both the North West and South East monitoring locations on 13 February. Meteorological data sourced from the OEH Beresfield site shows strong South to South East winds on this day. Under these conditions only the North West (downwind) monitoring site would be expected to have elevated results if NCIA was the primary source of PM₁₀ emissions. Elevated upwind readings and data sourced from the Upper Hunter EPA ambient monitoring sites indicates regional PM₁₀ concentrations were elevated on 13 February and the likely cause of exceedance at both locations.

Meteorological data sourced from the on-site meteorological station shows strong north westerly winds on this day. Under these conditions the North West monitoring station is upwind of the NCIA site.

More importantly, meteorological data sourced from the on-site meteorological station shows strong north westerly winds for 26 May. Under these conditions the North West monitoring station is upwind of the NCIA site

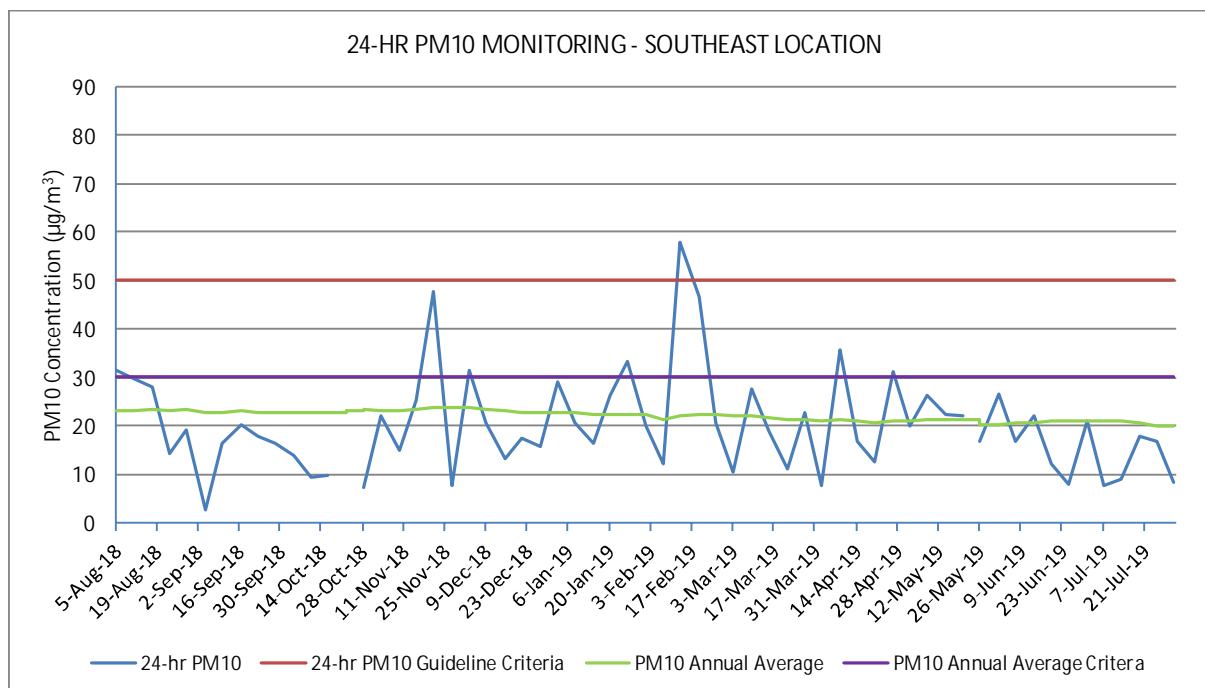
Figure 4 PM₁₀ monitoring – southeast location

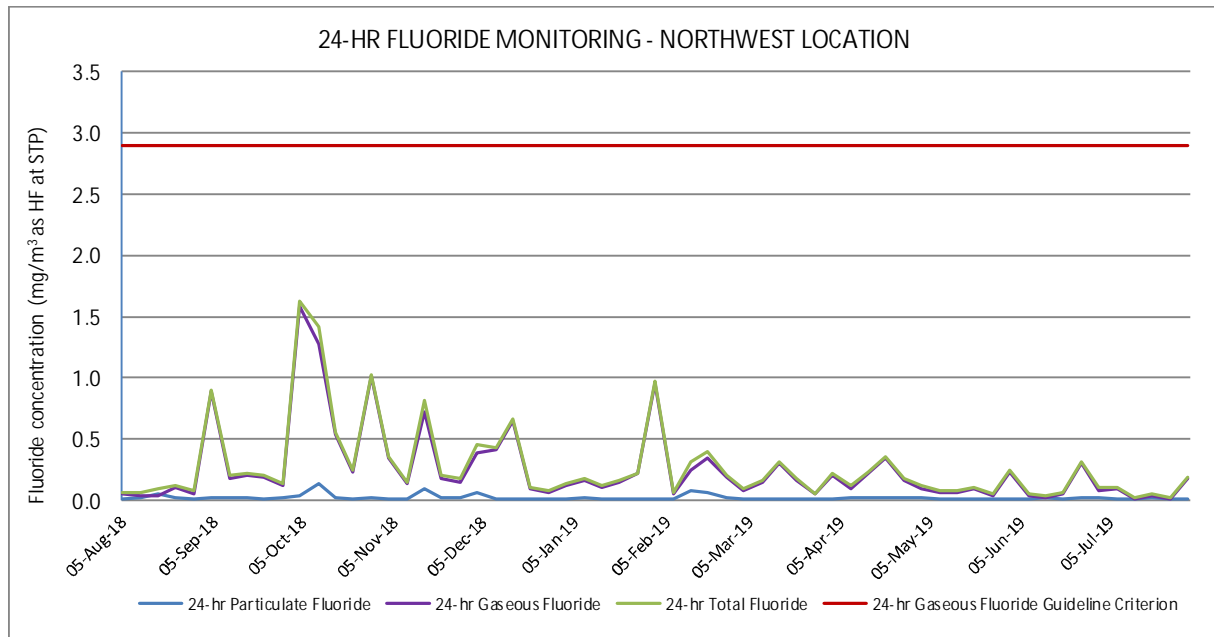
Figure 5 24-hour fluoride monitoring – northwest location

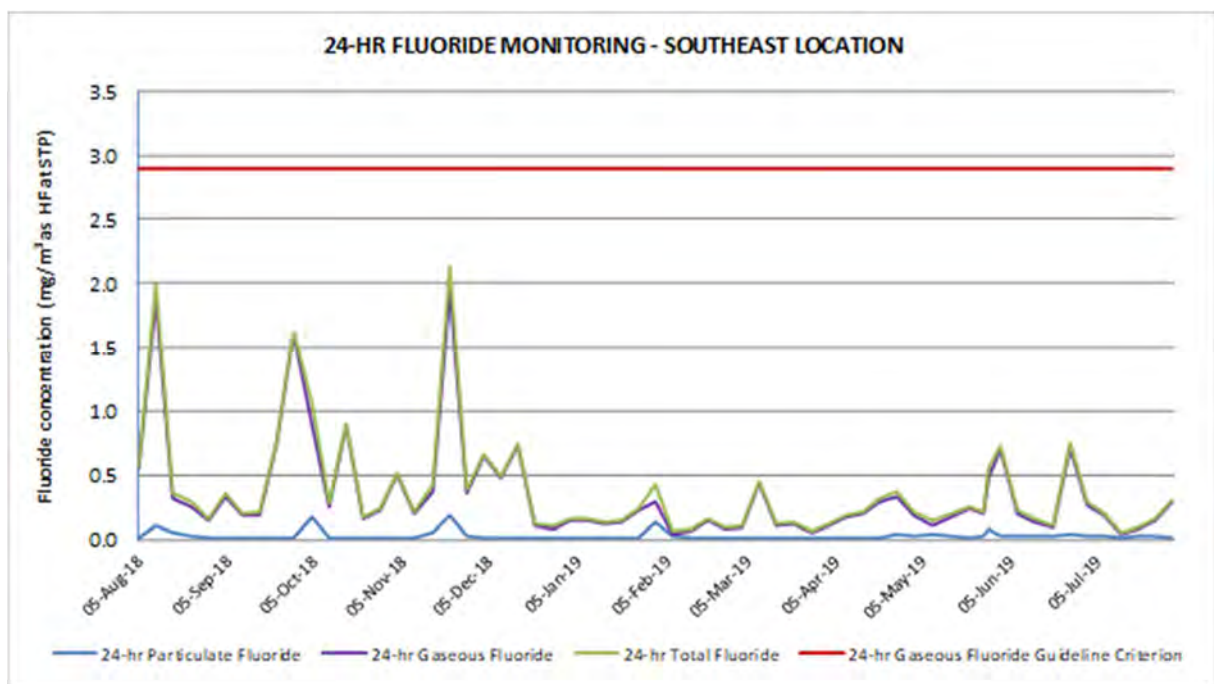
Figure 6 24 hour fluoride monitoring – southeast location

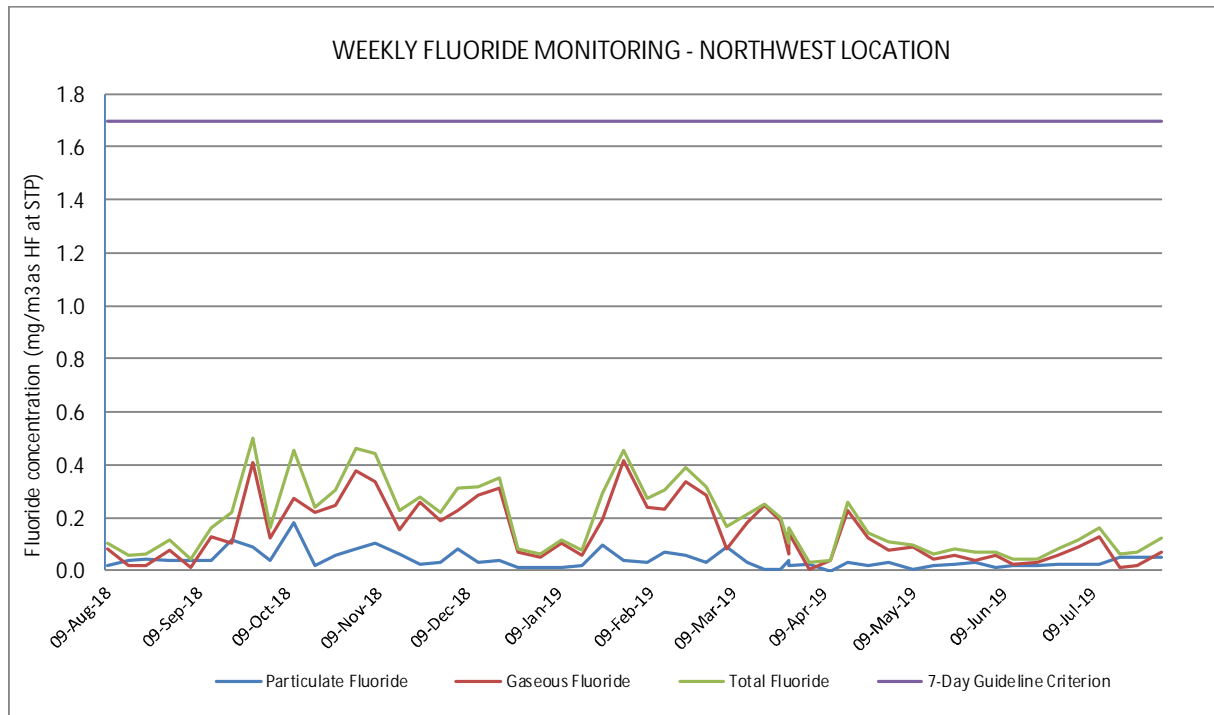
Figure 7 Weekly fluoride monitoring – northwest location

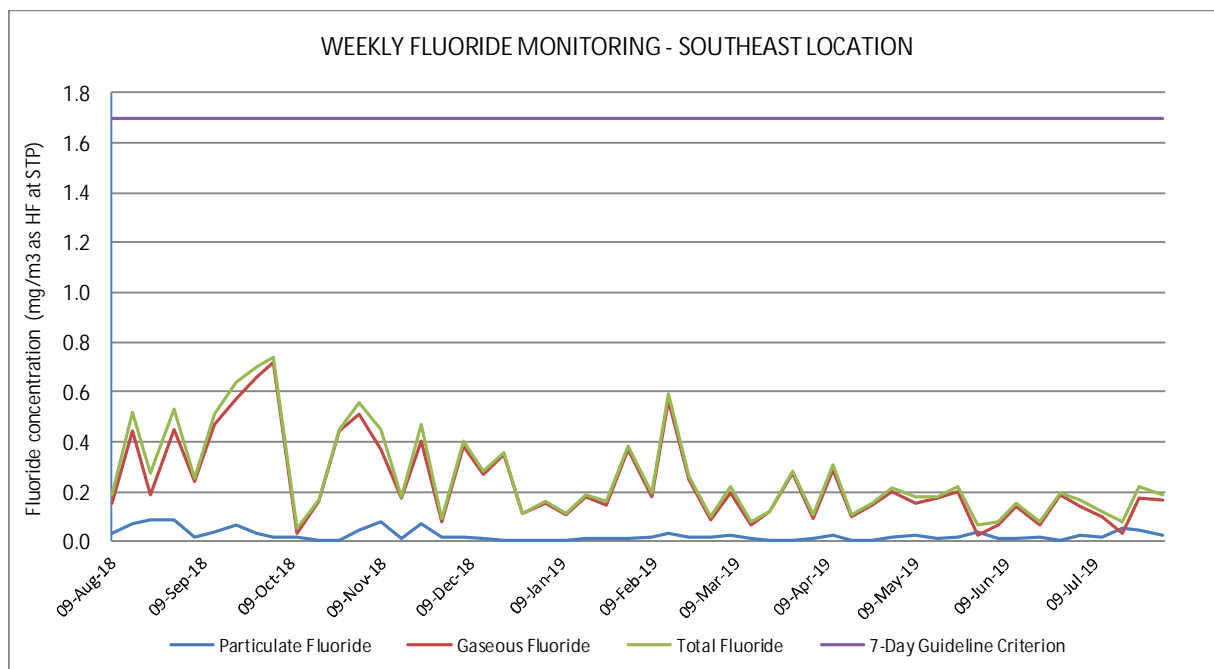
Figure 8 Weekly fluoride monitoring – southeast location

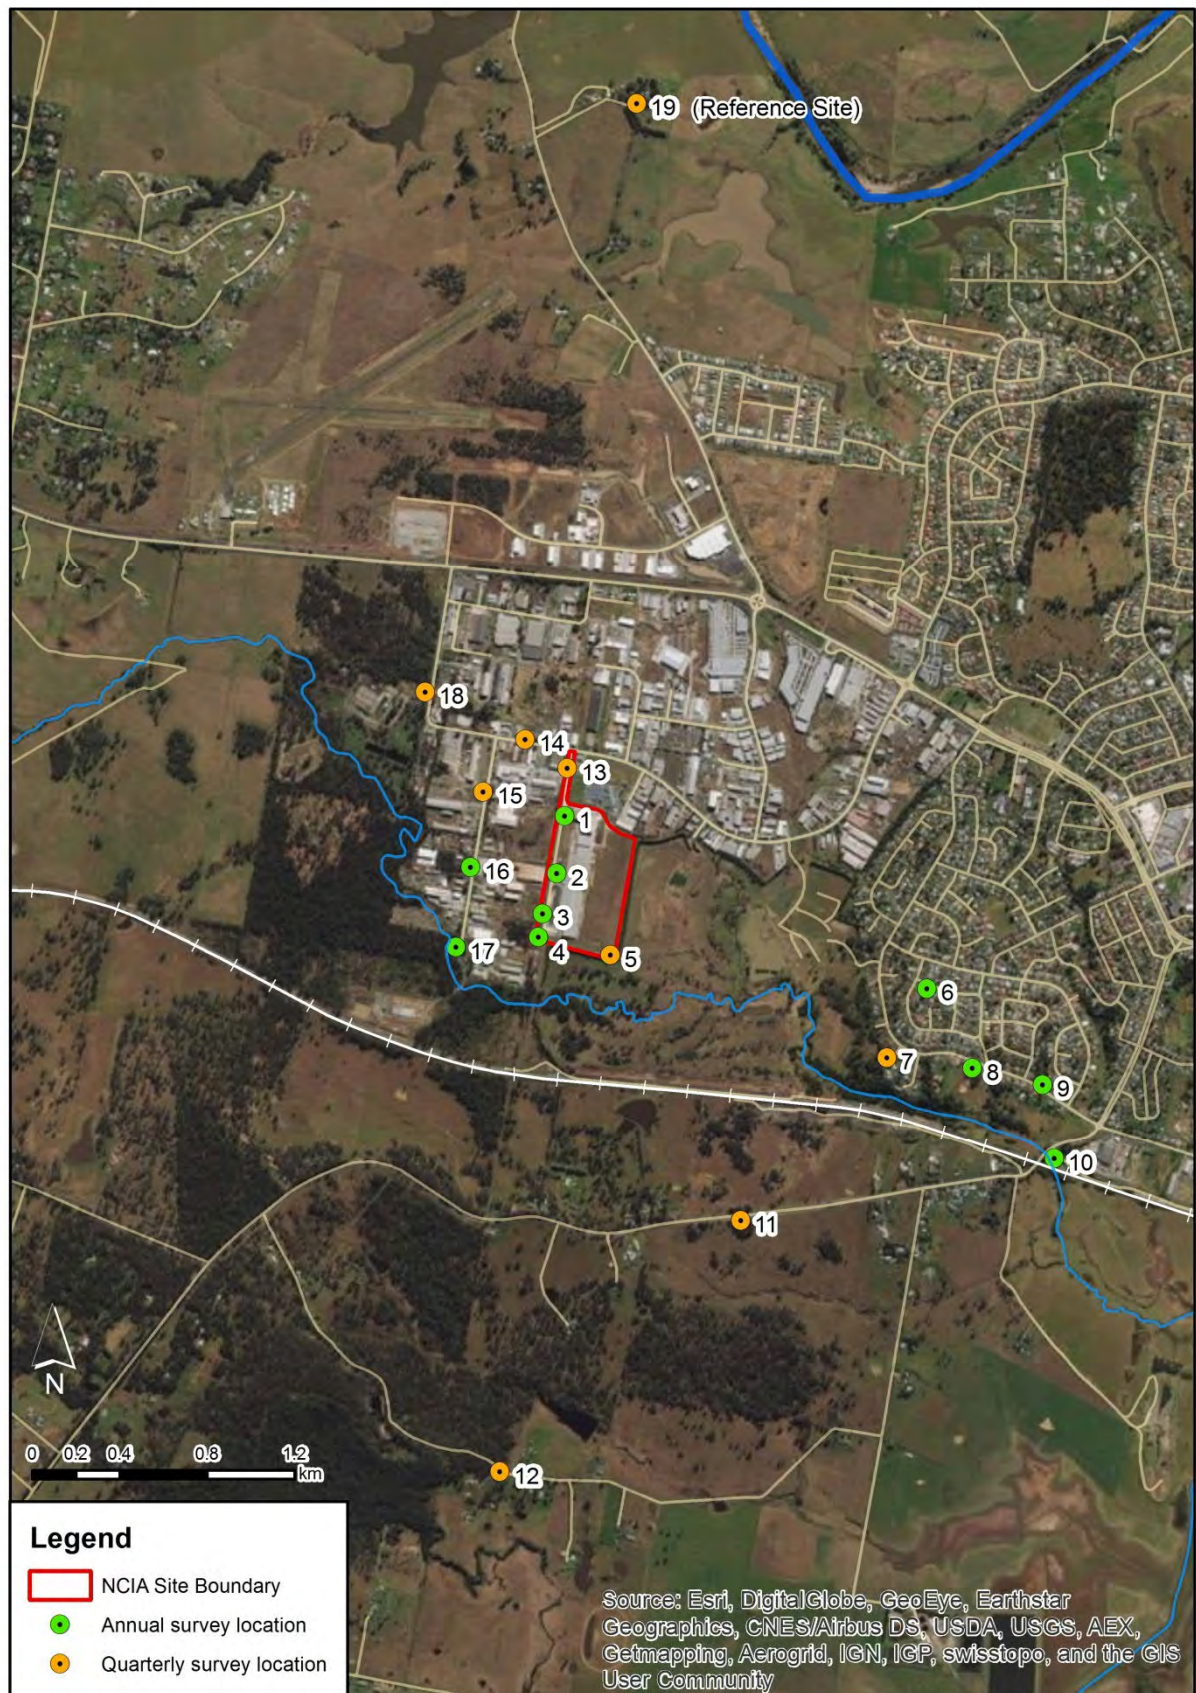
The sites monitored for vegetation condition assessments during the reporting period are shown in Figure 9. Details on the monitoring sites as well as a photograph of each monitoring site location (at the time of the annual Q4 2018 survey) are provided in Appendix A1. The monitoring locations included eighteen 'impact' sites (comprising eight sites monitored quarterly plus an additional ten sites monitored during the annual survey only) and one 'reference' site. All impact sites were selected to be generally within the areas of highest predicted ambient fluoride concentration – i.e. within the prevailing wind directions for the region (northwest-southeast axis), whilst the reference site location was selected to be outside the prevailing winds.

Figure 9 Vegetation survey monitoring location

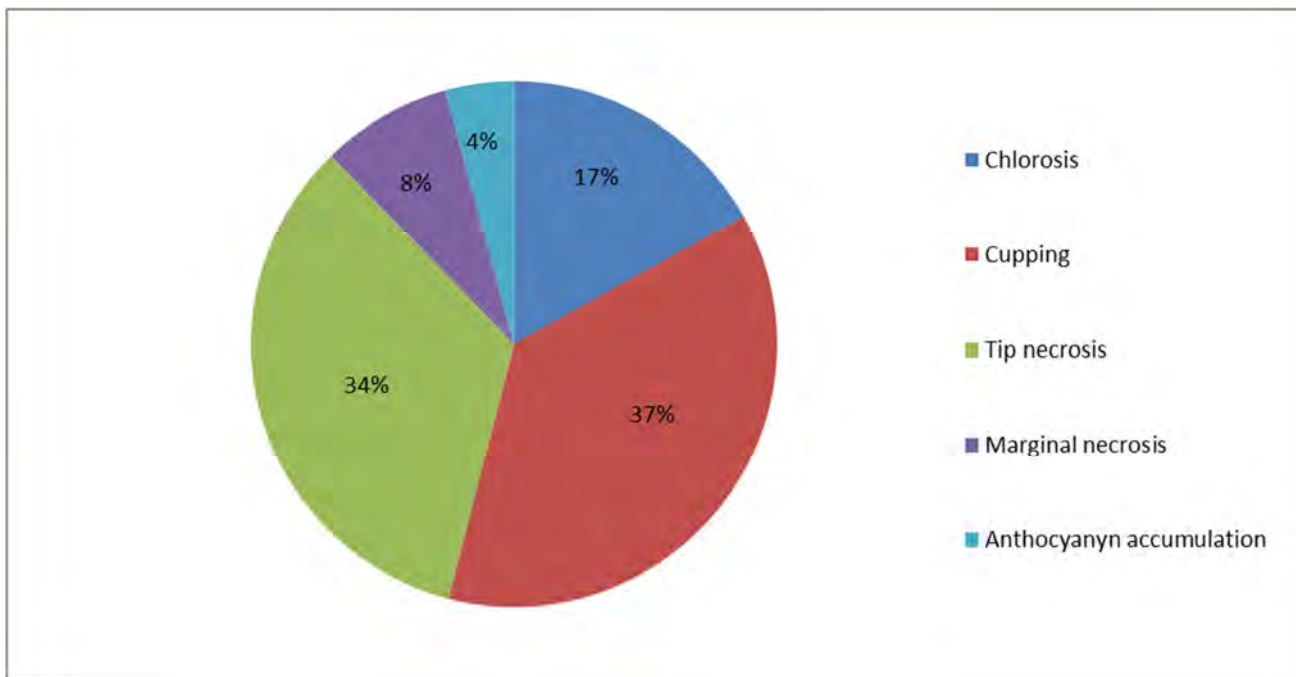
Figure 10 shows the prevalence of each visual foliage injury symptom observed in all species during the surveys. It indicates that tip necrosis, leaf undulation / cupping, and chlorosis were the most commonly occurring symptoms (with 88% of all observations), followed by marginal necrosis (8%), whilst symptoms of anthocyanin accumulation were generally uncommon (4% of all observations).

Figure 10 Relative prevalence of fluoride related symptoms

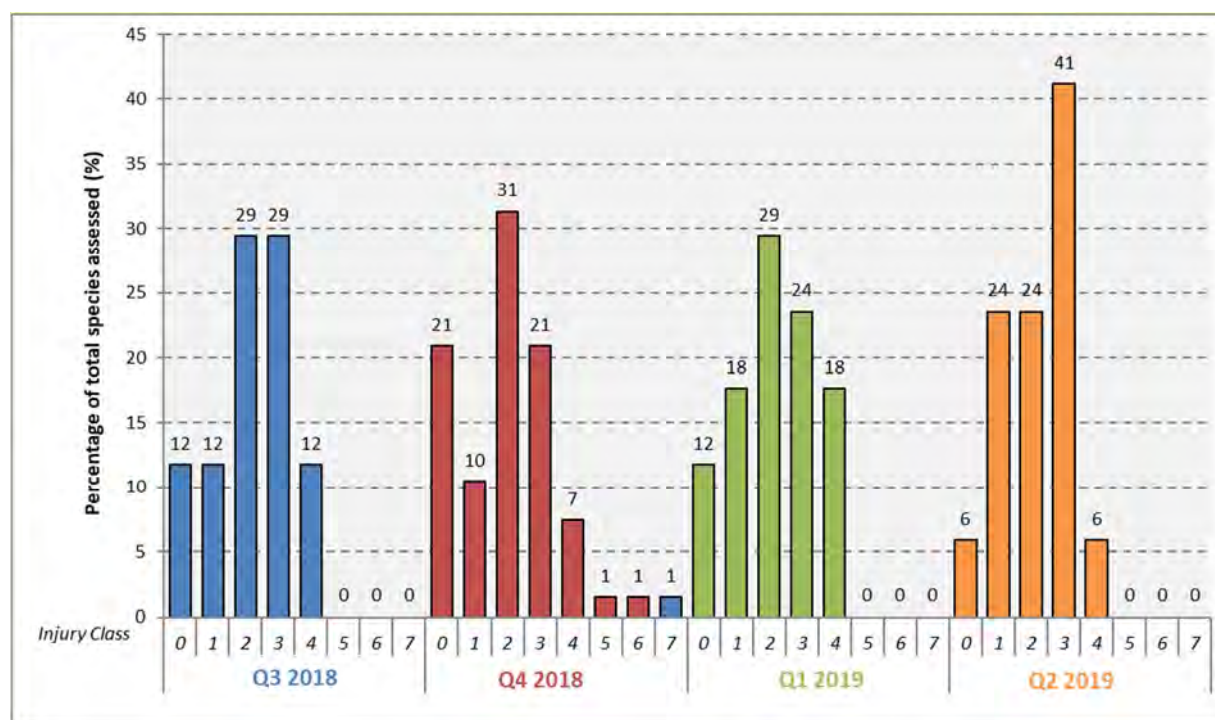
The severity of recorded emission related injury symptoms overall ranged from very slight to very severe (i.e. between 2% and 75% of leaf area affected – refer to Table 4-4). For each quarterly survey during the reporting period, Figure 11 depicts the distribution of injury severity classes recorded in all flora species surveyed. The results indicate the following:

- For each survey between 54% and 69% of plants surveyed were affected at worst by slight injury symptoms (i.e. injury class 2 and less, maximum of 5% leaf area impacted);
- For each survey between 29% and 47% of plants surveyed were affected by distinct or marked injury symptoms (i.e. injury class 3 or 4, 10-25% of leaf area impacted);
- During the annual Q4 2018 survey only, 2% of plants surveyed displayed severe to very severe visual injury symptoms (i.e. injury class 5 or 6, 50-75% of leaf area impacted); and
- Only one species displayed extreme injury symptoms (i.e. injury class 7, >75% of leaf area impacted) during the four surveys.

Figure 11 Proportion of flora species affected by emissions related visual injury symptoms during the surveys

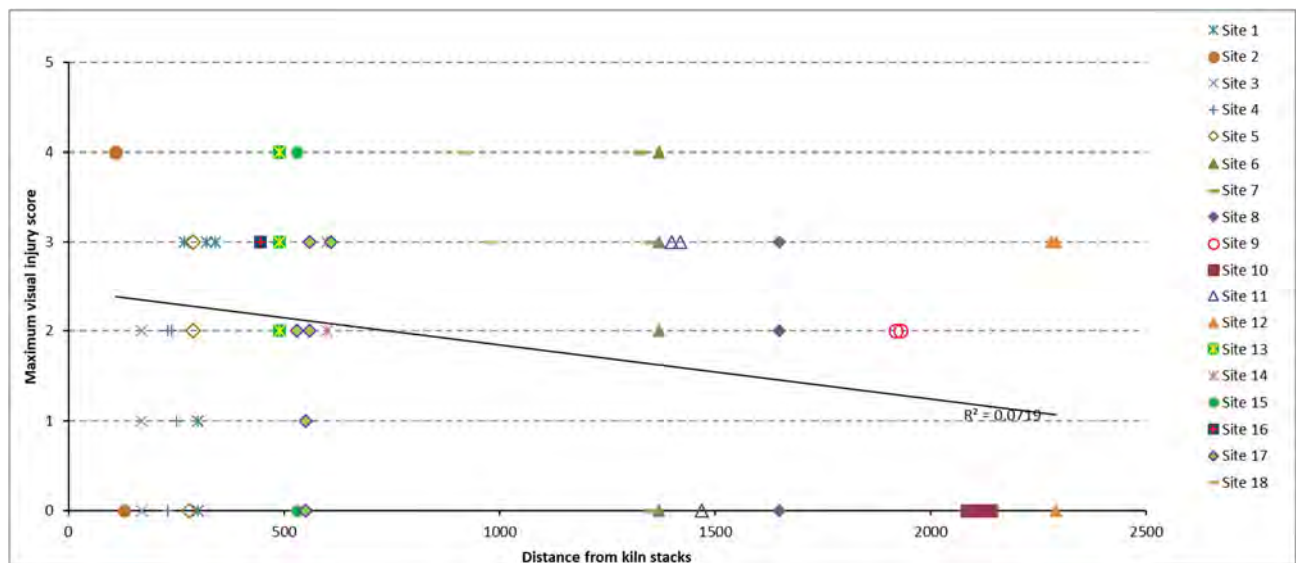
Figure 12 depicts the relationship between the maximum emission related visual injury score recorded for each species (inclusive of all surveys) and their distance from the kiln stacks at NCIA. The results showed little correlation between foliage injury and the distance to the emission source ($r^2 = 0.07$), indicating that emission impacts to foliage may spread further from the NCIA site than the furthest monitoring site. For instance, category 4 injury symptoms were observed up to ~1,400m away from the NCIA facility at Site 6 and Site 7, while category 3 symptoms occurred as far as Site 12 (~2,300m from the NCIA facility). This also suggests that within the current suite of monitoring sites, variables such as flora species type or the sensitivity of specific individuals are more relevant than the distance from emission source in determining atmospheric fluoride impacts on local vegetation. However and importantly, there are several other air pollution sources in the region which may impact vegetation and foliage condition. Therefore the geographical extent of fluoride impacts to foliage attributable to NCIA activities alone cannot be confidently determined.

Figure 12 Relationship between distance from kiln stacks and maximum visual injury score in foliage of species assessed

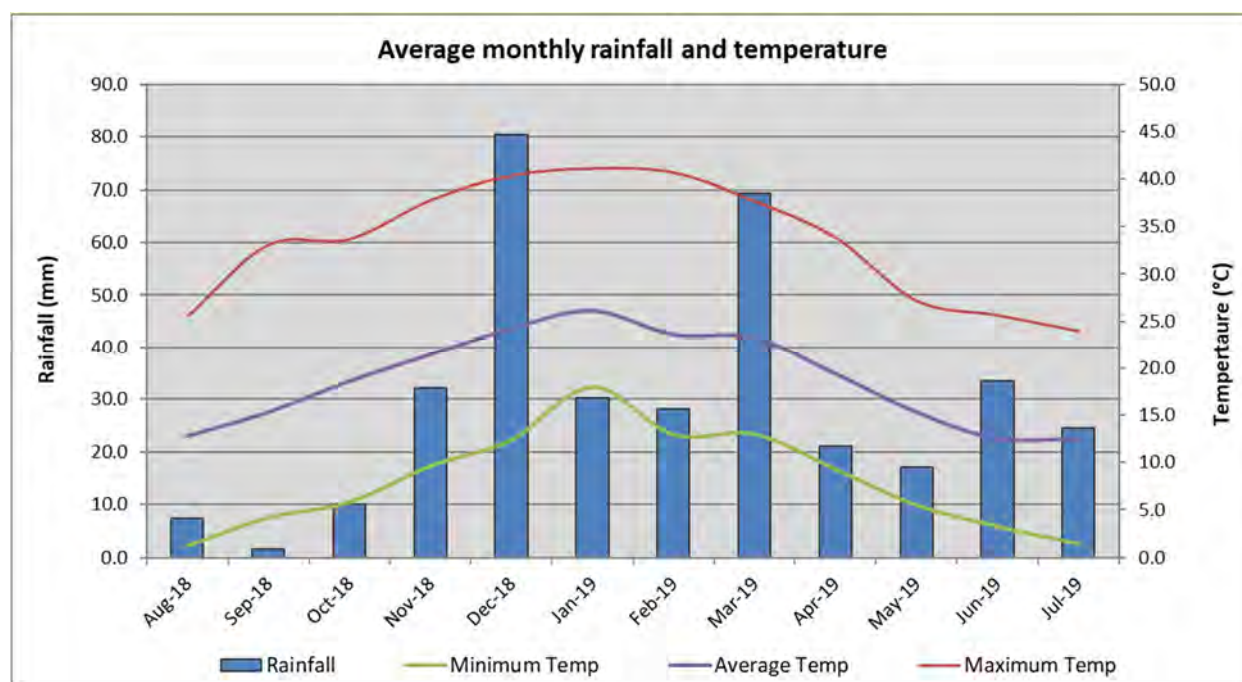
Wind speeds recorded over the year were generally low to medium with an average wind speed of 1.8 m/s during the reporting period. The maximum hourly average wind gust during the reporting period was recorded at 11.1 m/s on 23 November 2018 and 27 May 2019.

Figure 13 Average monthly rainfall and temperature range (1 August 2018 – 31 July 2019)

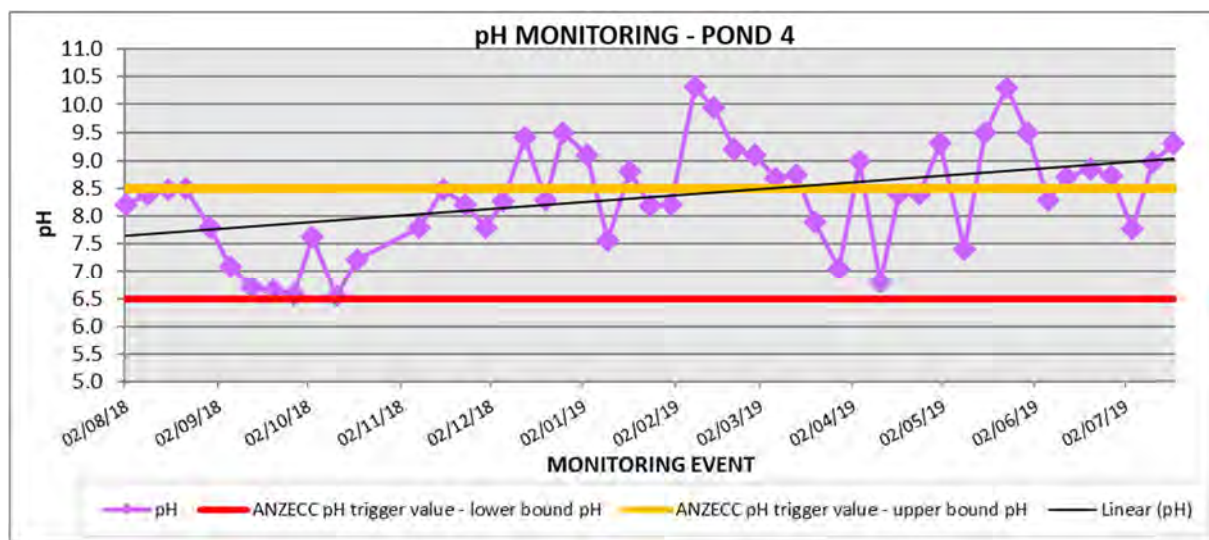
- pH values ranged between 6.6 and 10.3 with an increasing trend throughout the reporting period. Results were generally within the ANZG guidelines with the exception of 21 monitoring events.

Figure 14 Stormwater quality monitoring – pH

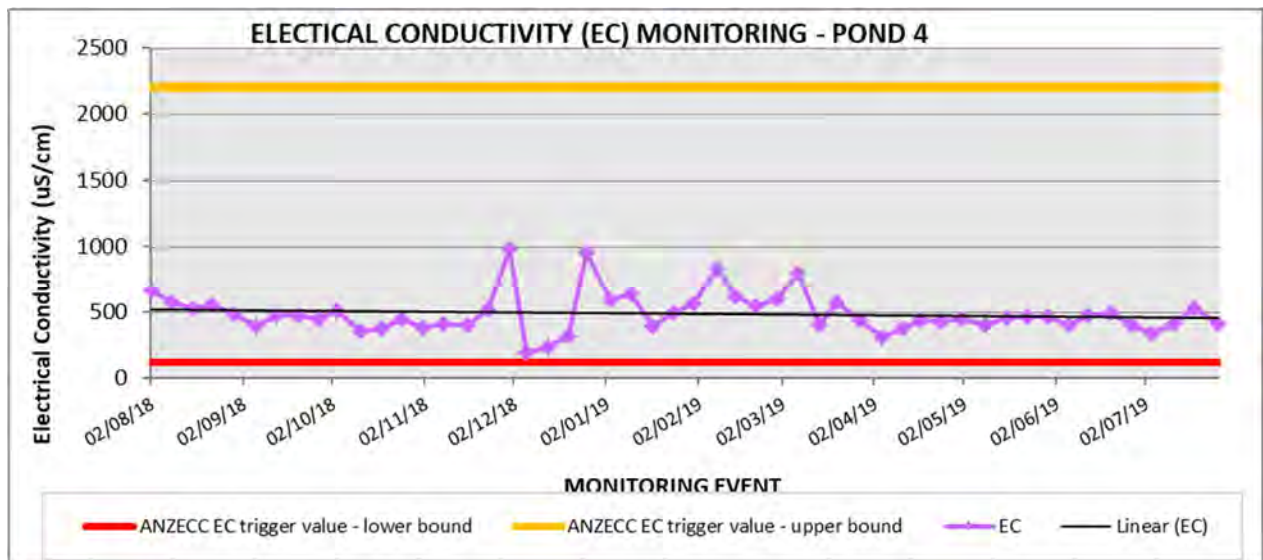
- EC values were low and show a very slight decreasing trend throughout the reporting period with levels generally around 500 $\mu\text{S}/\text{cm}$ indicating that the water is non-saline. The EC values were within the ANZG guidelines for the entire reporting period.

Figure 15 Stormwater quality monitoring – EC

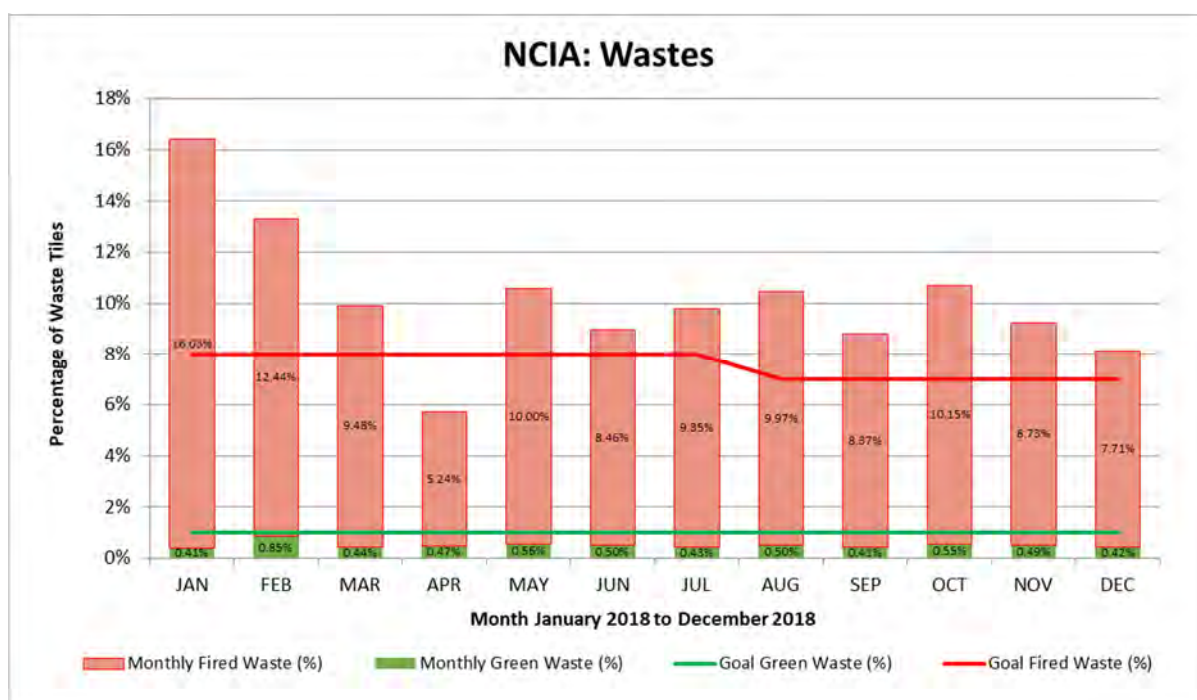
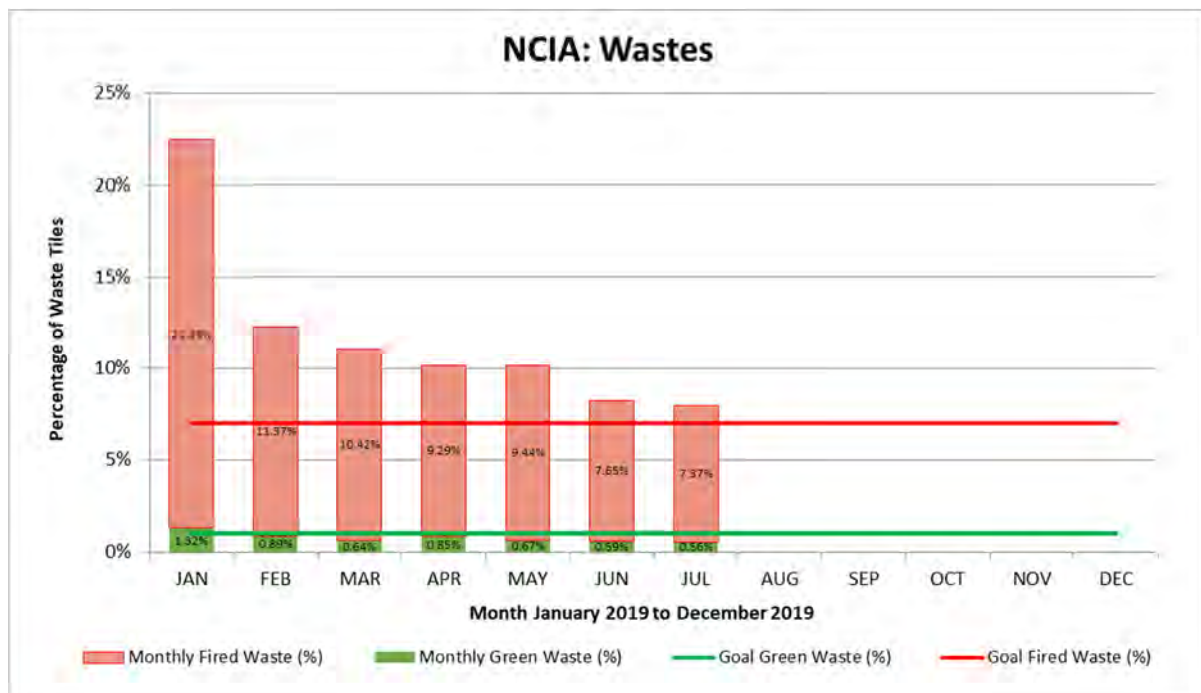
NCIA's targets for tile wastes were lowered in July 2018 to not exceed 1% (for green tile waste) and 7% (for fired tile waste) of the total tile production, respectively. The green tile waste target was achieved every month except for January 2019 with a result of 1.32%. The amount of fired tile waste exceeded the target for twelve months of the 2018 to 2019 reporting period, with a monthly average of 10.13%. However, fired tile waste levels were decreasing during the 2019 reporting period.

Figure 16 Tile waste (green and fired) generation during 2018-2019

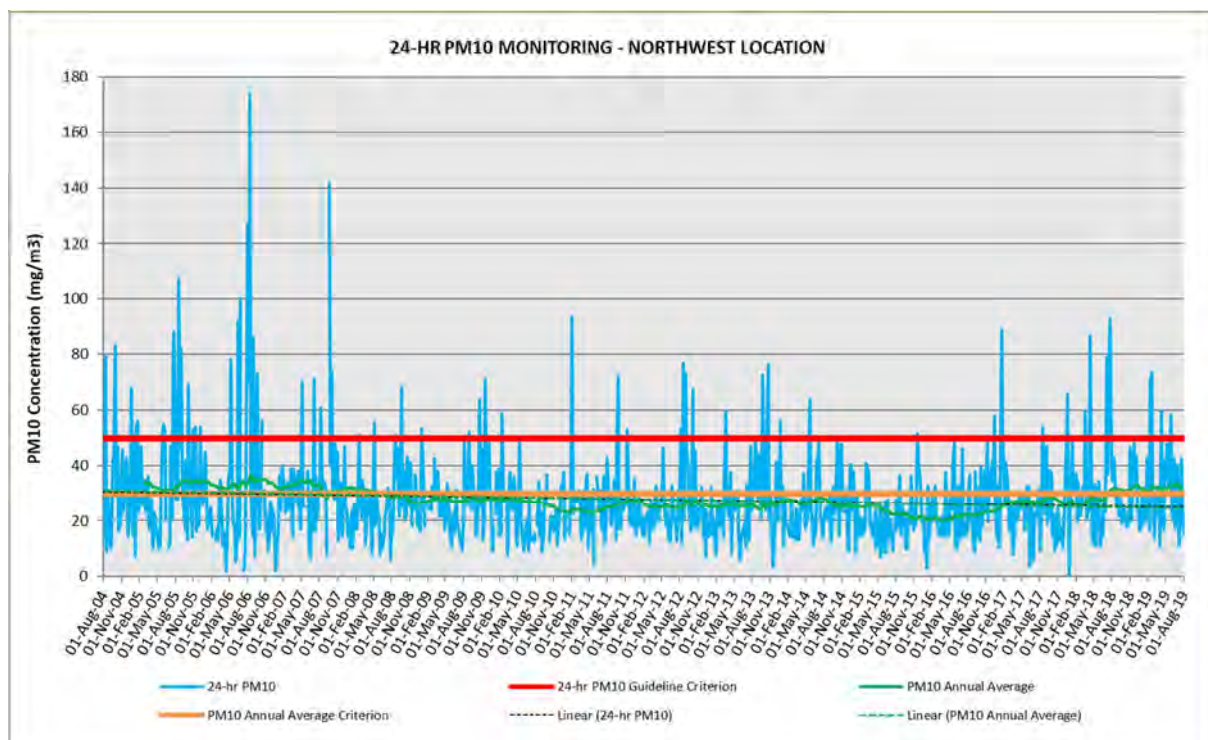
Figure 17 24-hour PM₁₀ monitoring – northwest location (2004 – 2019)

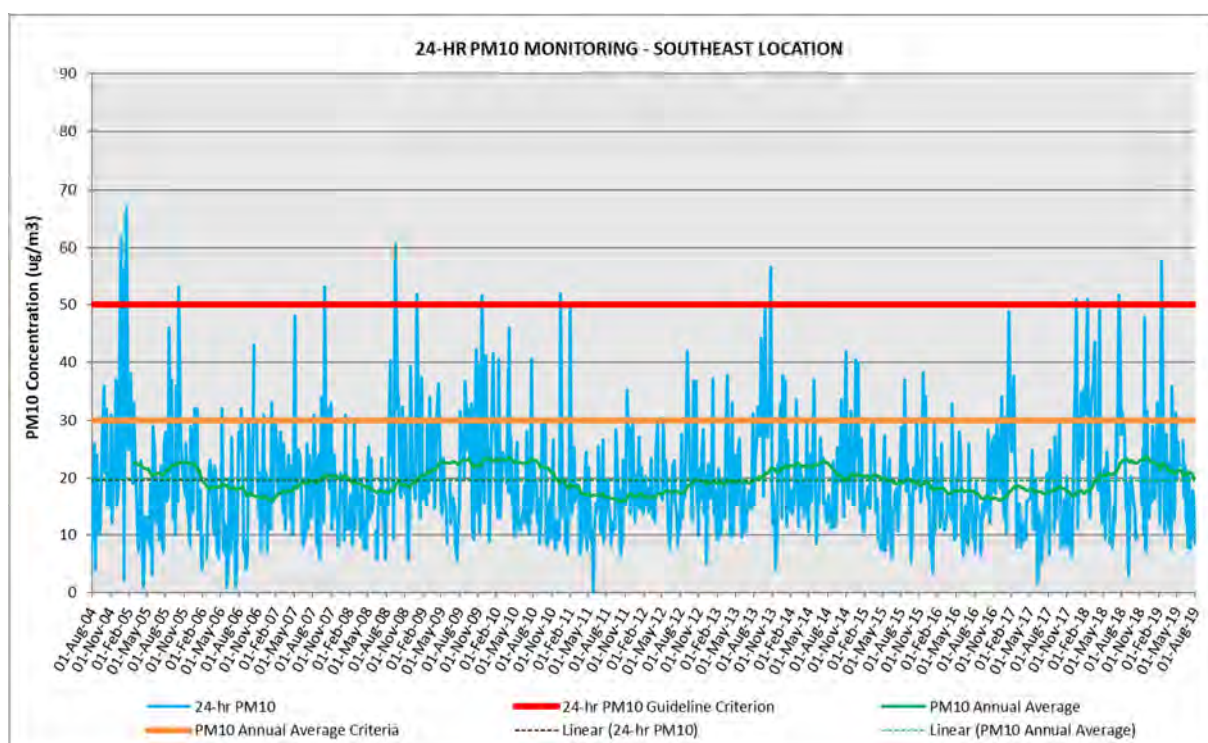
Figure 18 24-hour PM₁₀ monitoring – southeast location (2004 – 2019)

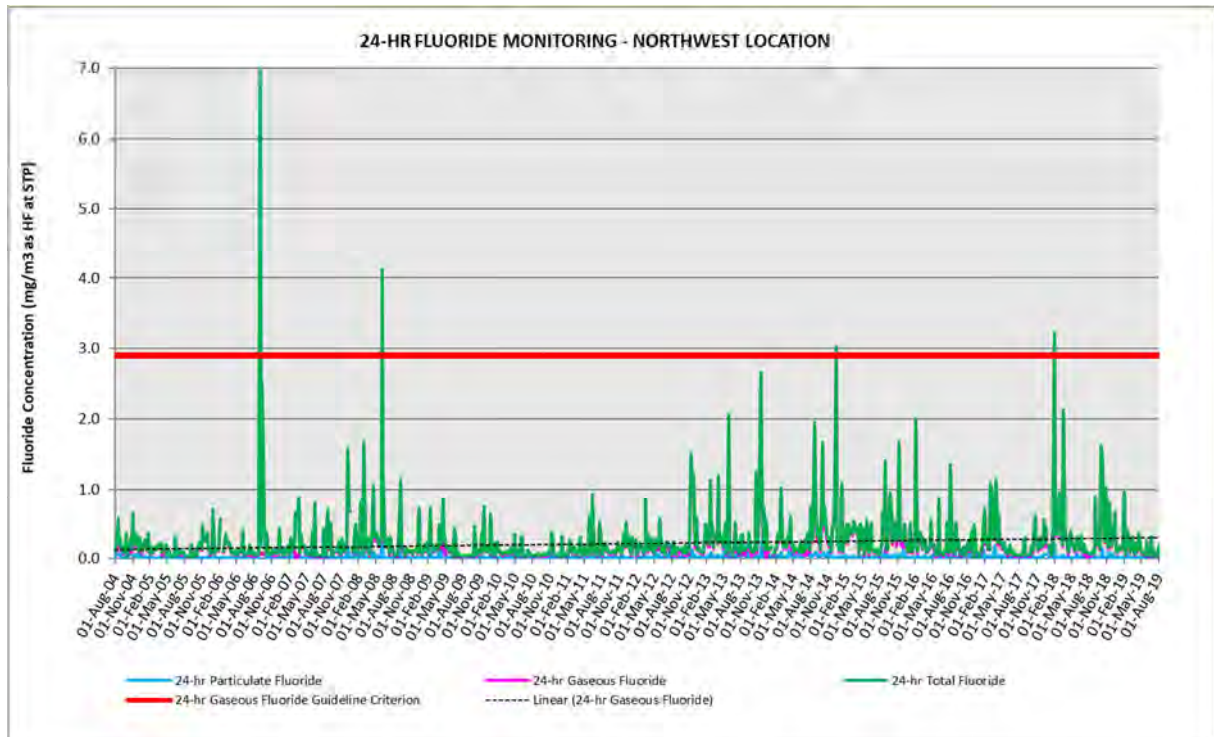
- Following seven years of relatively low and steady levels of fluoride emissions between 2004 and 2011 (despite isolated and episodic increases), gaseous fluoride levels have slightly increased since 2012 in both the 24-hour and weekly fluoride levels. Fluoride emissions during the 2019 reporting period were similar to the previous five years. Nonetheless, there is an overall increasing linear trend in 24 hour and weekly fluoride levels at both monitoring locations.

Figure 19 24-hour fluoride monitoring – northwest location (2004 – 2019)

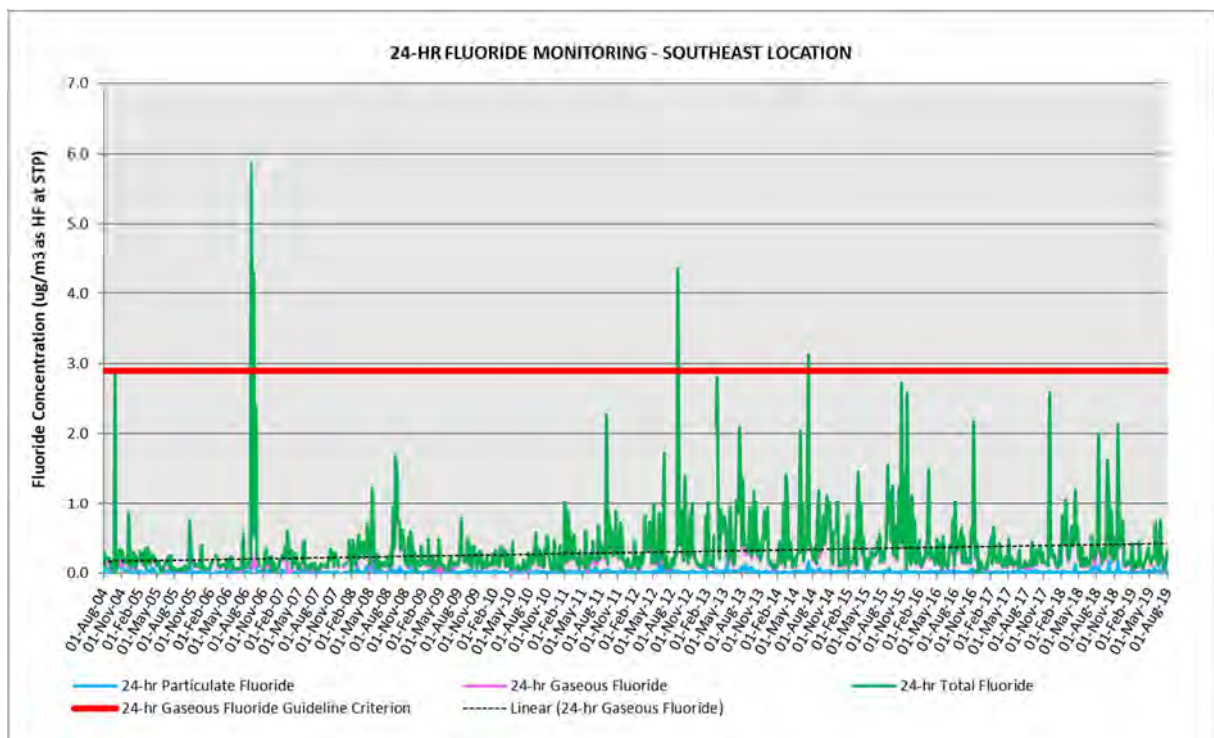
Figure 20 24-hour fluoride monitoring – southeast location (2004 – 2019)

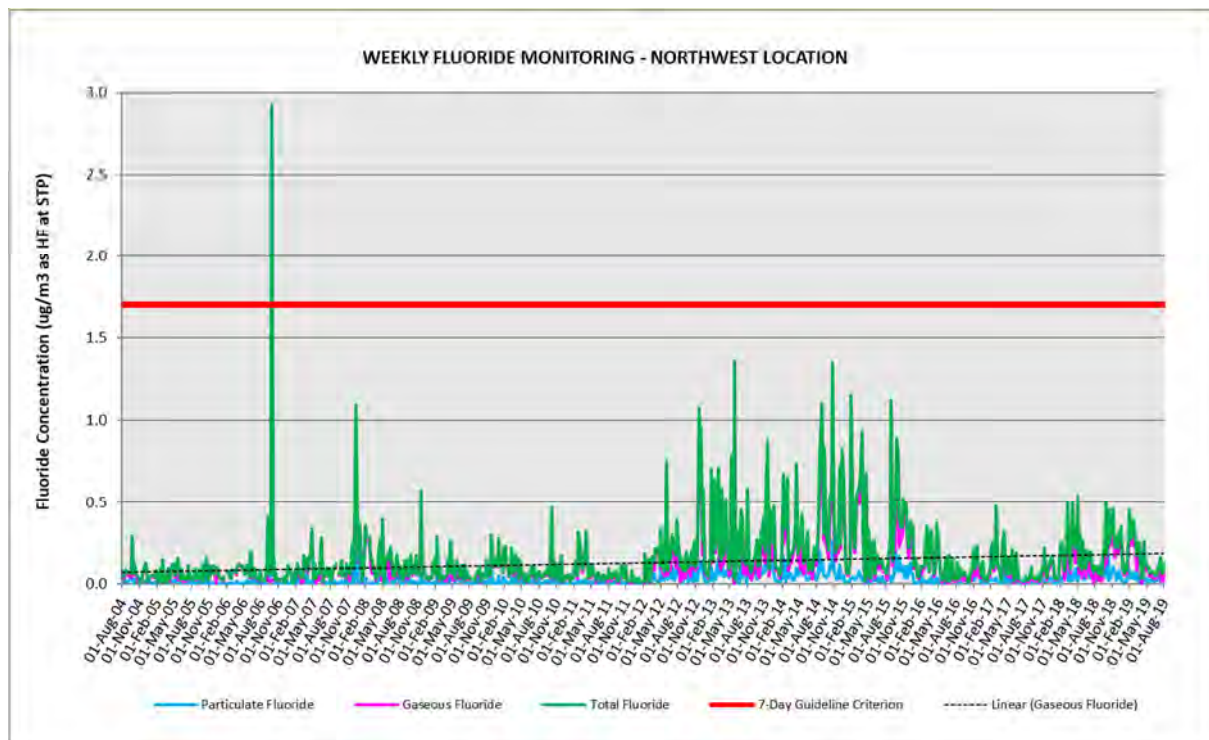
Figure 21 Weekly fluoride monitoring – northwest location (2004 – 2019)
