2019 Annual Environmental Management Report

1 August 2018 - 31 July 2019

Client: National Ceramic Industries Australia

AECOM Australia Pty Ltd

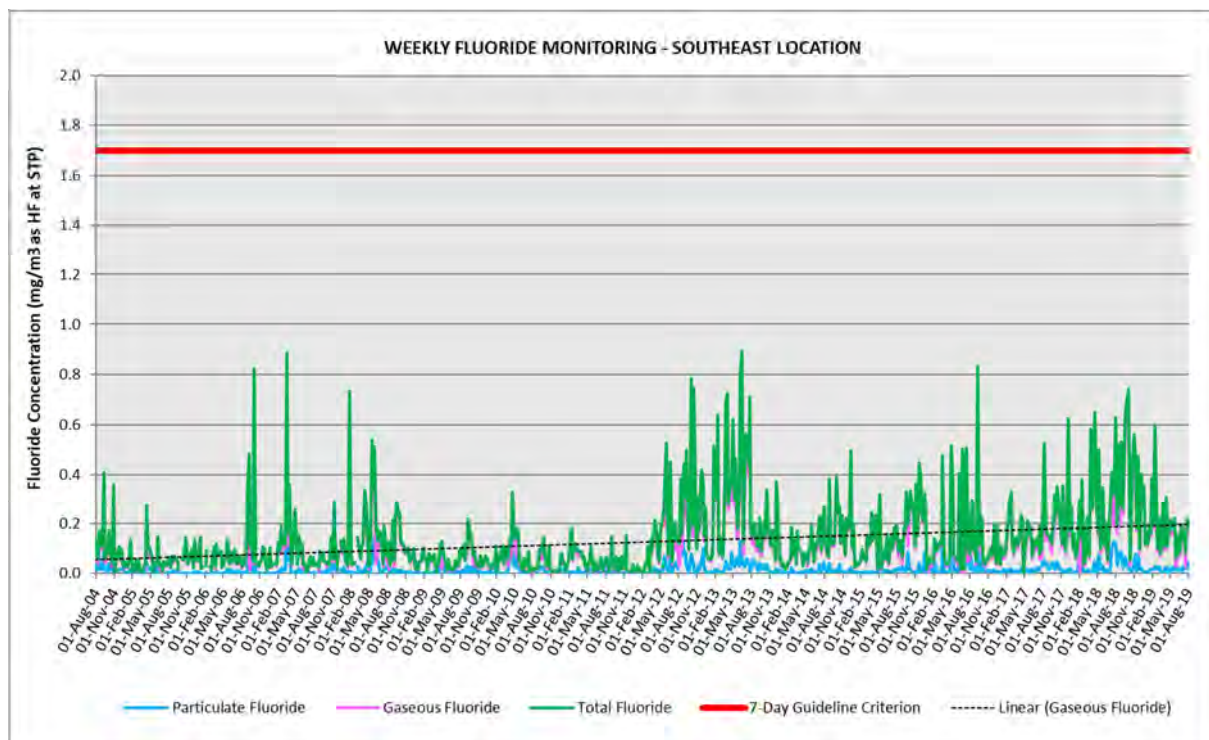
Figure 22 Weekly fluoride monitoring – southeast location (2004 – 2019)

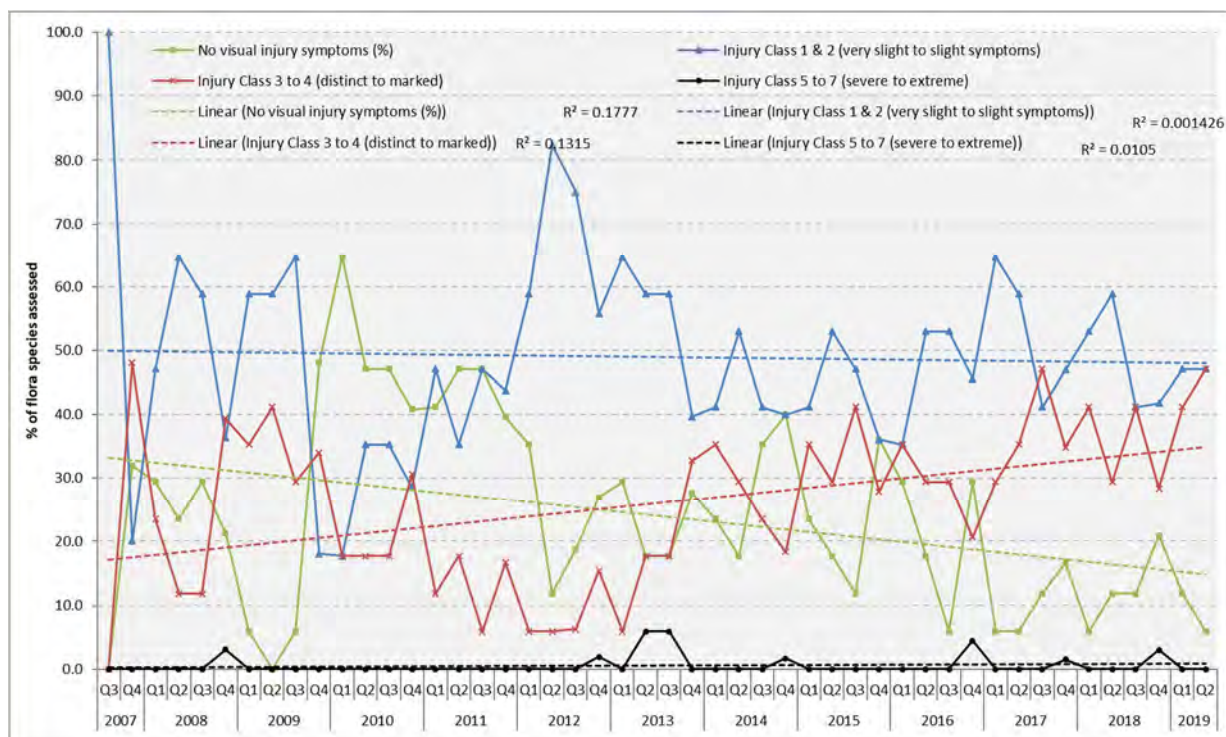
- Species showing no visible fluoride injury symptoms;
- Species displaying at worst class 1 (very slight) or class 2 (slight) injury symptoms;
- Species displaying at worst class 3 (distinct) or class 4 (marked) injury symptoms; and
- Species displaying class 5 injury symptoms and above (severe to extreme).

Figure 23 Proportion of flora species affected by emission related visual injury symptoms (2007-2019)

Despite clear seasonal variations, historical data show little long-term variability in the severity of fluoride impacts to vegetation surrounding the NCIA facility. The data supports no statistically significant increase or decrease in the severity of injury symptoms since the start of the monitoring program (as justified by the correlation r^2 values for all severity classes being <0.1777).

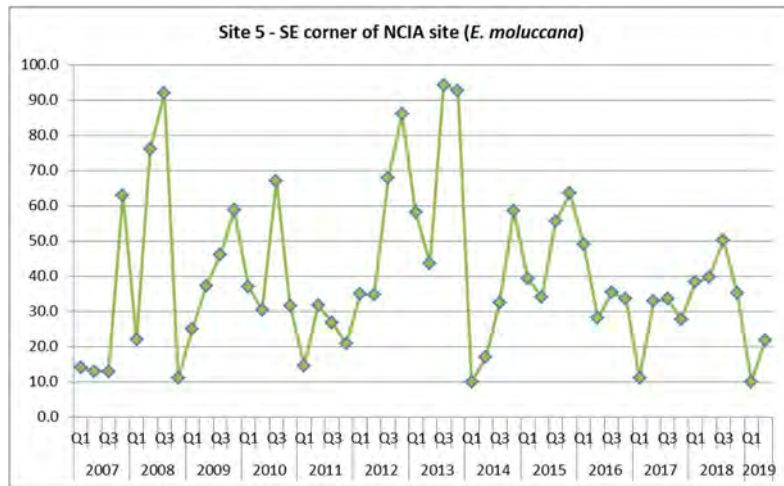
Figure 24 Fluoride content in *E. moluccana* foliage at Site 5 (Q1 2007 – Q2 2019)

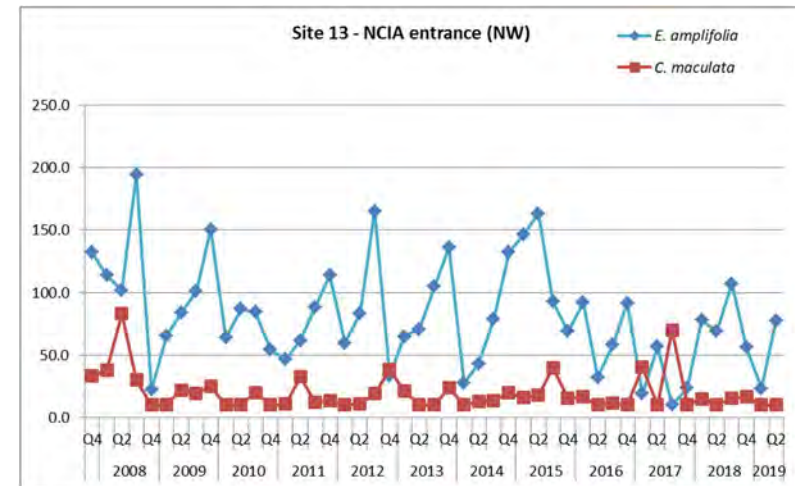
Figure 26 Fluoride content in *E. amplifolia* and *C. maculata* foliage at Site 13 (Q4 2007 – Q2 2019)

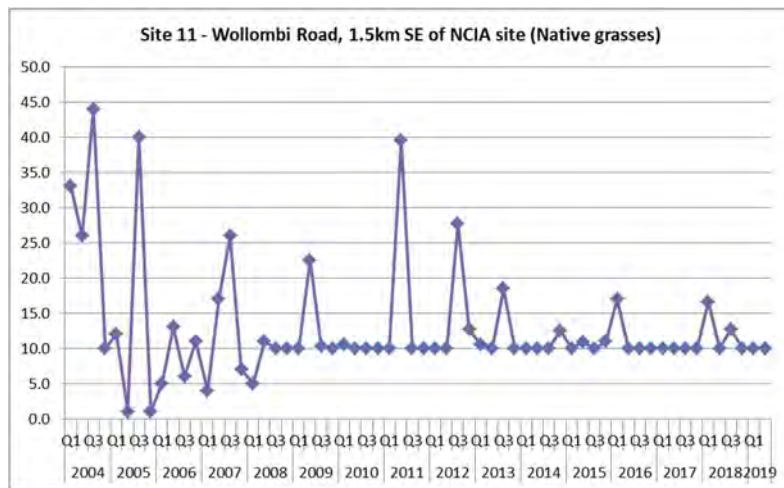
Figure 25 Fluoride content in grasses at Site 11 (Q1 2004 – Q2 2019)

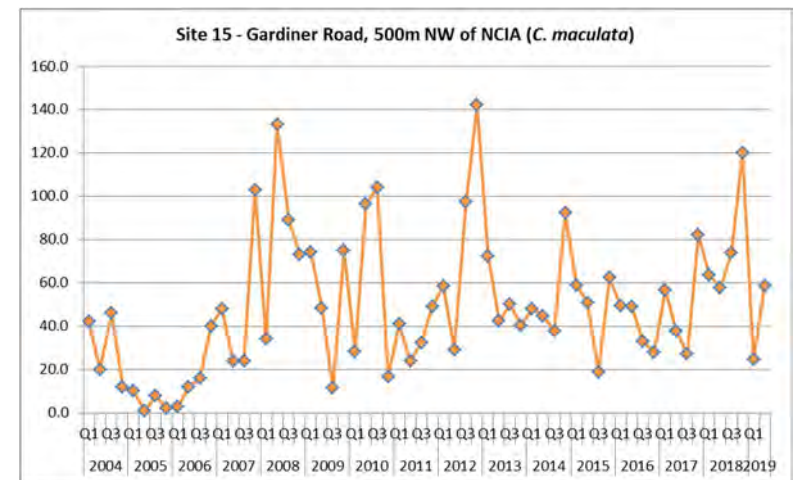
Figure 27 Fluoride content in *C. maculata* foliage at Site 15 (Q1 2004 – Q2 2019)

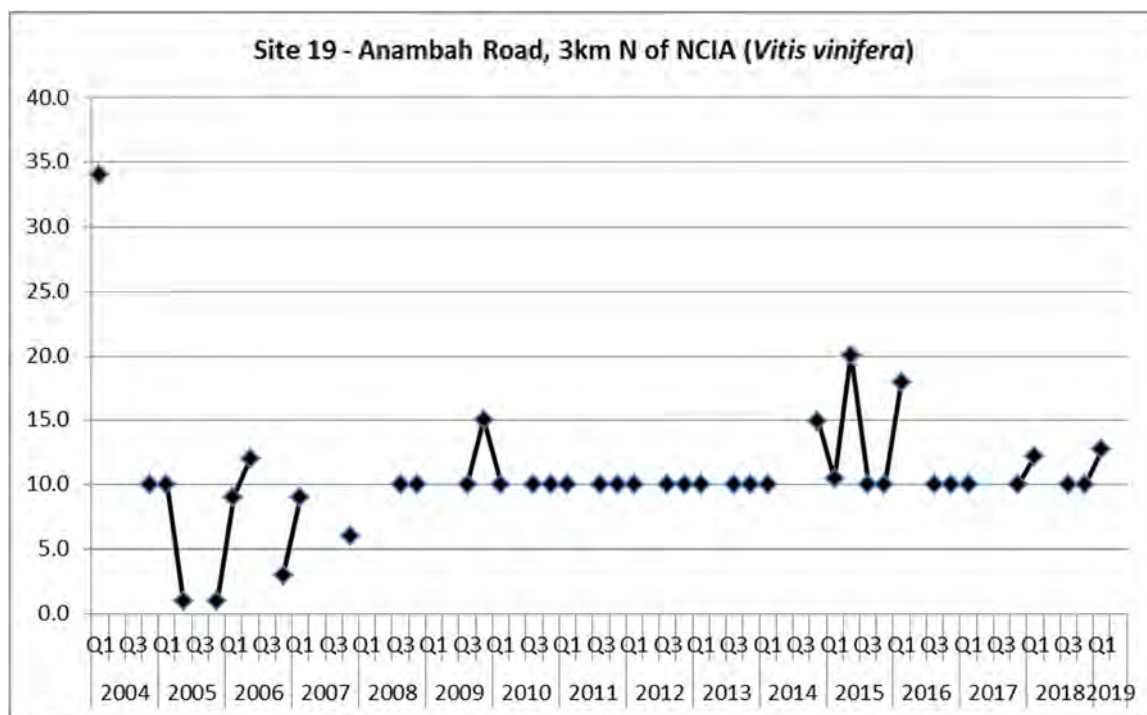
Given the social and economic importance of the viticultural industry in the Hunter Valley the potential impact of atmospheric pollutant emissions from industrial sources on the health of the grape vine *Vitis vinifera* (a known sensitive species) has traditionally been a concern for the industry. Consequently, foliar sampling and analysis of *Vitis vinifera* foliage from the reference site has historically been included as part of this vegetation monitoring program. Historical concentrations since the commencement of the monitoring programme are presented in Figure 28.

Figure 28 Fluoride content in *Vitis vinifera* foliage at Site 19 (Q1 2004 – Q2 2019)²

Long term data show that foliar fluoride has consistently returned very low concentrations for this species (<10.0 µg/g).

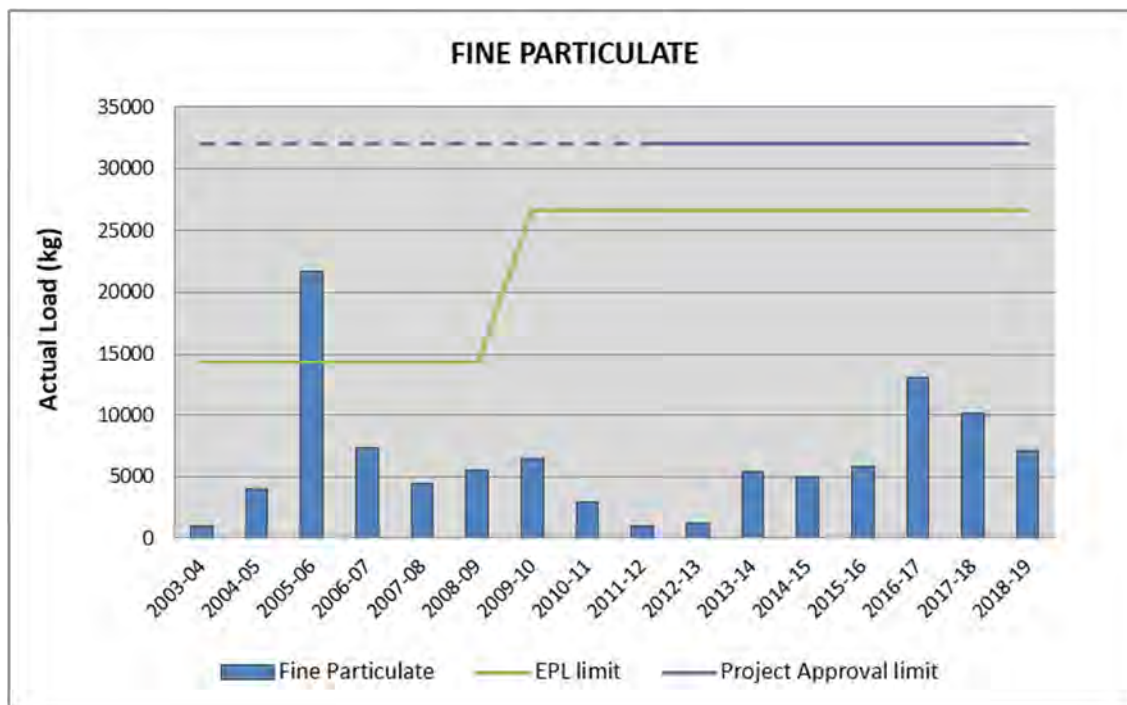
Figure 29 Fine particulate annual load (2004 – 2019)

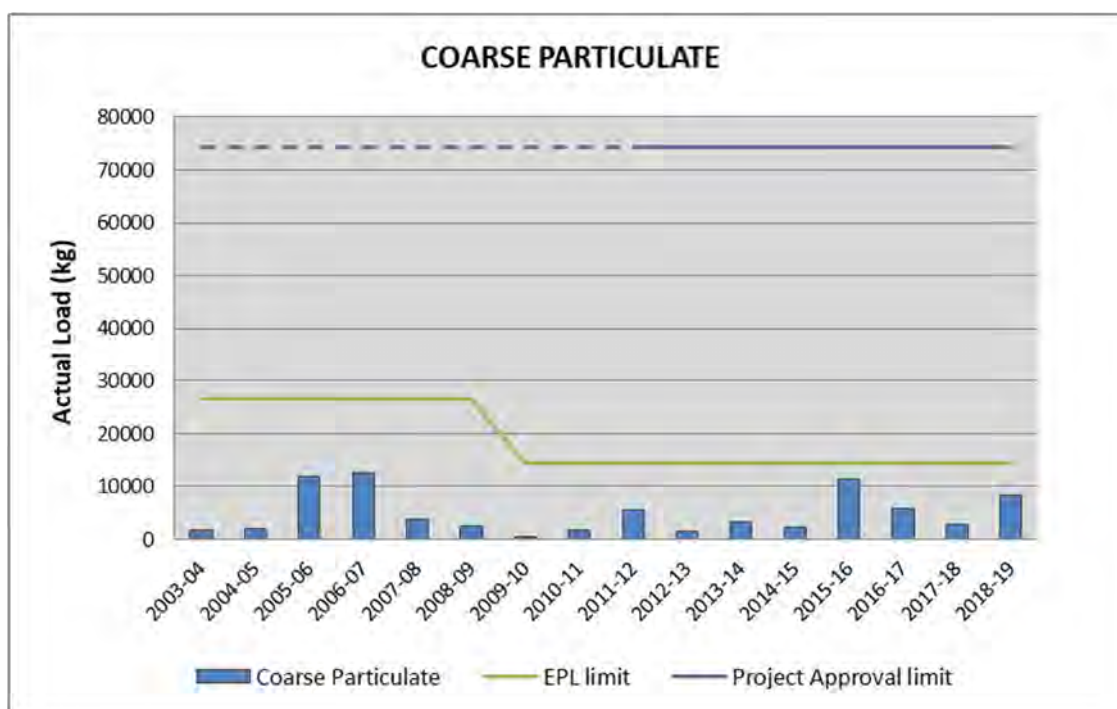
Figure 30 Coarse particulate annual load (2004 – 2019)

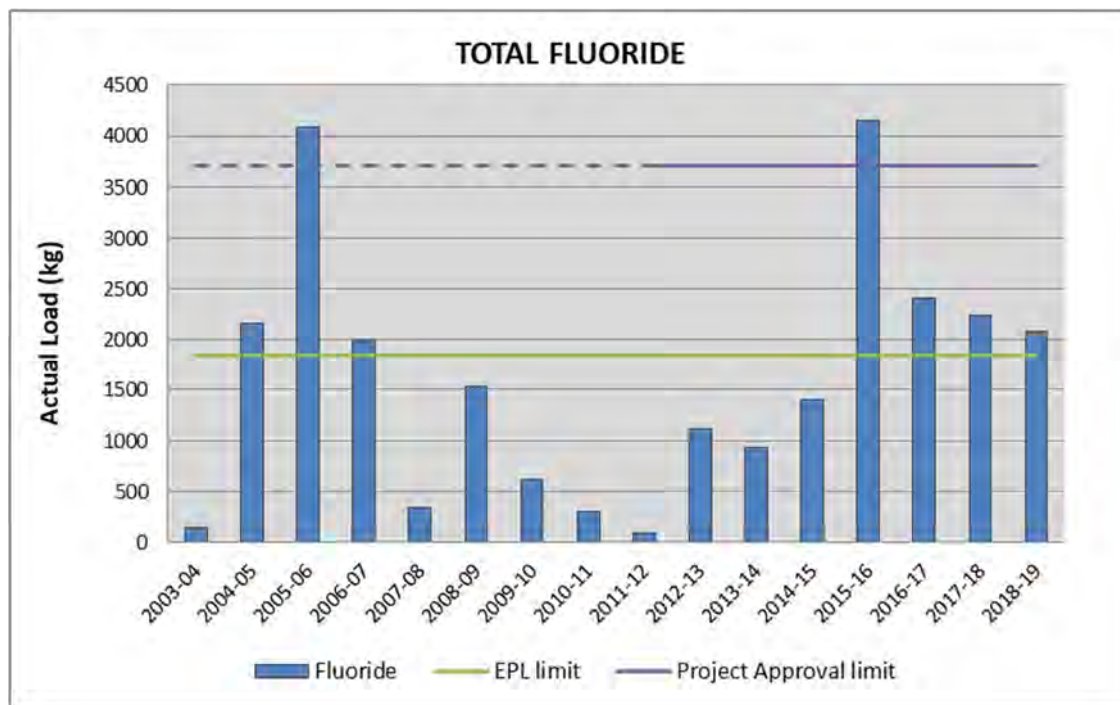
Figure 31 Fluoride annual load (2004 – 2019)

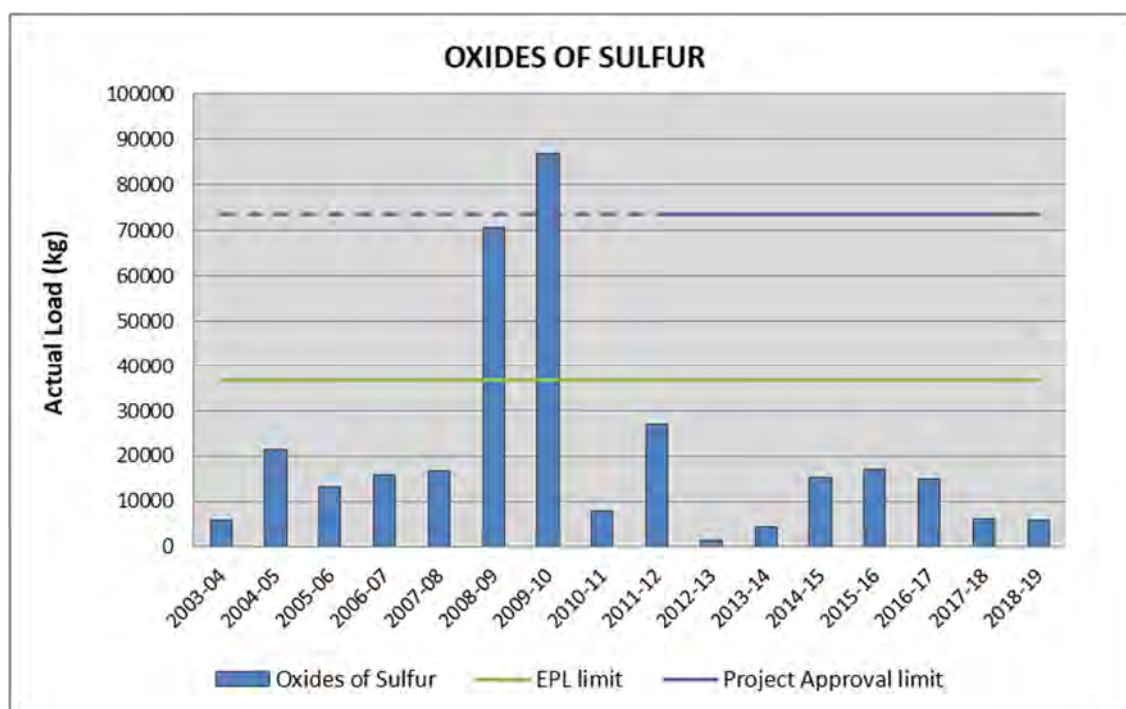
Figure 32 Sulfur oxides (as sulphuric acid mist and sulfur trioxide (as SO₃)) annual load (2004 – 2019)

Note: Sulfur oxide loads for the 2012-13 and 2013-14 reporting years have been corrected to only include sulfuric acid mist and sulfur trioxide, as agreed with regulatory authorities in 2012, and not sulfur dioxide as previously calculated.

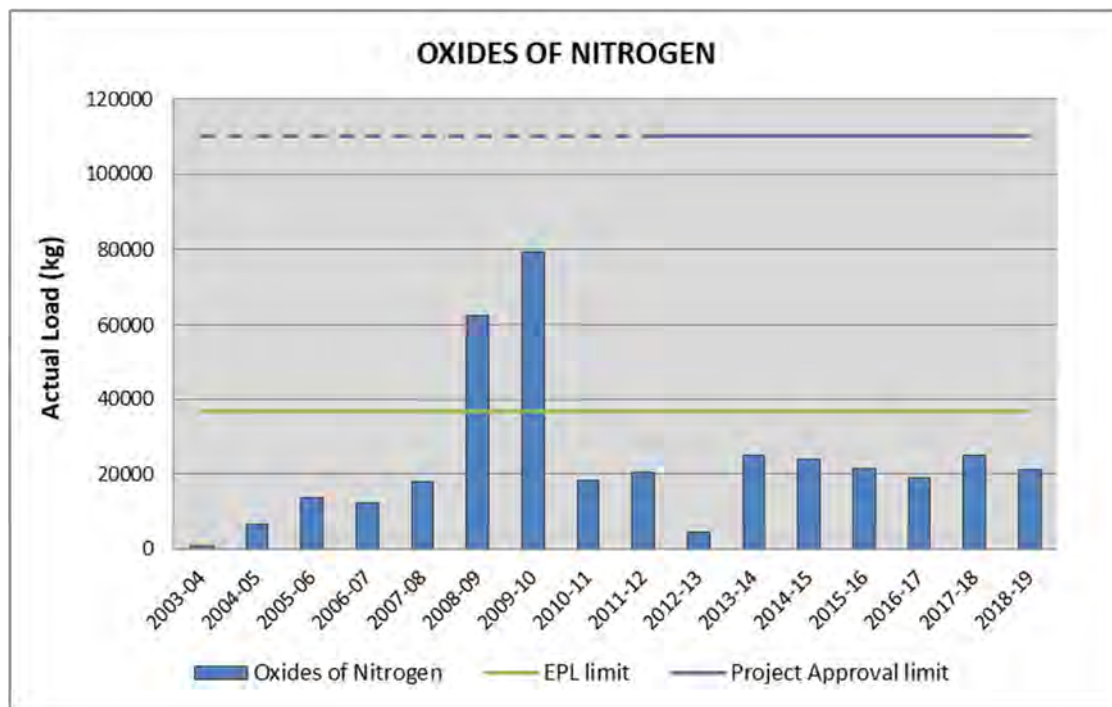
Figure 33 Nitrogen oxides annual load (2004 – 2019)

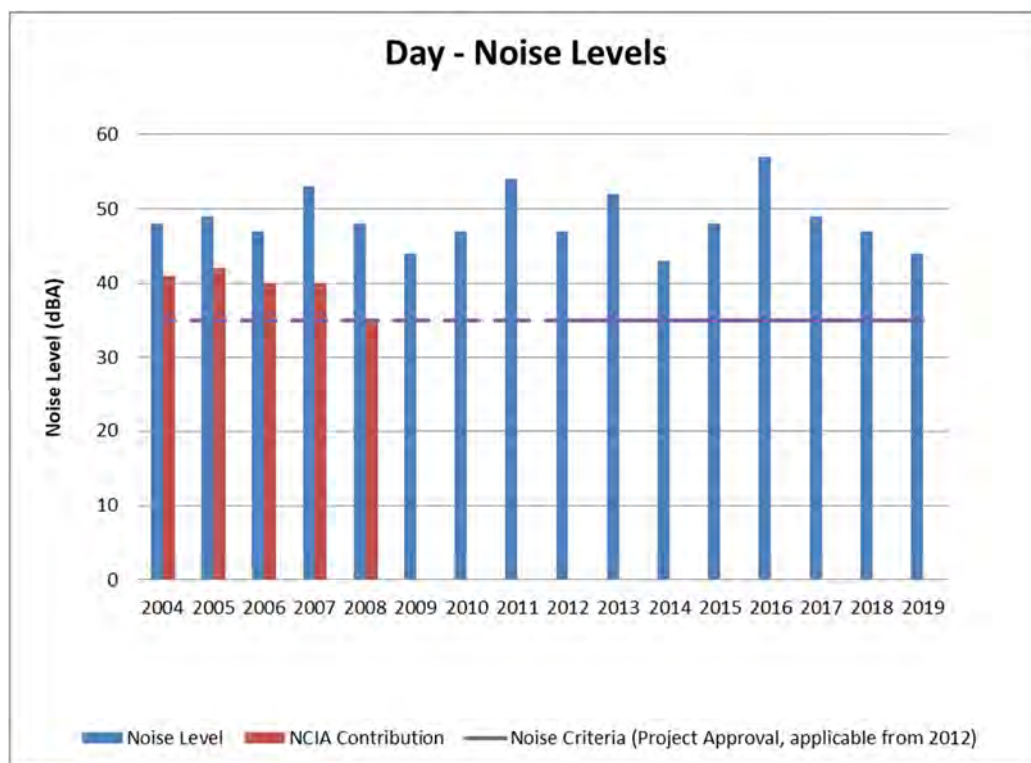
During the daytime for the past ten years the NCIA noise contribution was either inaudible or audible but not measurable. The current noise monitoring report noted that traffic noise from the New England Highway contributed significantly to the background noise levels at Kenvil Close.

Figure 34 Day noise levels 2004 – 2019

Note 1: 2009 - 2019: NCIA contribution was either inaudible or not measurable.

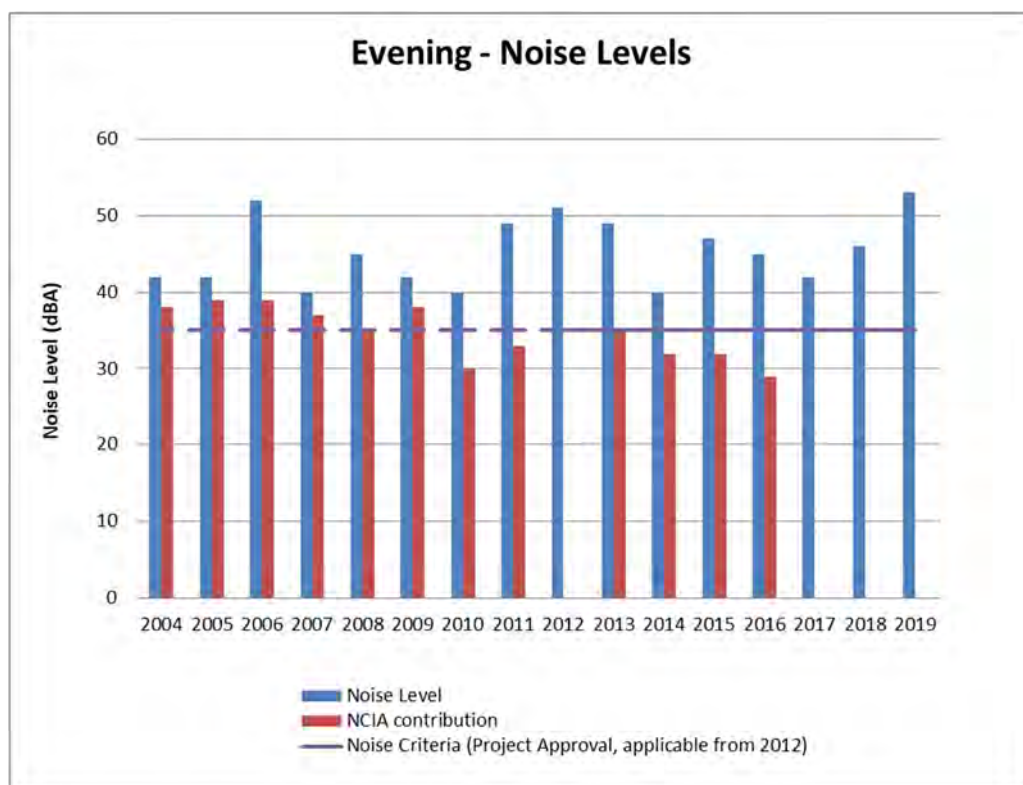
Figure 35 Evening noise levels 2004 – 2019

Note: 2012, 2017, 2018 and 2019: NCIA contribution was either inaudible or not measurable.

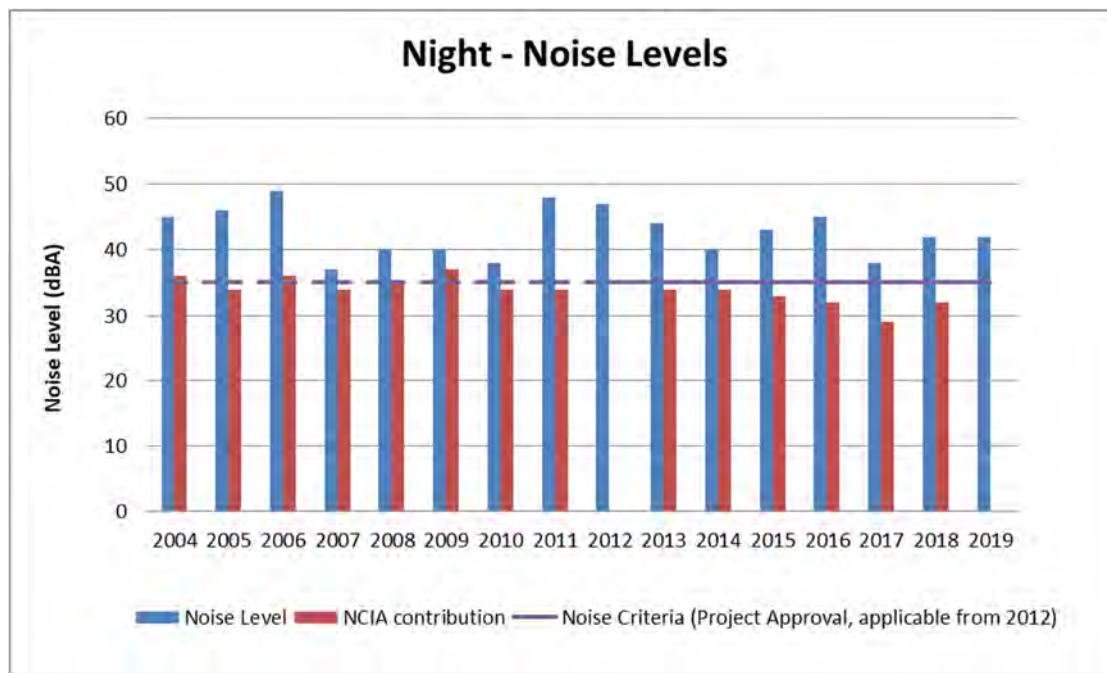
Figure 36 Night noise levels 2004 – 2019

Note: 2012 and 2019: NCIA contribution audible but not measurable.

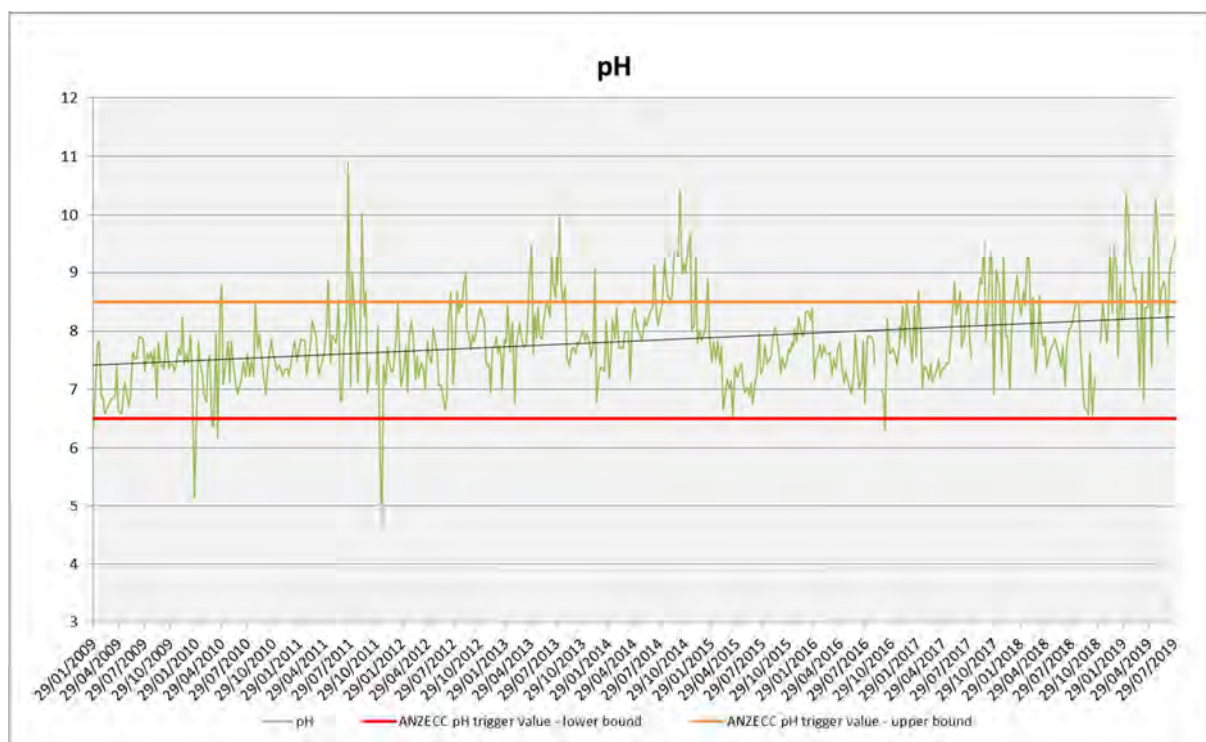
Figure 37 Stormwater quality, pH – Pond 4 (2009-2019)

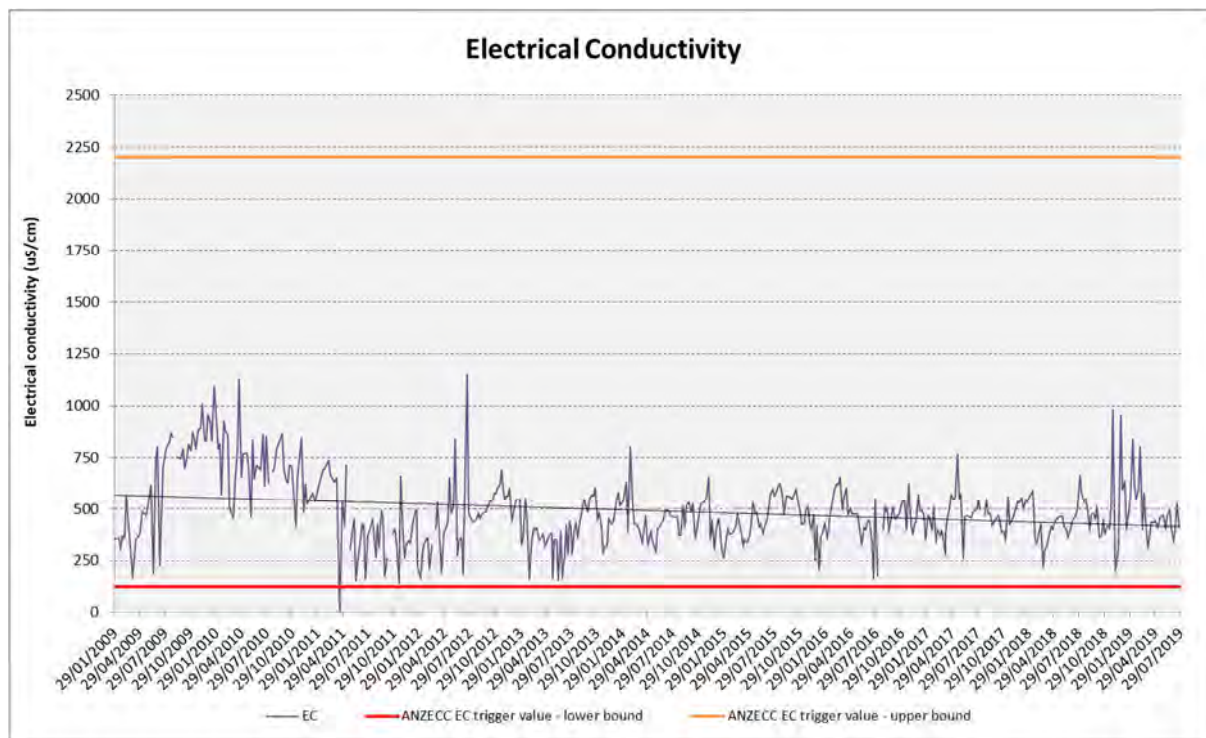
EC results during 2019 are comparable to previous years with a stable average and no exceedances of the criteria (refer to Figure 38). A review of historical EC values indicates an overall decreasing trend. EC values are generally within the ANZG guidelines trigger values and indicate that the stormwater is non-saline.

Figure 38 Stormwater quality, EC – Pond 4 (2009-2019)

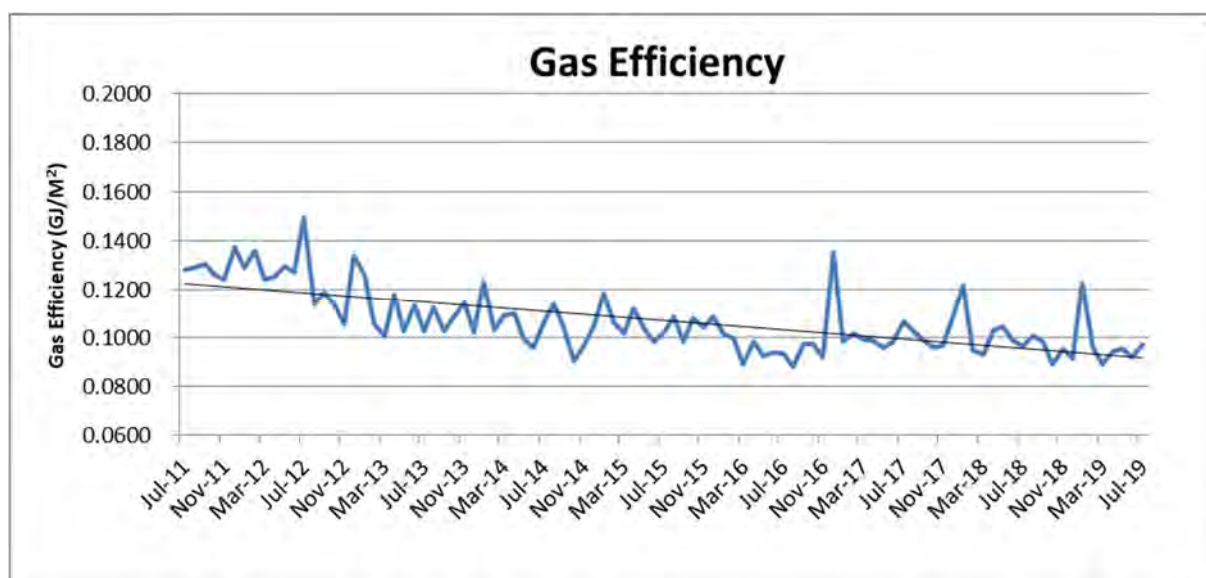
NCIA has installed a Quality Assurance (QA) machine before the kiln on each of its production lines. This effectively reduces waste tiles going through the kiln and being fired, creating both a reduction in waste and a saving in energy consumption.

Figure 39 Gas efficiency in tile manufacturing process

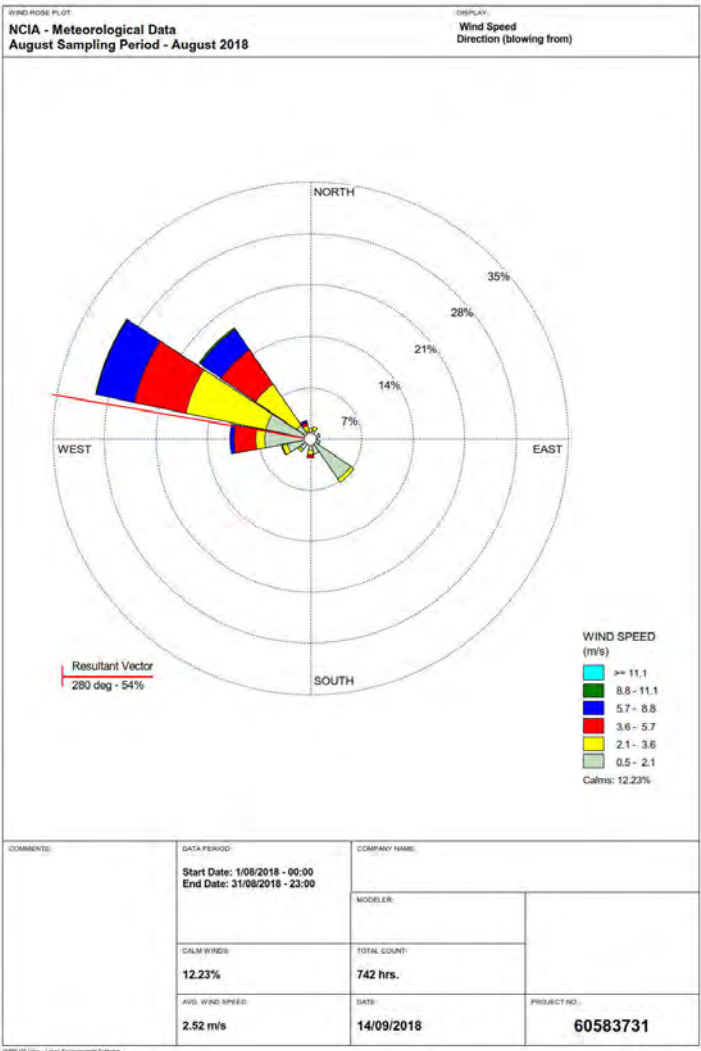
Figure B 1 Wind Speed and Direction (August 2018)

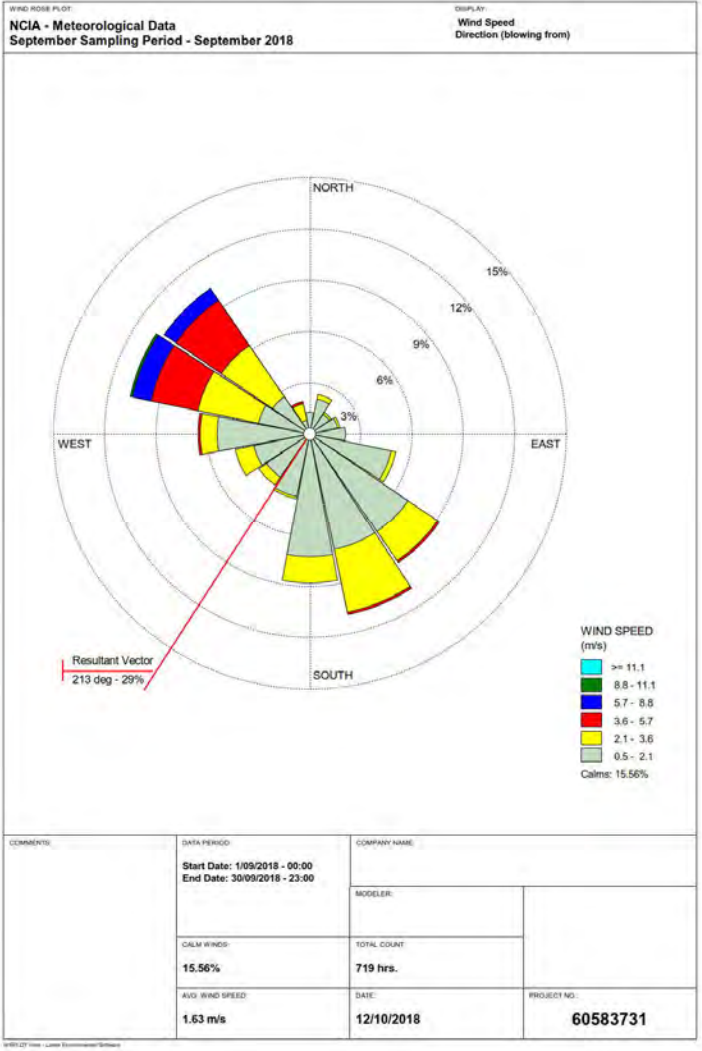
Figure B 2 Wind Speed and Direction (September 2018)

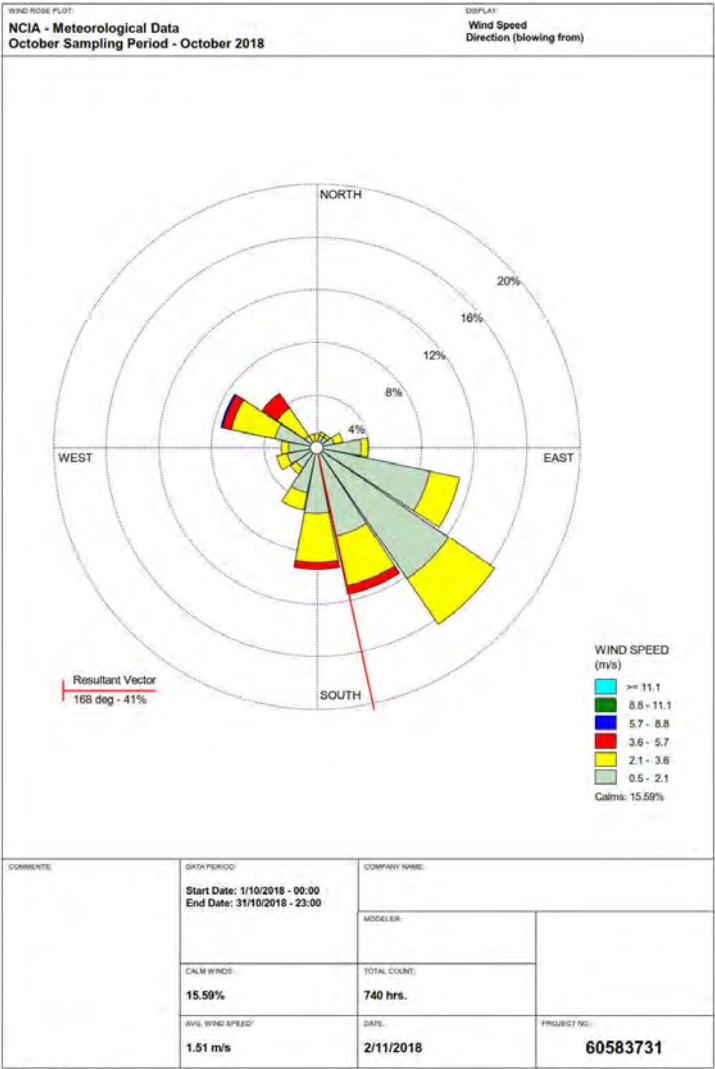
Figure B 3 Wind Speed and Direction (October 2018)

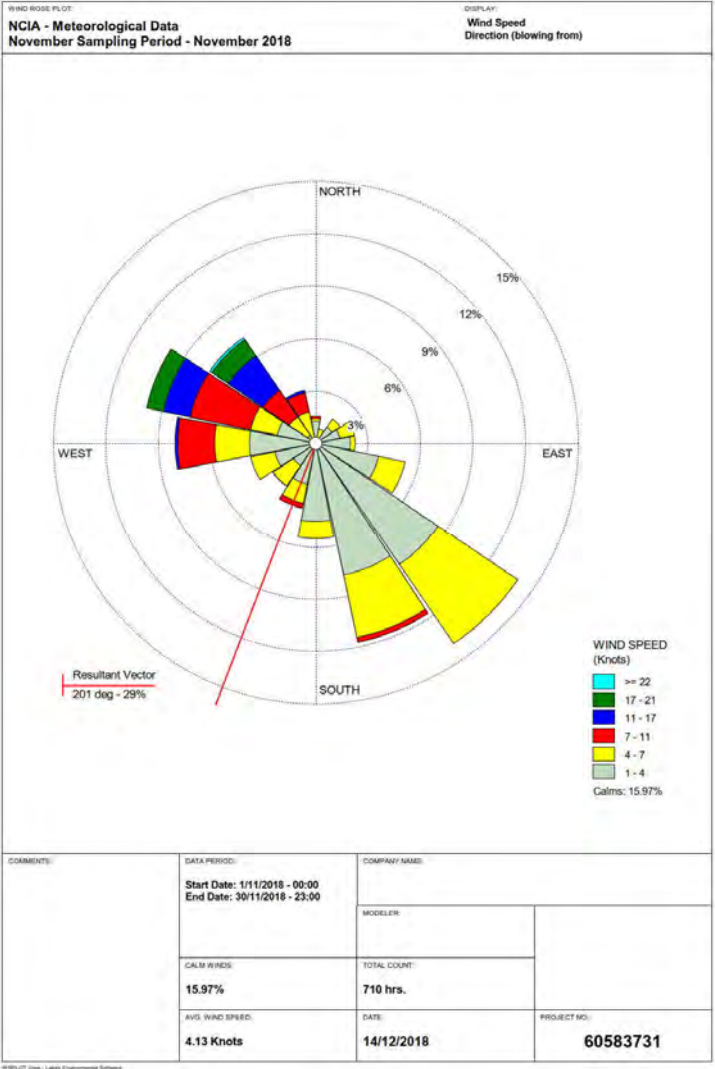
Figure B 4 Wind Speed and Direction (November 2018)

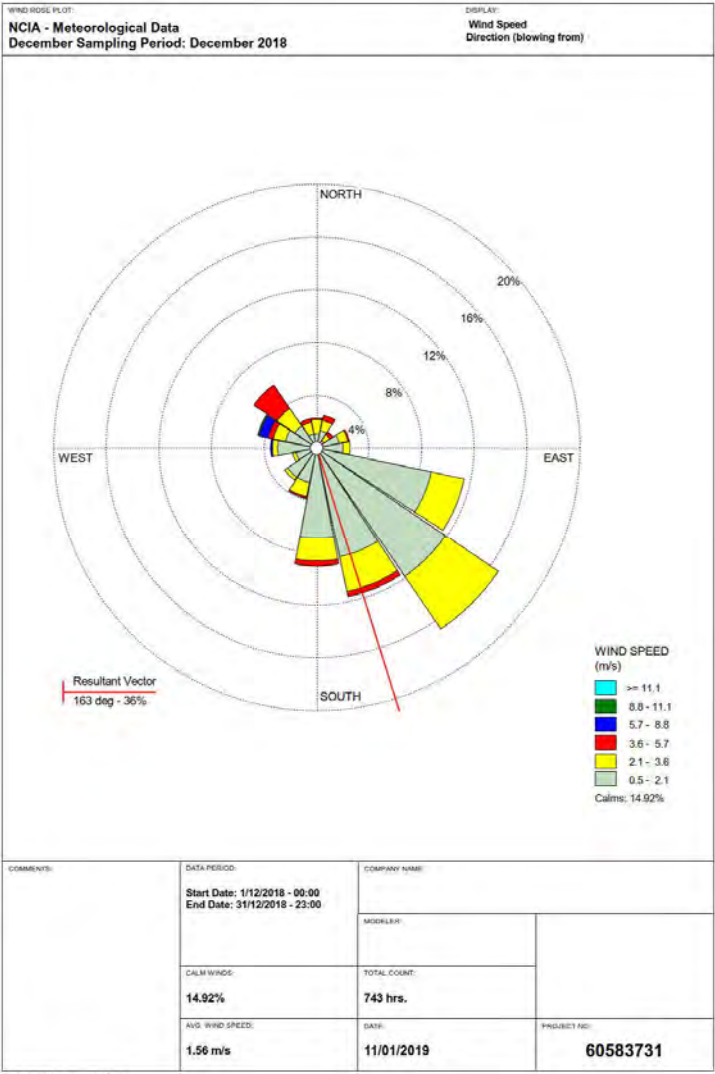
Figure B 5 Wind Speed and Direction (December 2018)

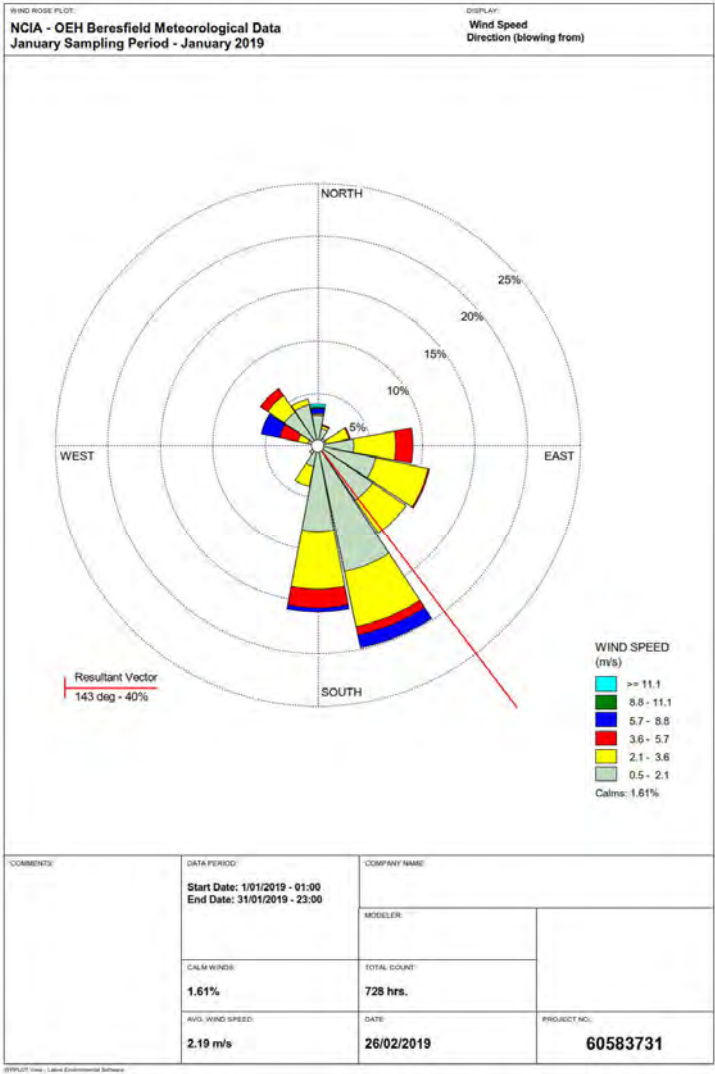
Figure B 6 Wind Speed and Direction (January 2019)

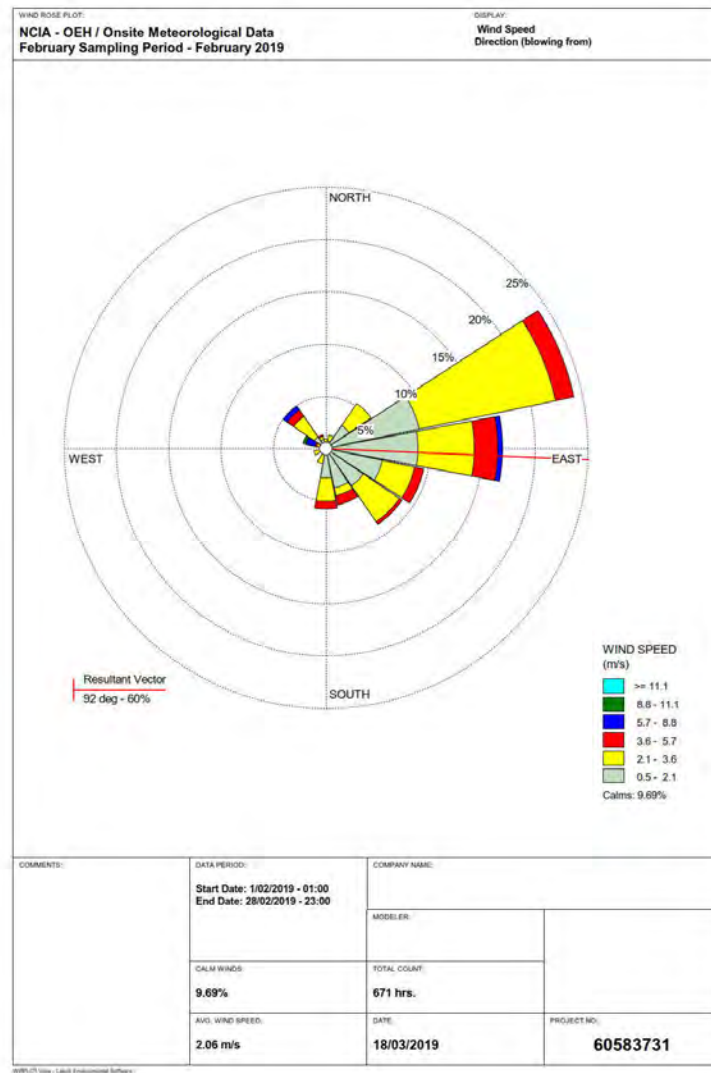
Figure B 7 Wind Speed and Direction (February 2019)

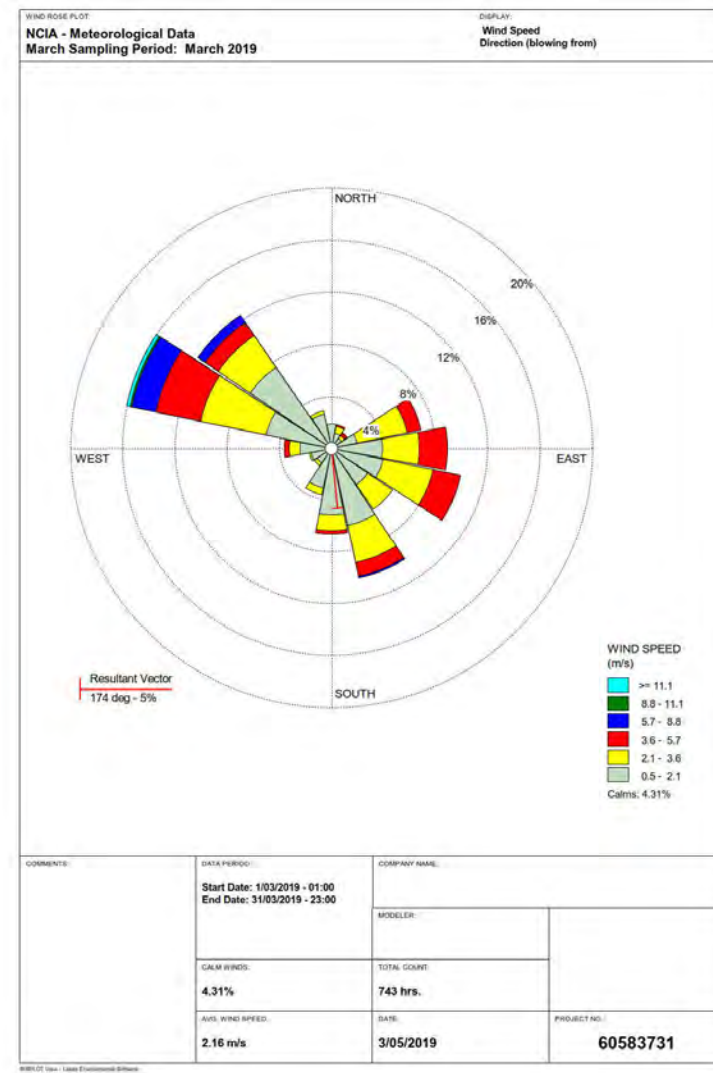
Figure B 8 Wind Speed and Direction (March 2019)

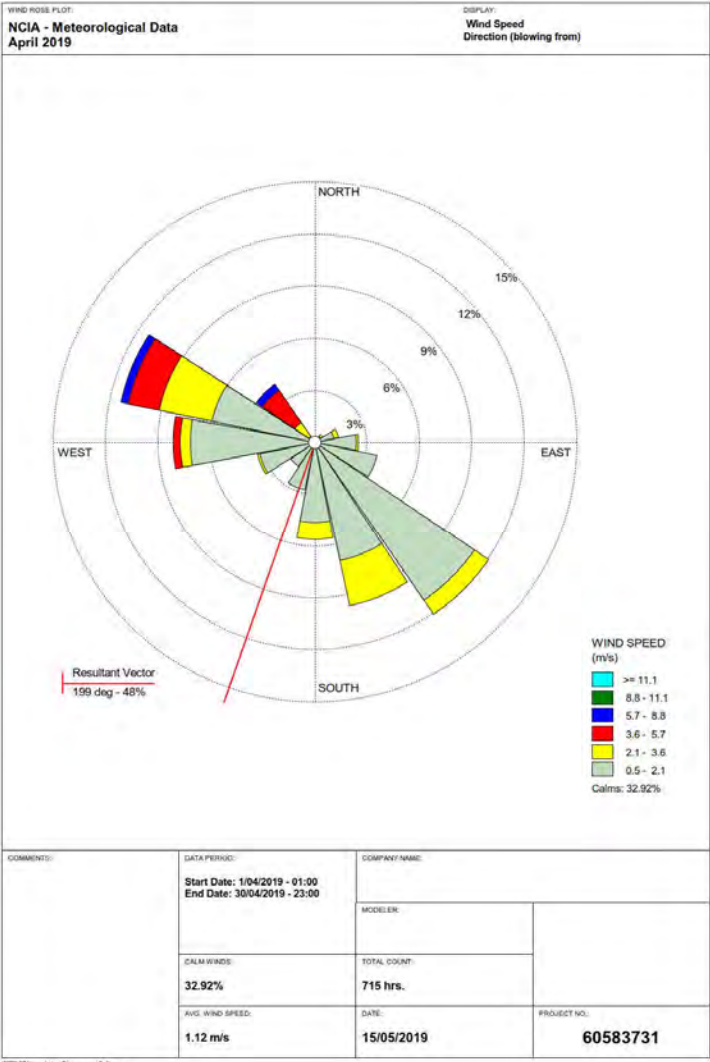
Figure B 9 Wind Speed and Direction (April 2019)

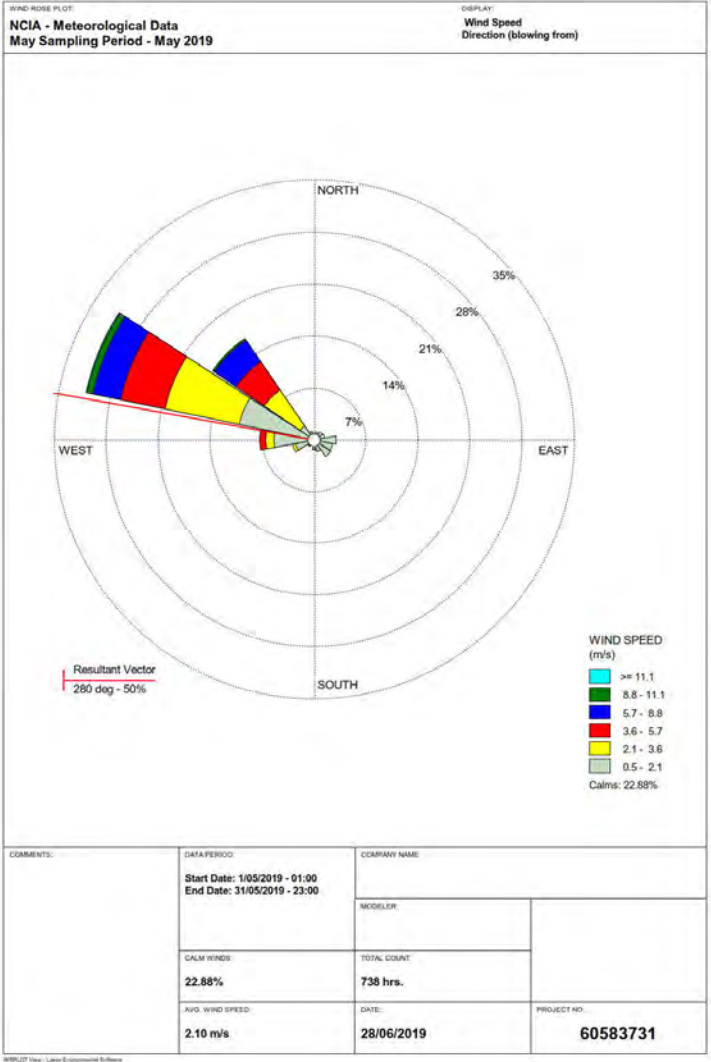
Figure B 10 Wind Speed and Direction (May 2019)

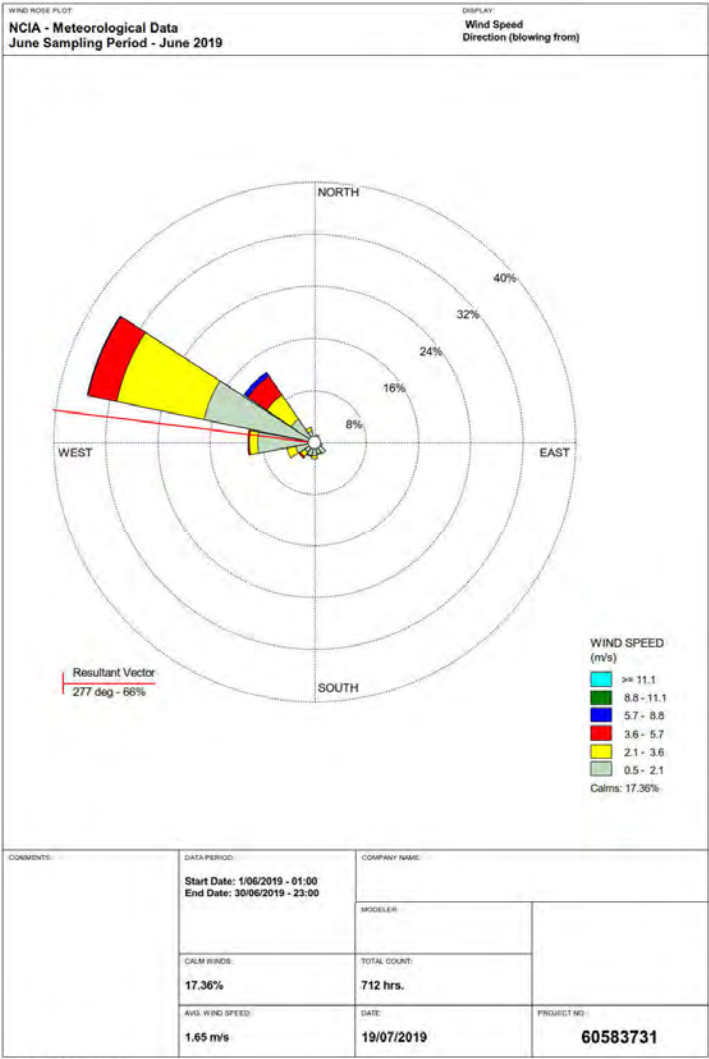
Figure B 11 Wind Speed and Direction (June 2019)

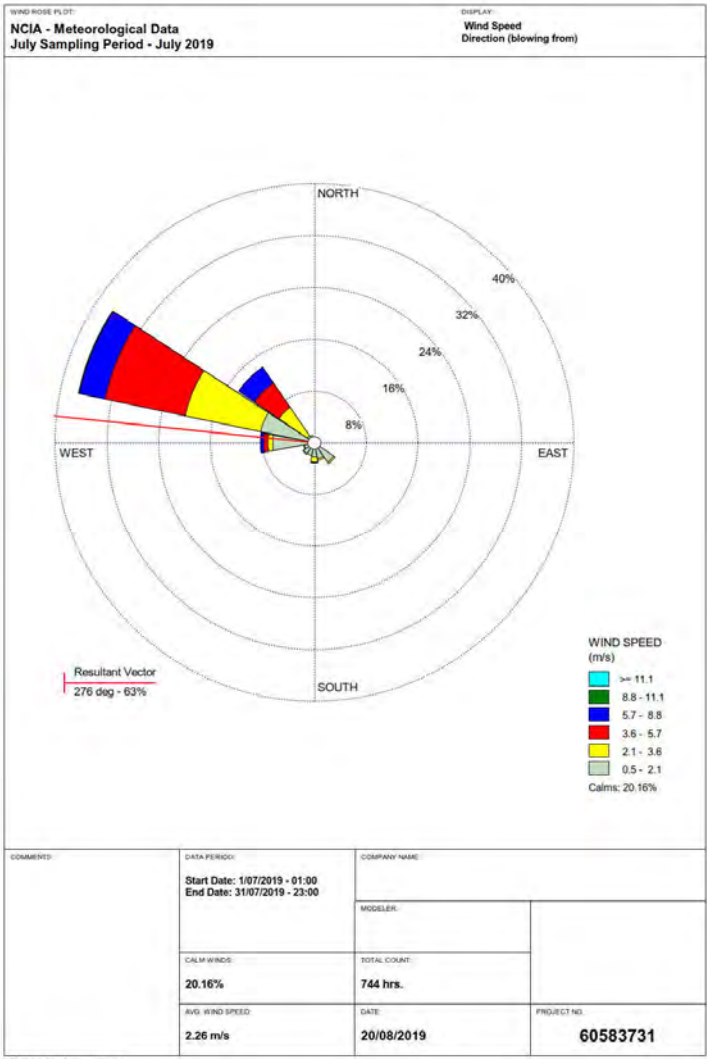
Figure B 12 Wind Speed and Direction (July 2019)
