# 2020 Annual Environmental Management Report

1 August 2019 - 31 July 2020

Client: National Ceramic Industries Australia

**AECOM Australia Pty Ltd**

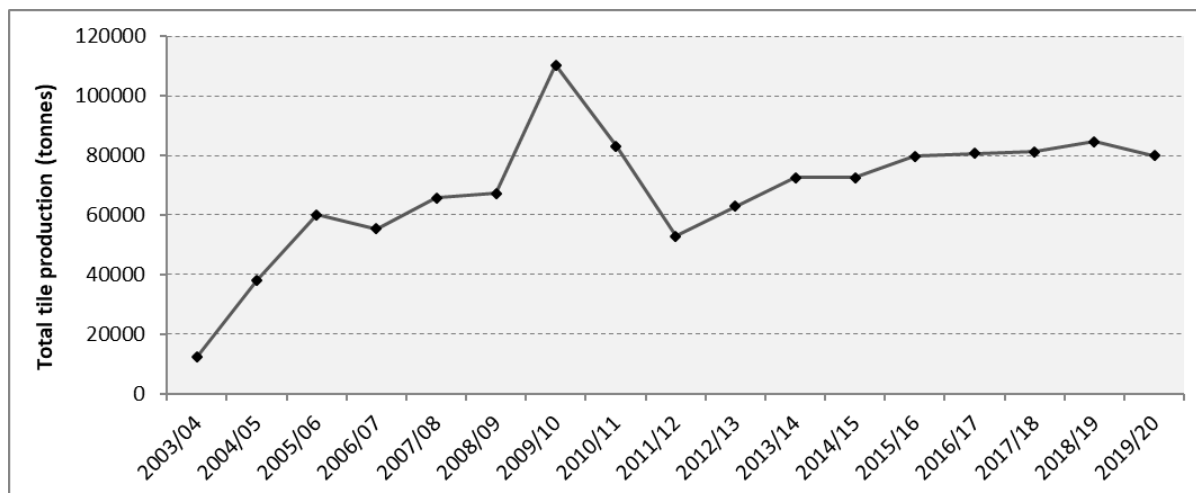
Figure 1 Production volume since 2004

Between 1 August 2019 and 31 July 2020, the facility operated 330 days, for a total output of 79,860 tonnes of ceramic tiles (or approximately 5.04 million m<sup>2</sup>). These production levels are below the maximum production authorised under NCIA's current approvals (refer to **Section 1.2**) and are commensurate to the current stage of development of the facility (i.e. Stage Two).

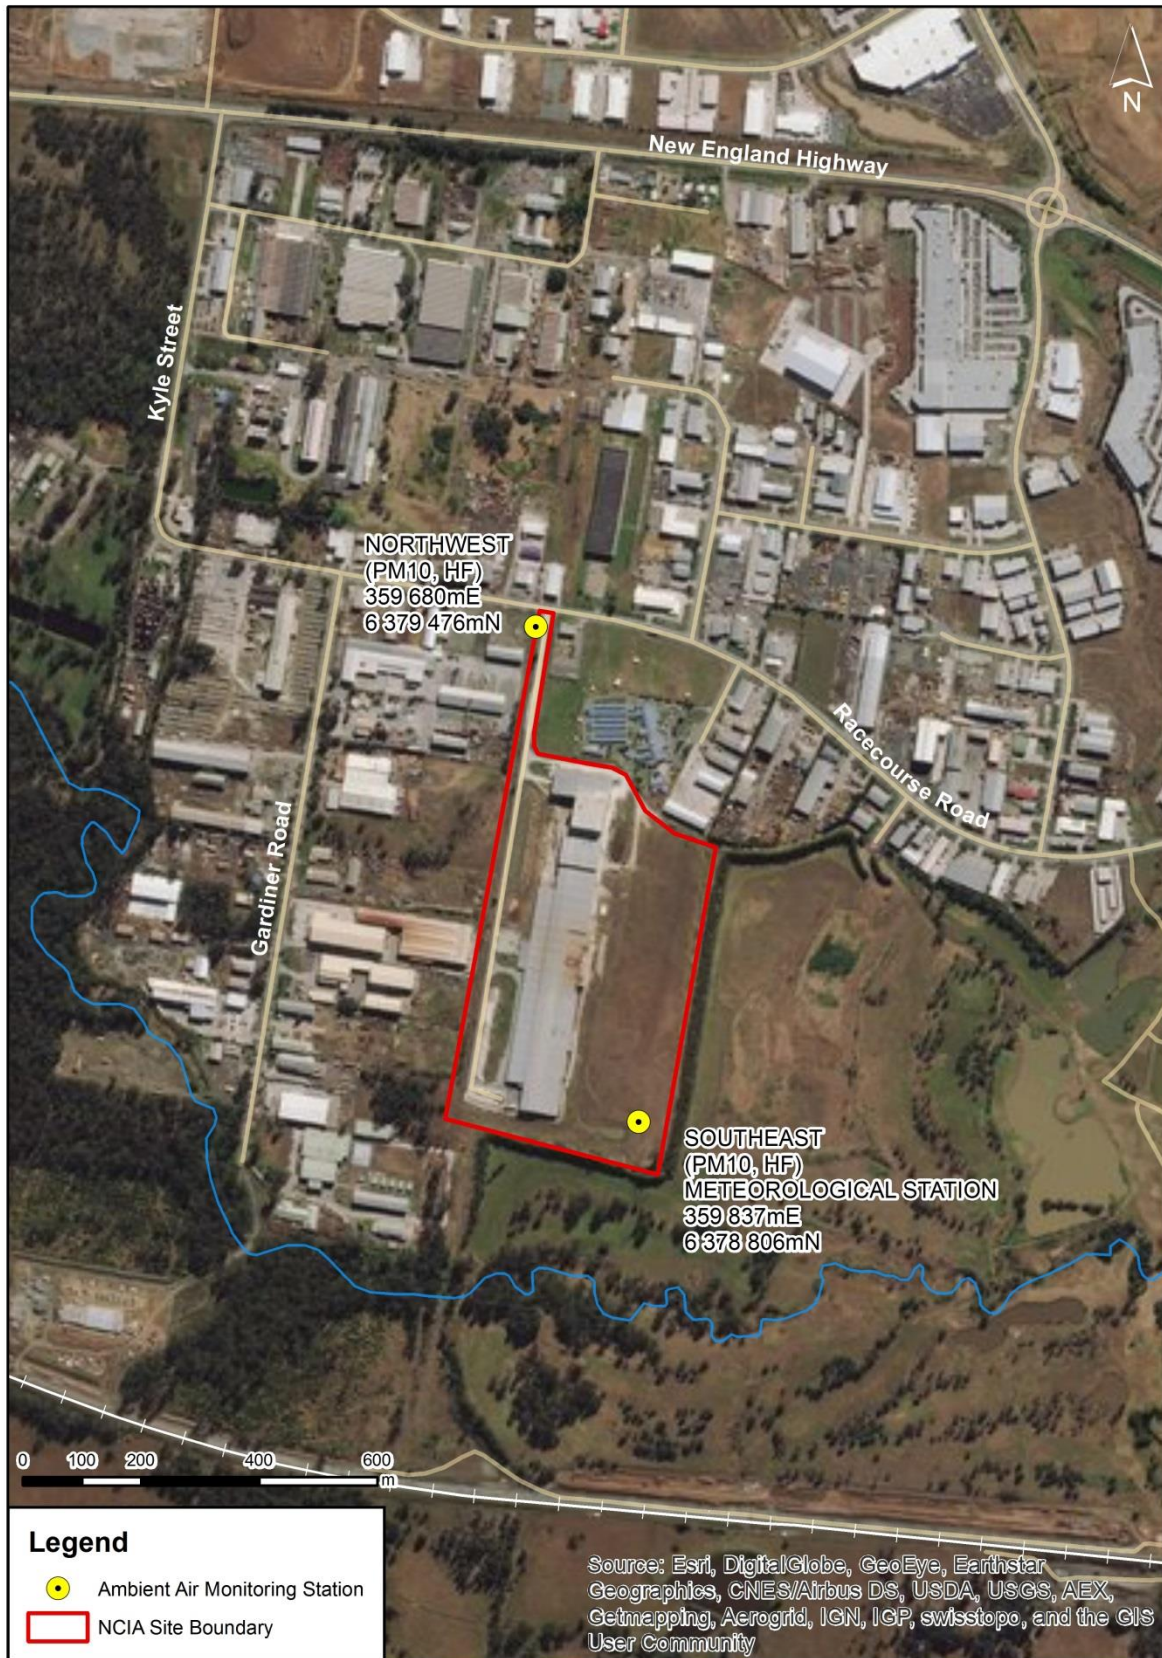
Figure 2 Ambient air monitoring locations

In accordance with EPL condition M2.1, PM<sub>10</sub> (24-hour) and Fluoride (24-hour and weekly) are monitored at two locations: northwest and southeast of the facility (refer **Figure 2**).

Two fluoride monitoring units (manual, double filter paper samplers) have been sited at each of the two locations identified for monitoring of PM<sub>10</sub> and are operated in accordance with *AS3580.13.2:2013 Determination of gaseous and acid-soluble particulate fluorides*. At each location, one monitor operates continuously over a 7-day period to provide weekly fluoride concentration averages. These units are designated 'Northwest HF<sub>7</sub>' and 'Southeast HF<sub>7</sub>'. The remaining unit at each site operates continuously for discrete 24-hour periods according to the NSW EPA 6-day cycle to provide 24-hour averages for sampler operation days. Units are designated 'Northwest HF' and 'Southeast HF'.

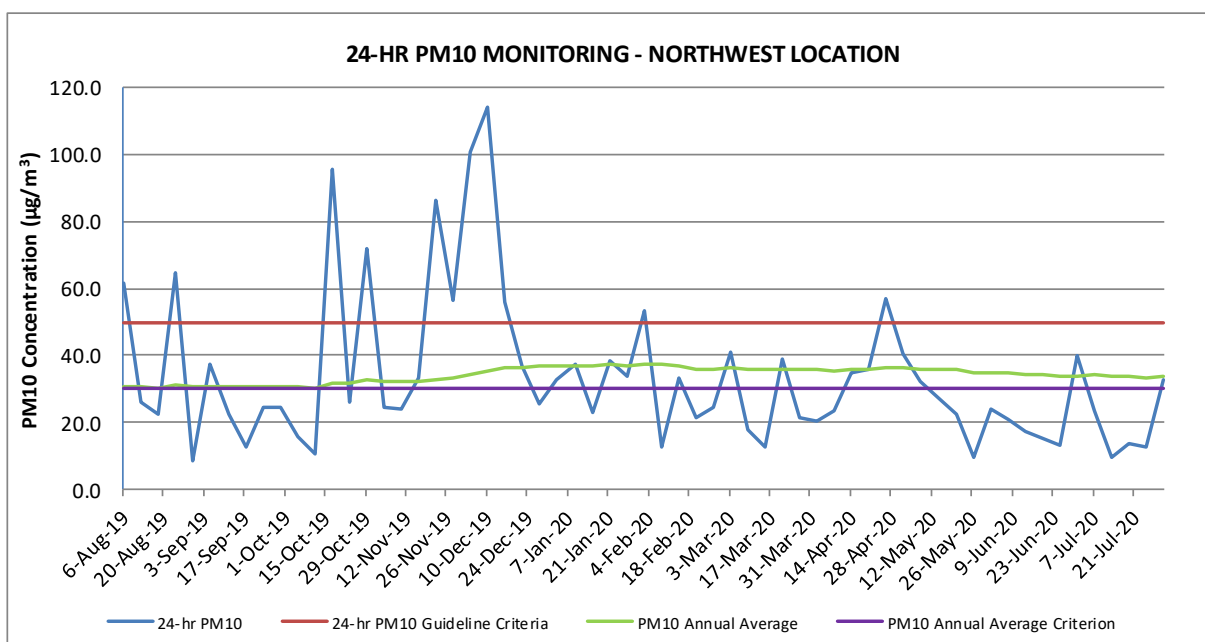
**Figure 3 PM<sub>10</sub> monitoring – northwest location**

At the completion of this 12 month period the North West location returned an annual average of 33.6 µg/m<sup>3</sup> which is above the criteria. The annual average has increased from the previous year value of 30.3 µg/m<sup>3</sup> largely due to elevated results recorded during November and December 2019 caused by regional heavy bushfire smoke. Recent results towards the end of the monitoring period indicate a likely return to values below the criteria.

The PM<sub>10</sub> exceedance at the North West sampler on 2 February 2020 was measured during a period of increased regional PM<sub>10</sub> levels and under meteorology conditions that do not place the site upwind of the sampler. This information indicates NCIA is not the source of this exceedance.

The PM<sub>10</sub> exceedance at the North West sampler on 26 April 2020 was measured during a period of increased regional PM<sub>10</sub> levels and under meteorology conditions that do not place the site upwind of the sampler. This information indicates NCIA is not the source of this exceedance.

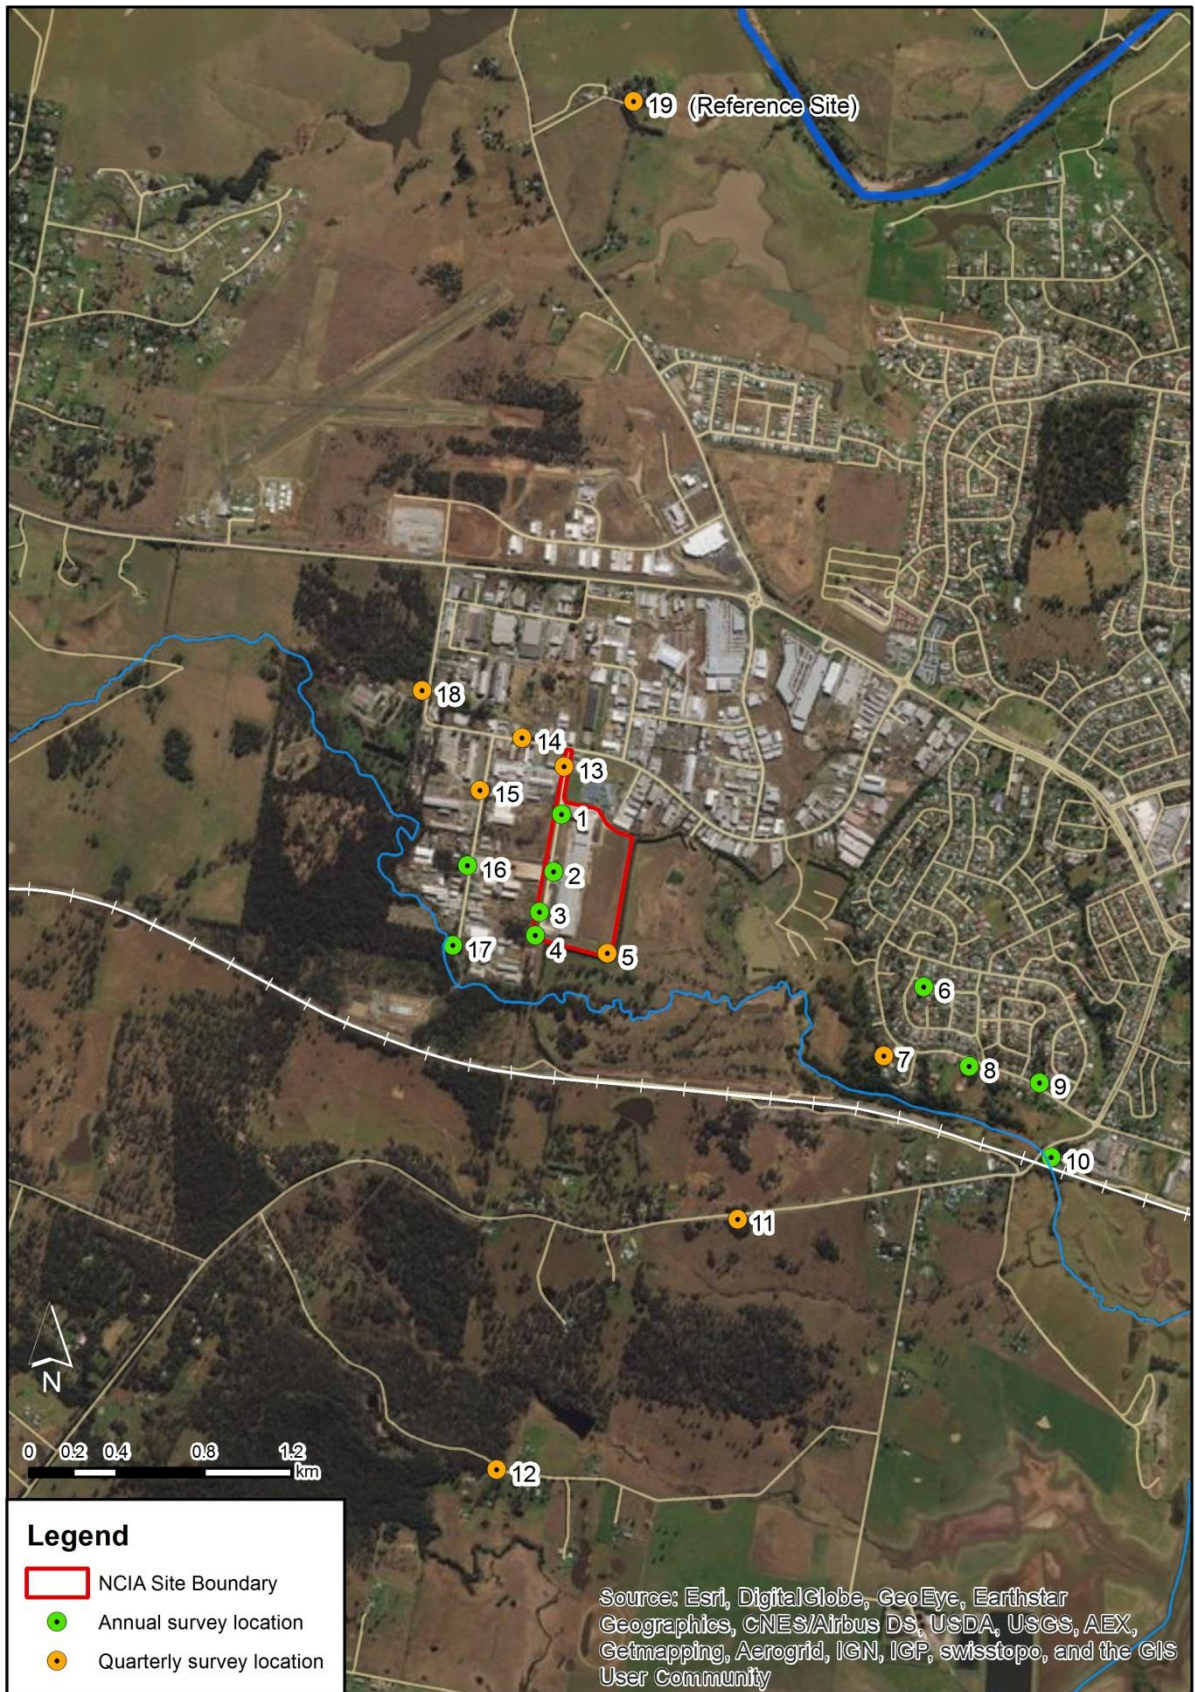
Figure 9 Vegetation survey monitoring location

The sites monitored for vegetation condition assessments during the reporting period are shown in **Figure 9**. Details on the monitoring sites as well as a photograph of each monitoring site location (at the time of the annual Q4 2019 survey) are provided in **Appendix A1**. The monitoring locations included eighteen 'impact' sites (comprising eight sites monitored quarterly plus an additional ten sites monitored during the annual survey only) and one 'reference' site. All impact sites were selected to be generally within the areas of highest predicted ambient fluoride concentration – i.e. within the prevailing wind directions for the region (northwest-southeast axis), whilst the reference site location was selected to be outside the prevailing winds.

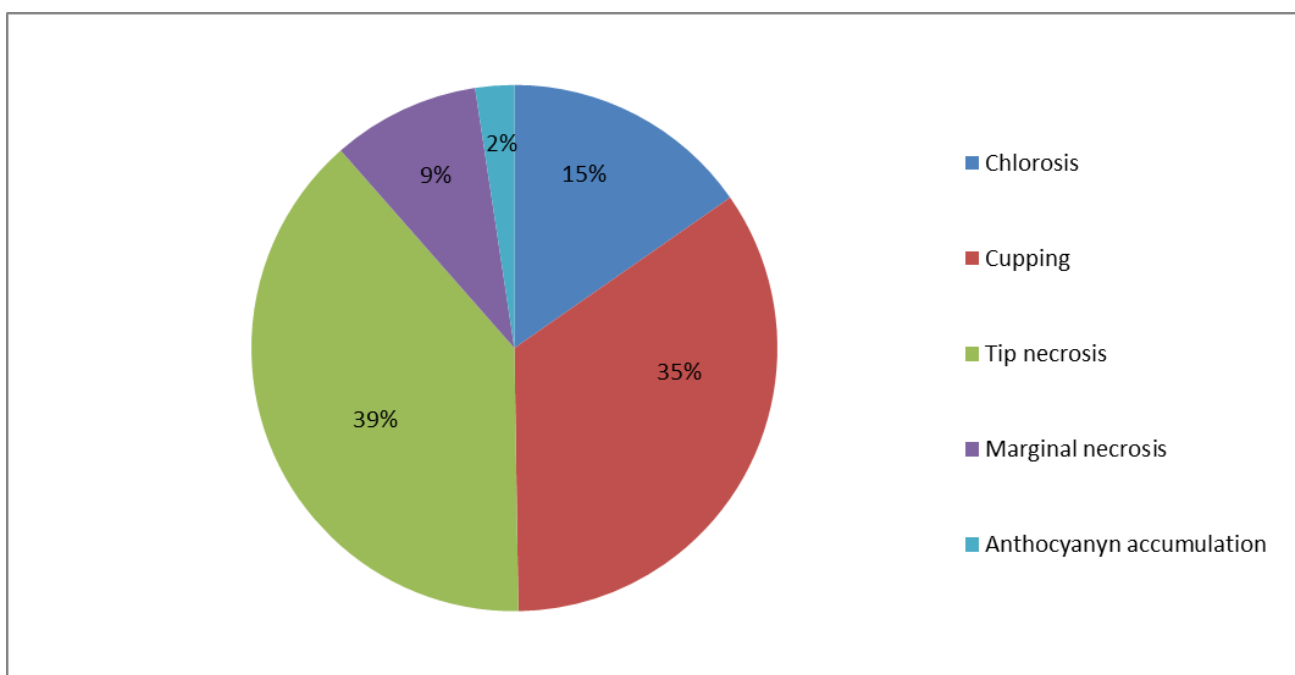
**Figure 10 Relative prevalence of fluoride related symptoms**

**Figure 10** shows the prevalence of each visual foliage injury symptom observed in all species during the surveys. It indicates that tip necrosis, leaf undulation / cupping, and chlorosis were the most commonly occurring symptoms (with 89% of all observations), followed by marginal necrosis (9%), whilst symptoms of anthocyanin accumulation were generally uncommon (2% of all observations).

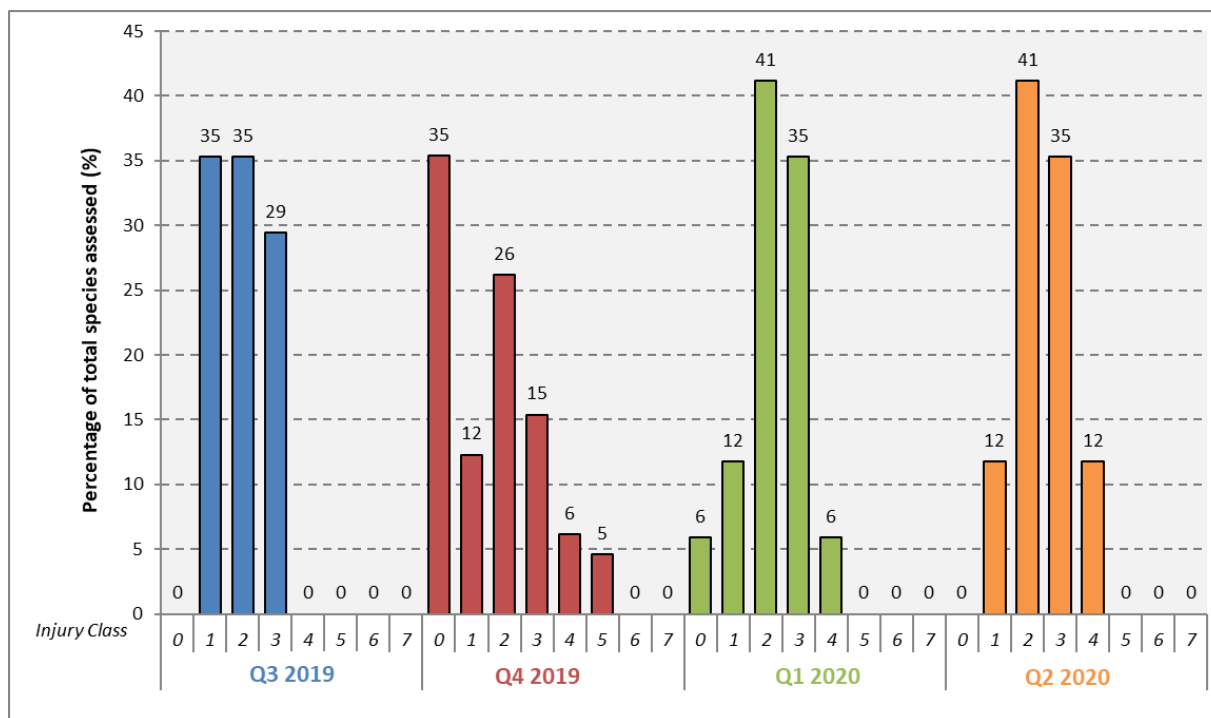
**Figure 11 Proportion of flora species affected by emissions related visual injury symptoms during the surveys**

- For each survey between 53% and 73% of plants surveyed were affected at worst by slight injury symptoms (i.e. injury class 2 and less, maximum of 5% leaf area impacted);
- For each survey between 21% and 47% of plants surveyed were affected by distinct or marked injury symptoms (i.e. injury class 3 or 4, 10-25% of leaf area impacted);
- During the annual Q4 2019 survey only, 5% of plants surveyed displayed severe to very severe visual injury symptoms (i.e. injury class 5 or 6, 50-75% of leaf area impacted); and
- No species displayed extreme injury symptoms (i.e. injury class 7, >75% of leaf area impacted) during the four surveys.

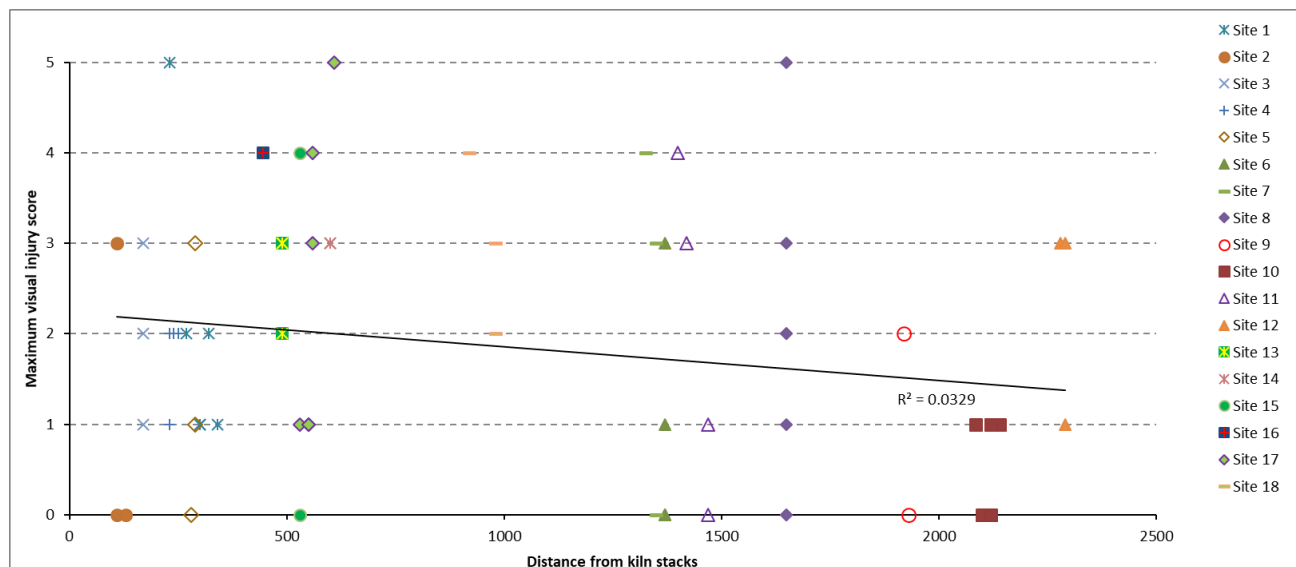
**Figure 12 Relationship between distance from kiln stacks and maximum visual injury score in foliage of species assessed**

**Figure 12** depicts the relationship between the maximum emission related visual injury score recorded for each species (inclusive of all surveys) and their distance from the kiln stacks at NCIA. The results showed little correlation between foliage injury and the distance to the emission source ( $r^2 = 0.03$ ), indicating that emission impacts to foliage may spread further from the NCIA site than the furthest monitoring site. For instance, category 4 injury symptoms were observed up to ~1,400m away from the NCIA facility at Site 7, while category 3 symptoms occurred as far as Site 12 (~2,300m from the NCIA facility). This also suggests that within the current suite of monitoring sites, variables such as flora species type or the sensitivity of specific individuals are more relevant than the distance from emission source in determining atmospheric fluoride impacts on local vegetation. However, and importantly, there are several other air pollution sources in the region which may impact vegetation and foliage condition. Therefore, the geographical extent of fluoride impacts to foliage attributable to NCIA activities alone cannot be confidently determined.

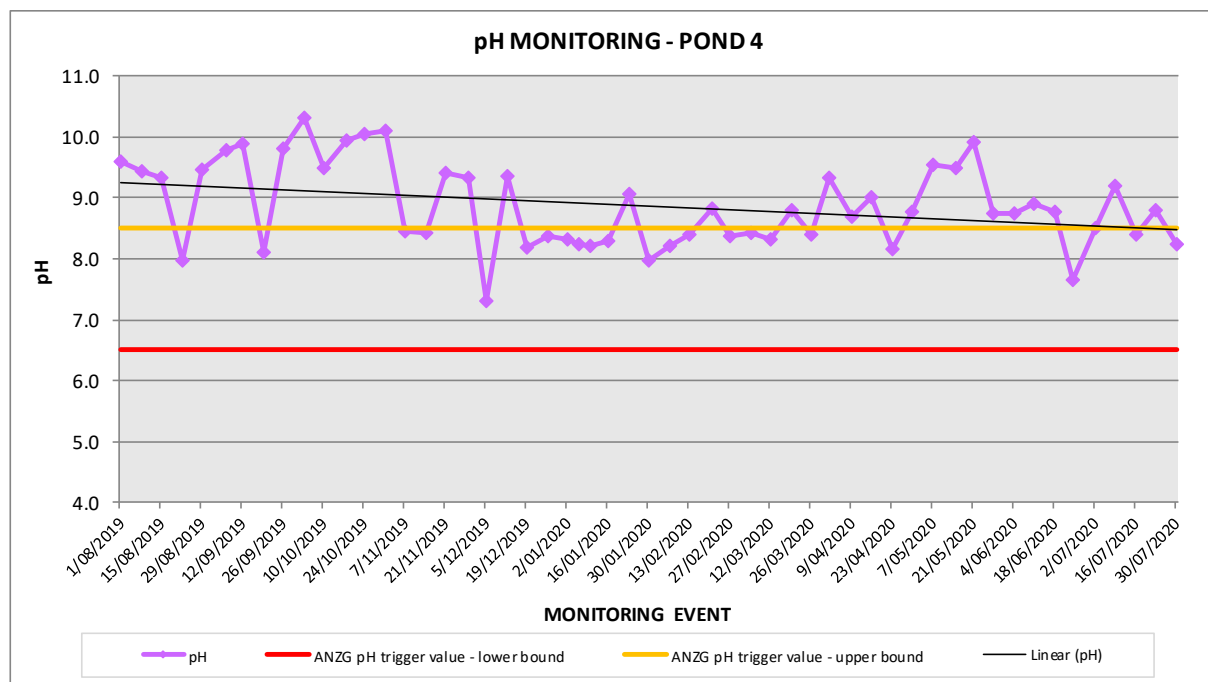
Figure 14 Stormwater quality monitoring – pH

- pH values ranged between 7.3 and 10.3 with a varying trend throughout the reporting period. Results generally exceeded the ANZG guidelines.

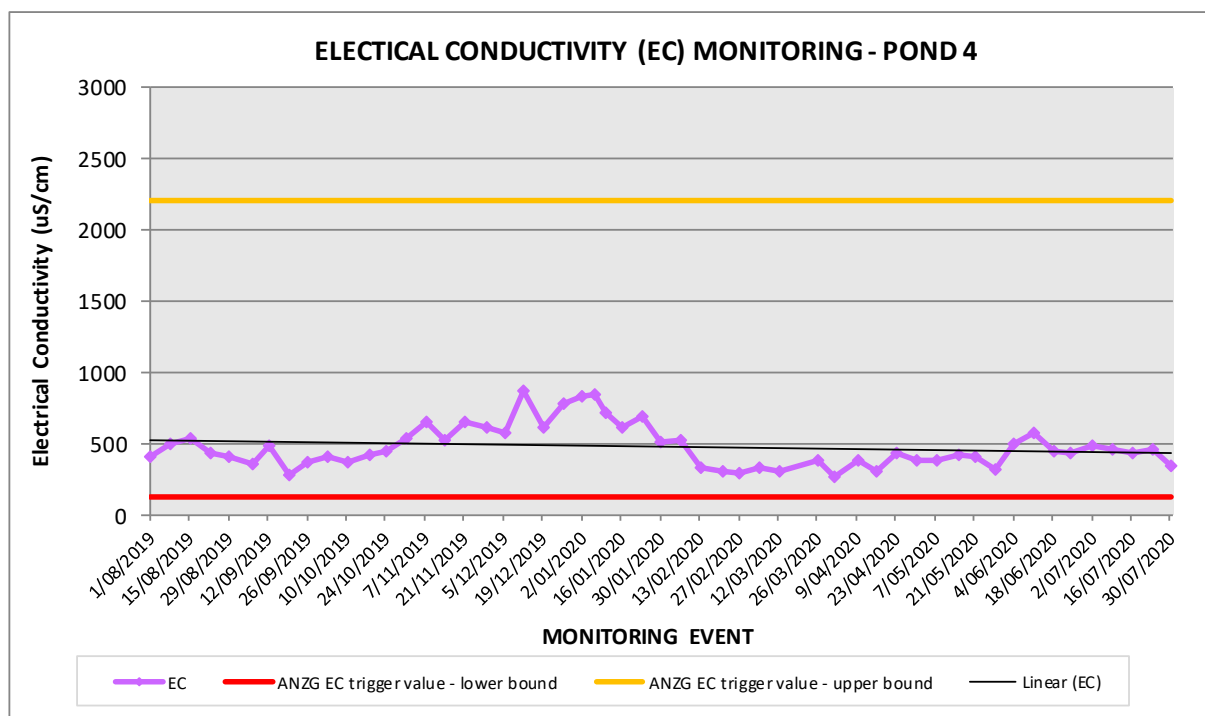
Figure 15 Stormwater quality monitoring – EC

- EC values were low and show a very slight decreasing trend throughout the reporting period with levels generally around 400 to 500  $\mu\text{S}/\text{cm}$  indicating that the water is non-saline. The EC values were within the ANZG guidelines for the entire reporting period with the exception of 19/03/2020 which was not included in the data set.

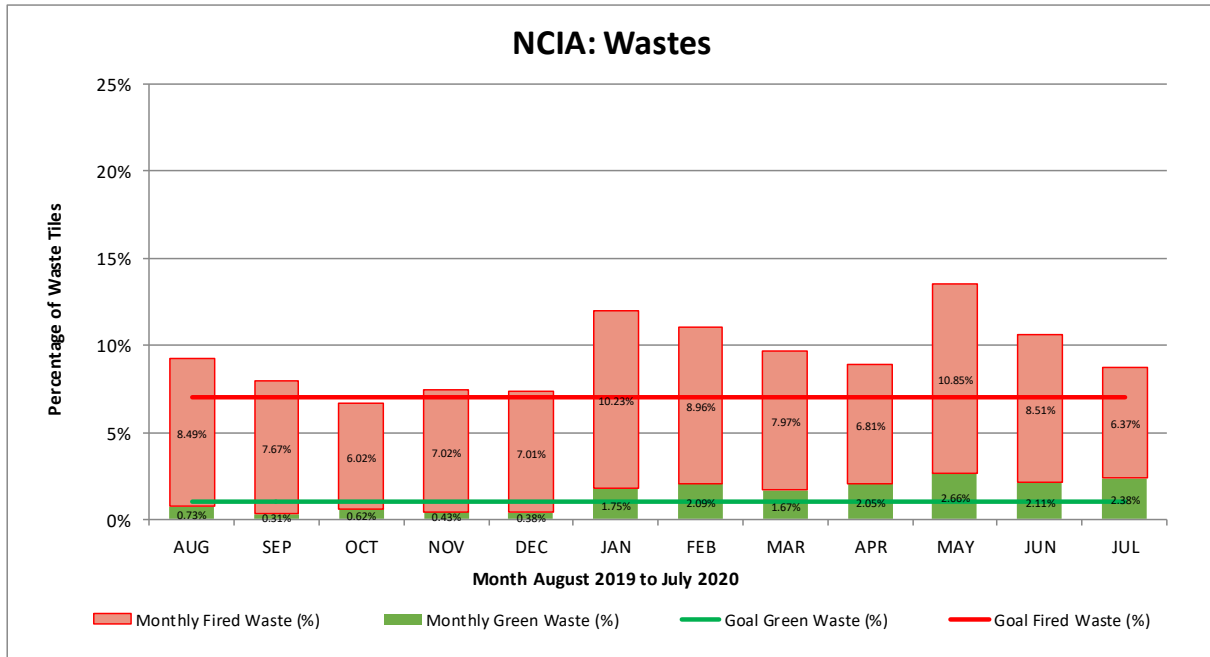
Figure 16 Tile waste (green and fired) generation during 2019-2020

NCIA's targets for tile wastes were lowered in July 2018 to not exceed 1% (for green tile waste) and 7% (for fired tile waste) of the total tile production, respectively. From January 2020 the amount of green waste has increased as a result of capturing more defective product prior to firing resulting in all 2020 months exceeding the green tile waste target. It must be noted that all green waste is recycled. The increased capture of green waste has resulted in the amount of fired tile waste reducing significantly from a monthly average of 10.1% recorded in the previous reporting period to a monthly average of 8.0%. with only seven months exceeding the target in the 2019-20 reporting period

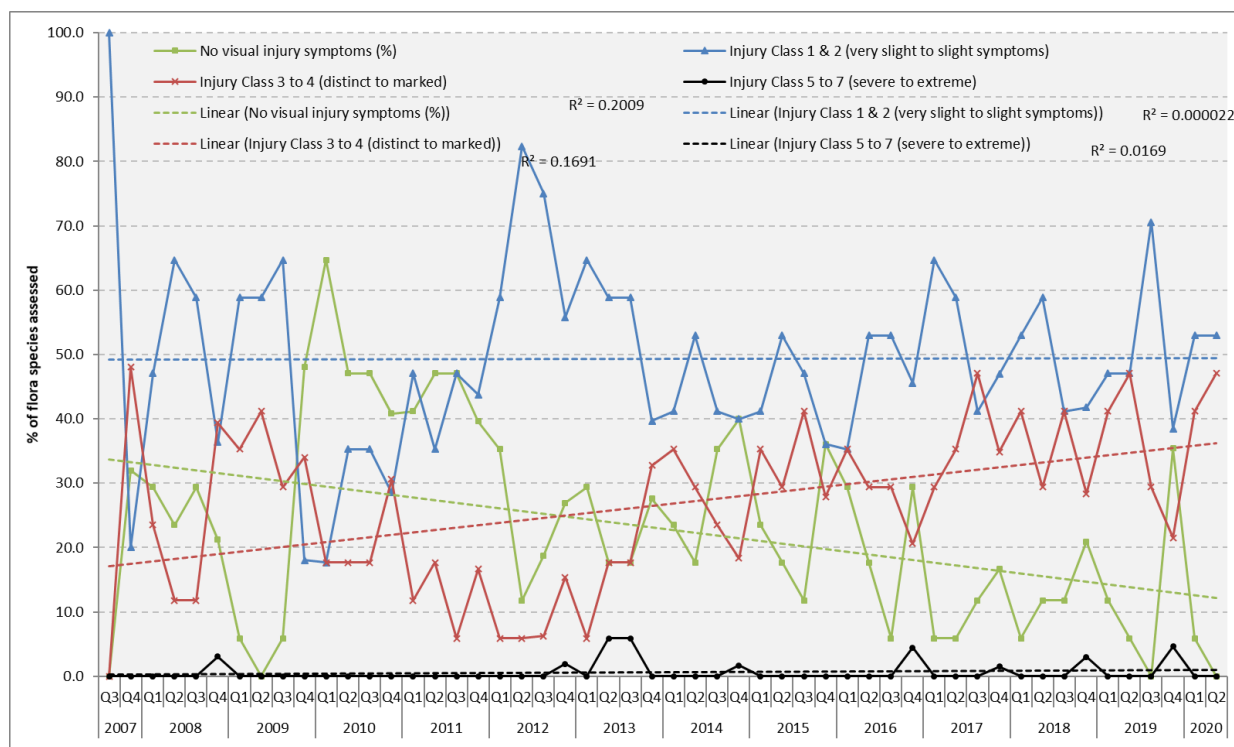
**Figure 23 Proportion of flora species affected by emission related visual injury symptoms (2007-2020)**

- Species showing no visible fluoride injury symptoms;
- Species displaying at worst class 1 (very slight) or class 2 (slight) injury symptoms;
- Species displaying at worst class 3 (distinct) or class 4 (marked) injury symptoms; and
- Species displaying class 5 injury symptoms and above (severe to extreme).

Despite clear seasonal variations, historical data show little long-term variability in the severity of fluoride impacts to vegetation surrounding the NCIA facility. The data supports no statistically significant increase or decrease in the severity of injury symptoms since the start of the monitoring program (as justified by the correlation  $r^2$  values for all severity classes being  $<0.2009$ ).

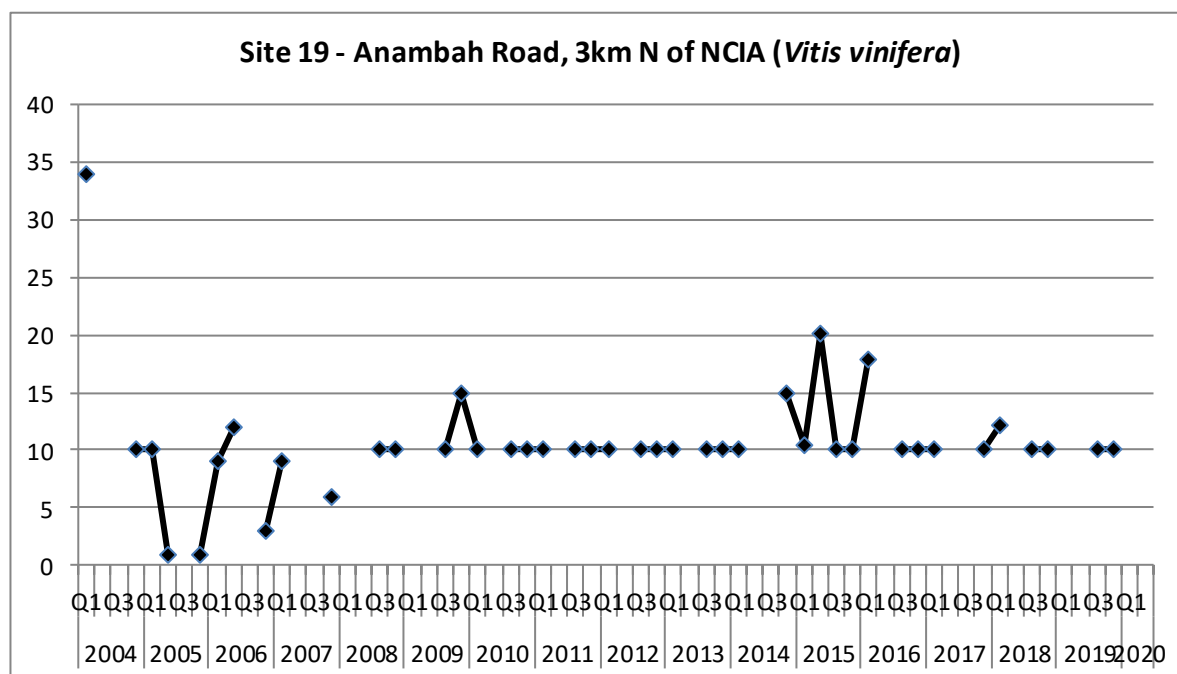
Figure 28 Fluoride content in *Vitis vinifera* foliage at Site 19 (Q1 2004 – Q2 2020)<sup>2</sup>

Given the social and economic importance of the viticultural industry in the Hunter Valley the potential impact of atmospheric pollutant emissions from industrial sources on the health of the grape vine *Vitis vinifera* (a known sensitive species) has traditionally been a concern for the industry. Consequently, foliar sampling and analysis of *Vitis vinifera* foliage from the reference site has historically been included as part of this vegetation monitoring program. Historical concentrations since the commencement of the monitoring programme are presented in **Figure 28**.

Long term data show that foliar fluoride has consistently returned very low concentrations for this species (<10.0 µg/g).

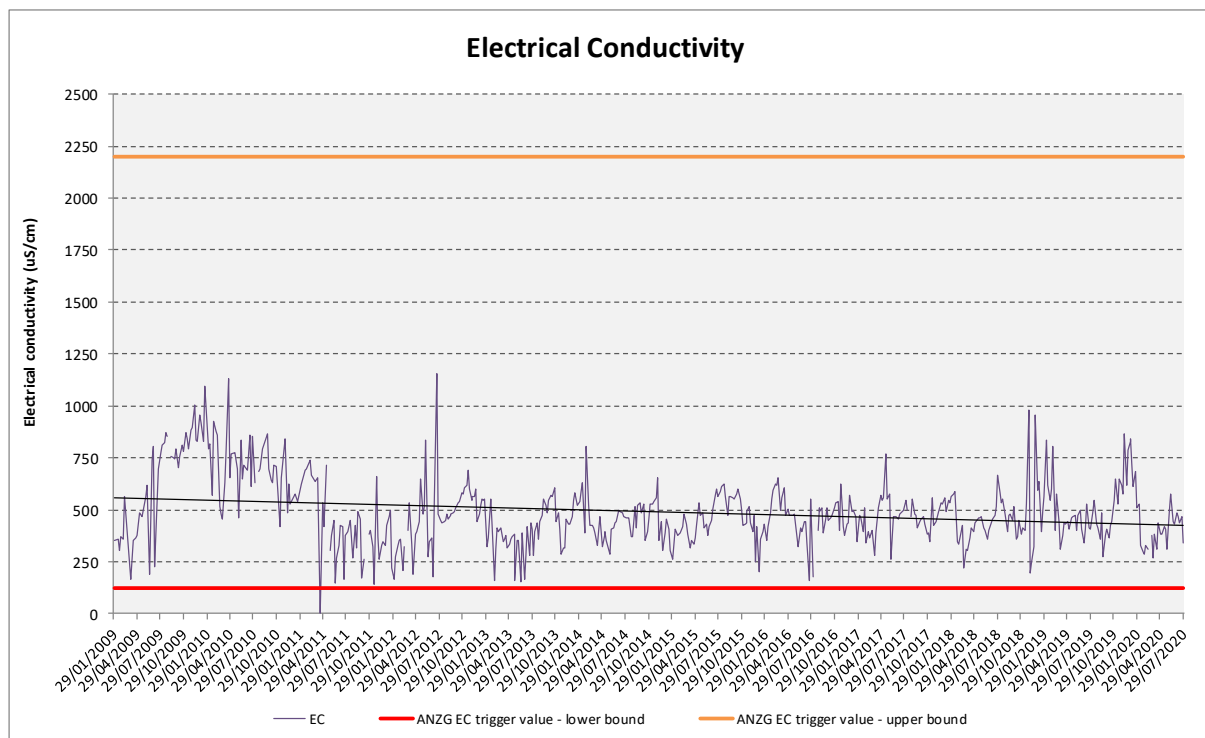
Figure 38 Stormwater quality, EC – Pond 4 (2009-2020)

EC results during 2020 are comparable to previous years with a stable average and no exceedances of the criteria (refer to **Figure 38**). A review of historical EC values indicates an overall decreasing trend. EC values are generally within the ANZG guidelines trigger values and indicate that the stormwater is non-saline.

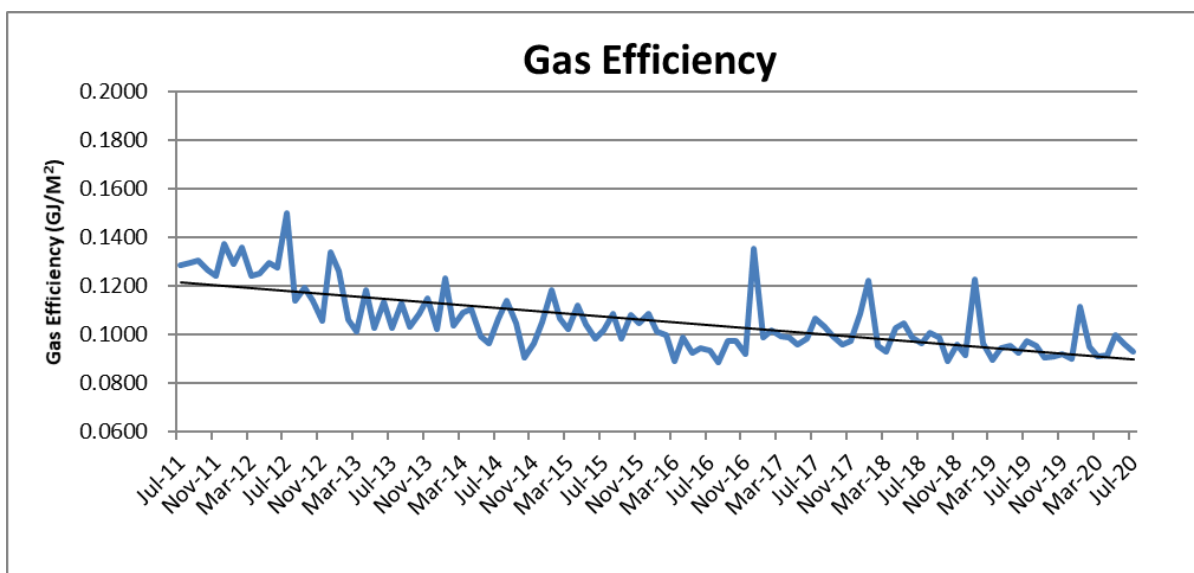
Figure 39 Gas efficiency in tile manufacturing process

NCIA has installed a Quality Assurance (QA) machine before the kiln on each of its production lines. This effectively reduces waste tiles going through the kiln and being fired, creating both a reduction in waste and a saving in energy consumption.
